Accelerator Facility Accident Report

31 May 2013

Subject: Radioactive Material Leak at the Hadron Experimental Facility of Japan Proton Accelerator Research Complex (J-PARC)

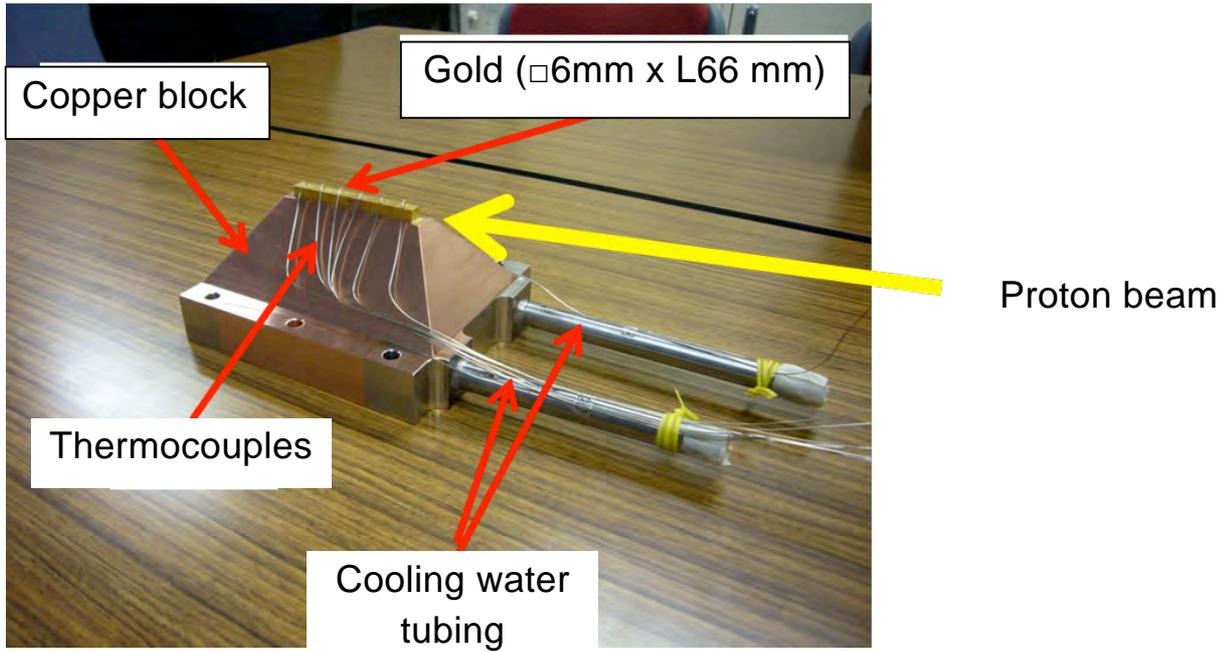
Figure 4: Gold Target before Installation

At around 11:55 of 23 May, due to a malfunction of the beam extraction system of the MR, a beam consisting of 2×10^{13} protons was delivered to the gold target (Fig. 4) within a very short time (5/1000 of a second), whereas normally a total of 3×10^{13} protons were slowly and evenly extracted and delivered to the target over a period of 2 seconds. As a result, the gold target is considered to have momentarily reached an extremely high temperature and possibly to have been partially damaged.

Fig. 4 shows the design of the gold target. It is a square rod of gold (W6 mm x H6 mm x L66 mm) which is mounted directly on top of a copper block which is water-cooled for removal of heat. Thermocouples are used to monitor the target temperature. This target assembly is housed in a metal container as shown in Fig.5.

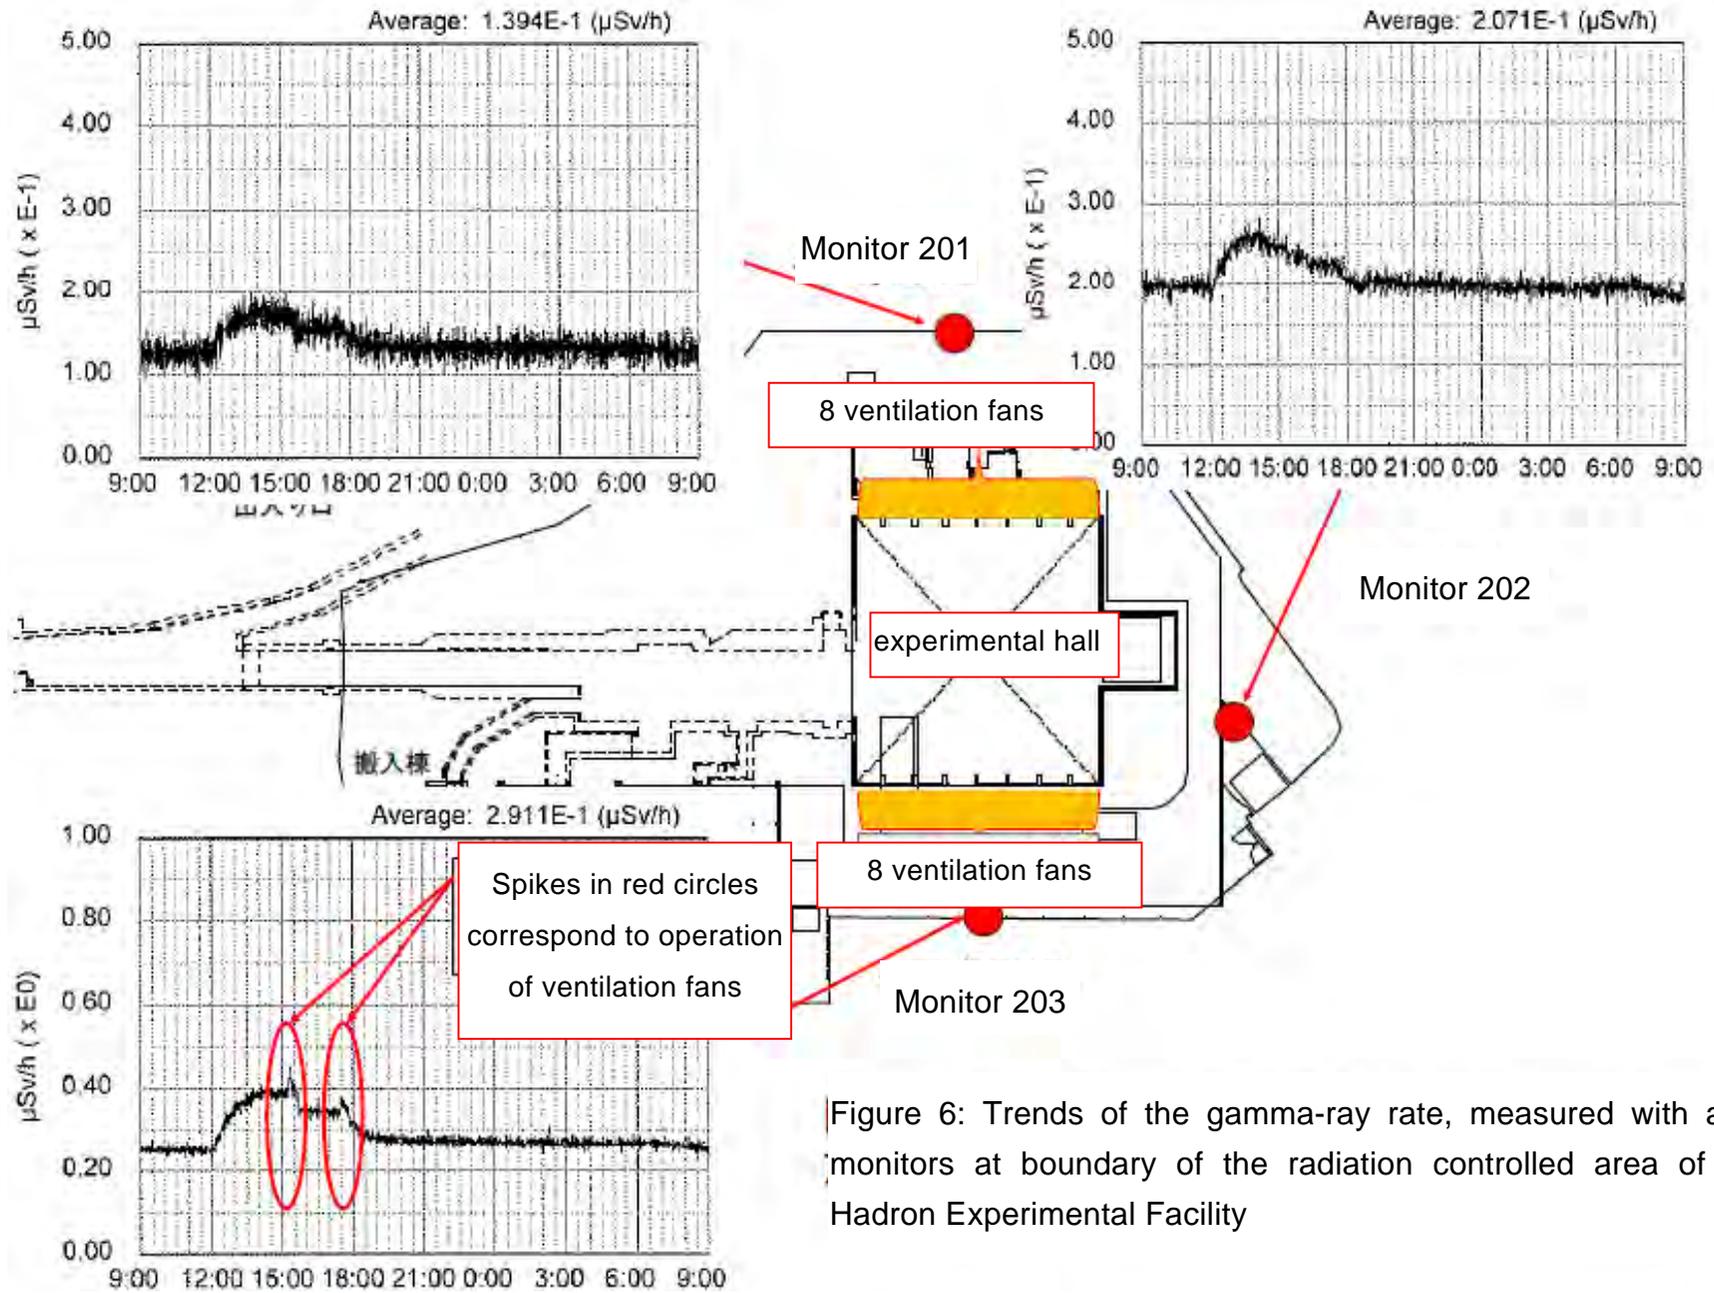
Figure 6: Trends of the gamma-ray rate, measured with area monitors at boundary of the radiation controlled area of the Hadron Experimental Facility

It was confirmed that readings of the area monitors, which were installed at the external boundary of the controlled area near the hadron experimental hall, showed increases when ventilation fans were turned on (Figure 6). However, the data logs of radiation dose rates at monitoring posts in other places in the Nuclear Science Research Institute showed no signatures. On the other hand, at the three monitoring posts and stations of the neighboring Nuclear Fuel Cycle Engineering Laboratories, near J-PARC, momentary rises of the radiation dose rate, exceeding the normal range of fluctuation, were observed twice, and they were in coincidence with the release associated with operation of ventilation fans. They indicated that it is likely that radioactive material was allowed to leak from inside the hadron experimental hall to the surrounding environment (outside the radiation controlled area).
