The radioactive material leak at the Hadron Experimental Facility of the Japan Proton Accelerator Research Complex (J-PARC) (2nd Report)

1. Introduction

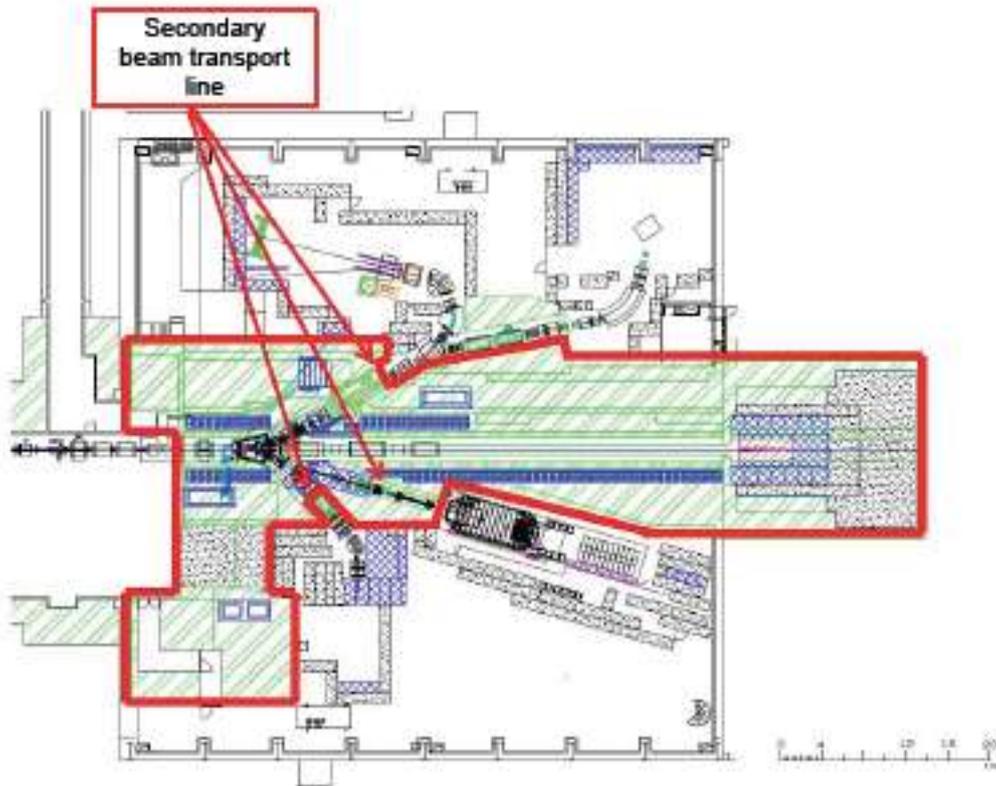
The radiation controlled areas of the Hadron Experimental Facility comprises a class 2 radiation controlled area as of the radiation hazard prevention regulations that is set in the Hadron Experimental Hall as well as in its surrounding area, and a class 1 radiation controlled area that just covers the primary beam line room in the class 2 area. Figure 2.2 illustrates the present extent of the class 1 radiation controlled area. At present a single layer shield is set up near the boundary of the primary beam line room to confine the air inside the class 1 radiation controlled area. While the 50 GeV Synchrotron is in beam operation, the air within the class 1 area is circulated and cleaned by letting part of it go through a filter to remove radioactive material. Before allowing personnel into the class 1 area for maintenance, etc. after beam operation, we exhaust the air through filters, while monitoring the concentration of radioactive material.

It is considered that the air-tightness of the target system was insufficient for the extent of radioactive material released in this accident, and the radioactive material from the class 1 area leaked into the hadron experimental hall which is categorized as class 2. Then part of the radioactive material was released from the experimental hall and then the radiation controlled area due to operation of ventilation fans.

Figure 2.2: Present configuration of the Hadron Experimental Hall. The class 1 radiation controlled area is surrounded by a thick red line.

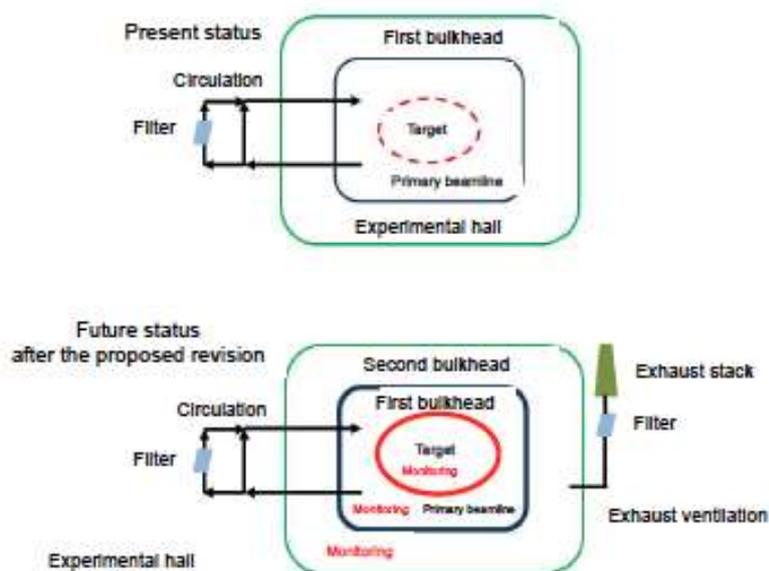
In this accident radioactive material dispersed in a class 1 radiation controlled area

leaked into the hadron experimental hall that is designated as class 2, from which the radioactive material leaked out into the surrounding space (class 1) and also released into an uncontrolled area due to operation of ventilation fans. In response to this accident, we reexamine the present state of the radiation controlled areas in the Hadron Experimental Facility and develop plans for necessary reviews of the facility and equipment based on the following policy:

Figure 2.11 shows a schematic of these points. At present, a single-layer bulkhead is set up near the boundary of the primary beam line corridor for air isolation. We will replace it with a double-layered barrier so as to enforce hermeticity around the target assembly. At present the air inside the single-layer barrier is not monitored for possible contamination with radioactive material. Our proposal includes monitoring of radioactive material in the air within each layer.

Figure 2.11: Schematic for revision of the facility and equipment. Present state (top), and after the proposed revision (bottom)

- (1) Confinement of radioactive material in the primary beam line area of the hadron experimental hall, and
- (2) Strictly controlled exhaust of air from the hadron experimental hall.

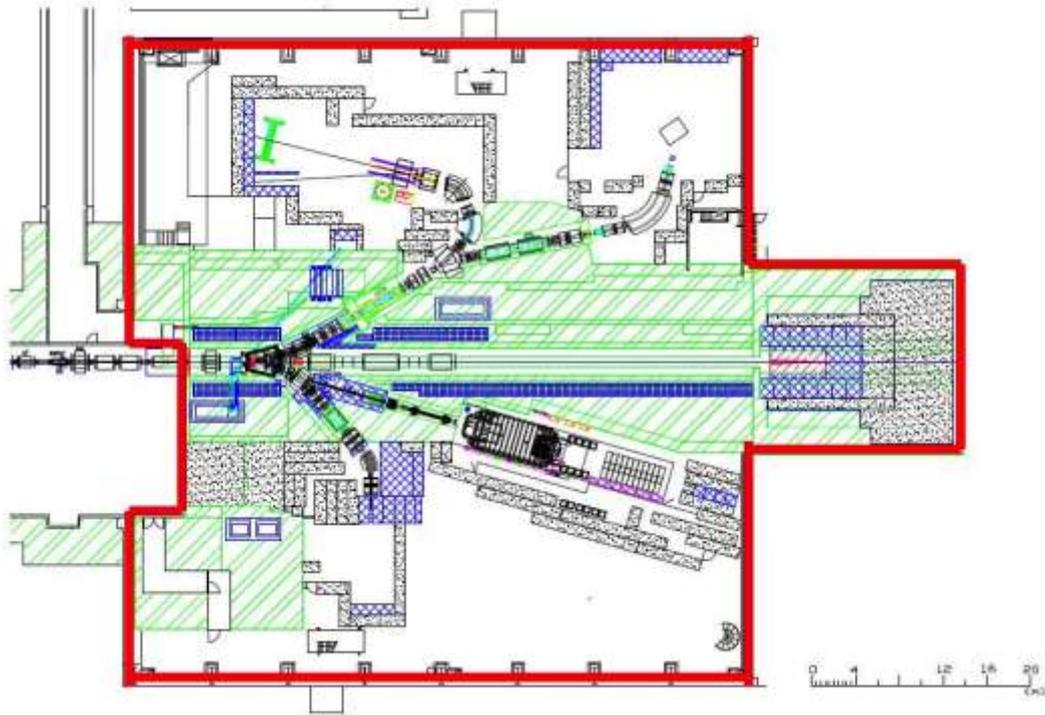
Figure 2.12: The extent which is subject to possible revision of the radiation controlled areas in the hadron experimental hall.

In addition to implementing these measures, we will reexamine the configuration of the radiation controlled areas in the hadron experimental hall. Figure 2.12 shows the extent to which the review for possible revision is to be considered.
