Report from the Working Group

Working Group for the External Expert Panel
on the Radioactive Material Leak Accident
at the Hadron Experimental Facility of J-PARC

The Second External Expert Panel Meeting to
Review the Radioactive Material Leak Accident at
the Hadron Experimental Facility of the J-PARC
at KKR Hotel Tokyo on July 5, 2013

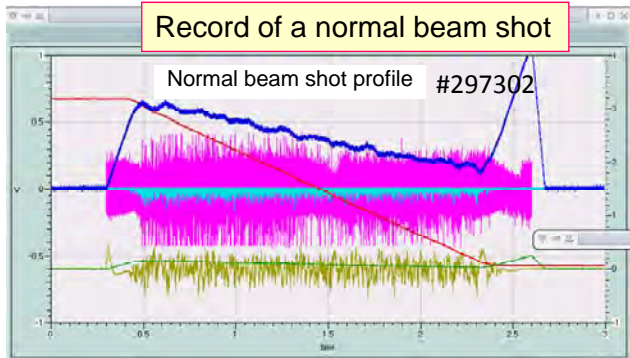
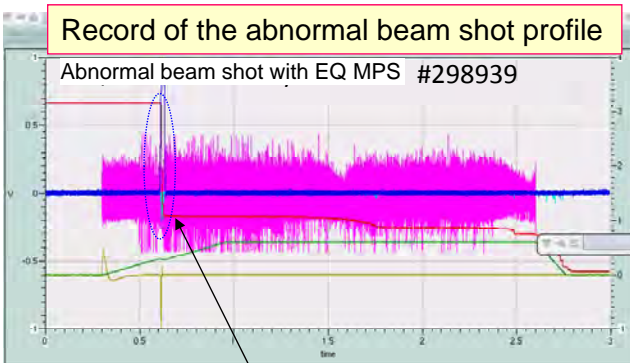
The monitor display for beam extraction

EQ: instantaneous high current output

A power supply for driving a magnet, which controls the slow beam extraction, did not properly respond to the control signal during the first fraction of a second in the period of beam spill, and then it abruptly brought a large current to the magnet.

- The accelerator operation was automatically stopped by detecting the malfunction of the power supply and the signals from the beam loss monitors.
- While the operation staff of the accelerator misunderstood that it had been due to a malfunction of the fast extraction kicker. A large fraction of the proton beam in fact was delivered to the target in HD Facility.
- The accelerator staff did not recognize the incident as one that had led to any possibility of partial melting of the gold target.

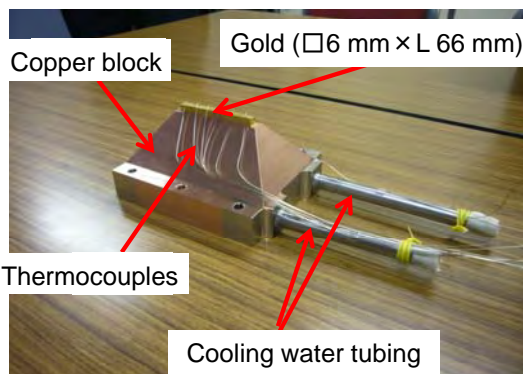
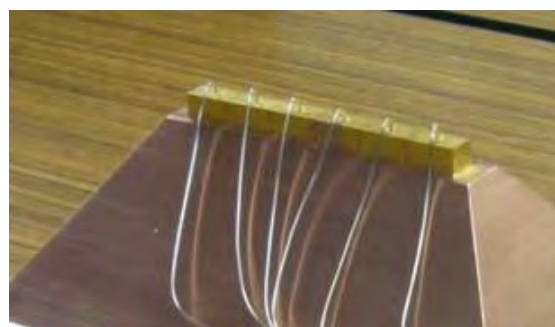
Close-up of the gold target

The target was instantaneously heated up to a very high temperature and was partially damaged, causing dispersion of radioactive material in the air of the target container.

When the beam with a diameter of ~1mm penetrated the target, a large amount of energy was deposited within a short period of 5 ms, resulting a very high temperature within the gold.

- A volume of ~1 mm in diameter and ~40 mm in length is presumed melted. The estimate above is based on simulation, which needs to be verified with site investigation that requires reduction of ambient dose rate in the neighborhood of the target as well as understanding of local authorities and local residents.
- Leak of radioactive material has not been aggravated by subsequent operation of the accelerator.

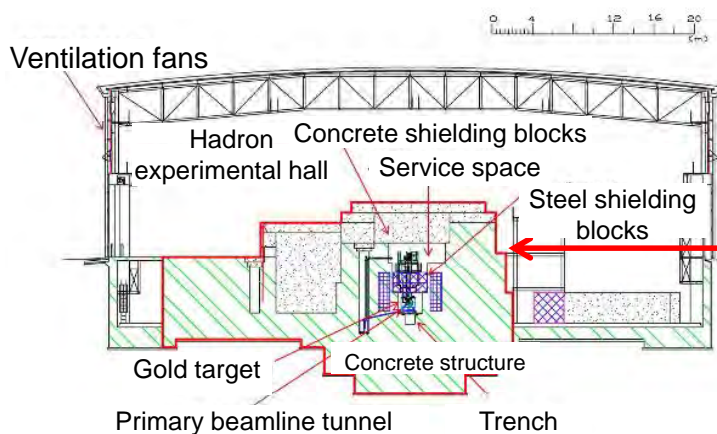
Cross section

- Air tightness of a radiation shielding wall, made of concrete or steel shielding blocks, was insufficient for this incident.
 - Rubber sheets are inserted in space between the blocks. Putty filling is applied in gaps at penetrations of ducts and tubes.
 - The provisions above are sufficient for containing Argon-41 that is produced from radioactivation of the air during normal operation.
 - The provisions above could prevent radioactive material leakage due to the target damage if the target were hermetically sealed.
 - The provisions above are not sufficient in case of an accident involving damages to the non-sealed target as in this accident.

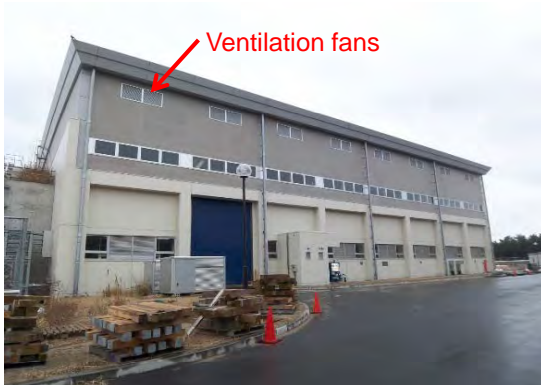
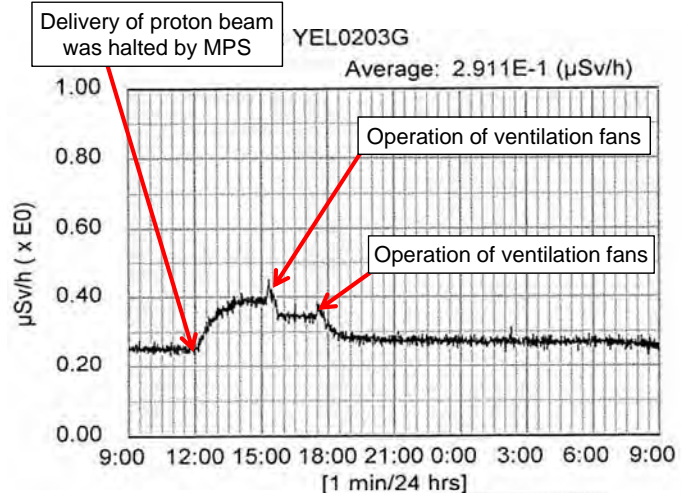
Radioactive material leaked out to the environment outside the building.

Cause: The leakage is resulted from operations of ventilation fans

- Operation of ventilation fans
 - 1st instance: to confirm the soundness of area monitors in the HD hall
 - 2nd instance: to reduce radiation exposure to users
- Since the radiation dose rate in the HD hall was below the legal limit, the environmental effect associated with operation of ventilation fans was considered negligible.
- Lack of integration of information including data from radiation monitors in the hall and those at other facilities for adequate assessment of the situation.
- Failure in making rational and logical judgment, leading to personnel's radiation exposure and delays in reporting.
