Status for Linac, etc.

Status on April 1 (1)

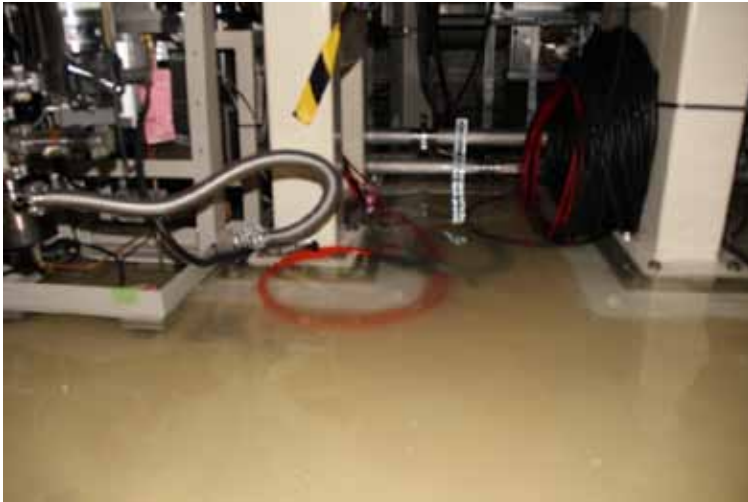
Status for Linac on March 24.

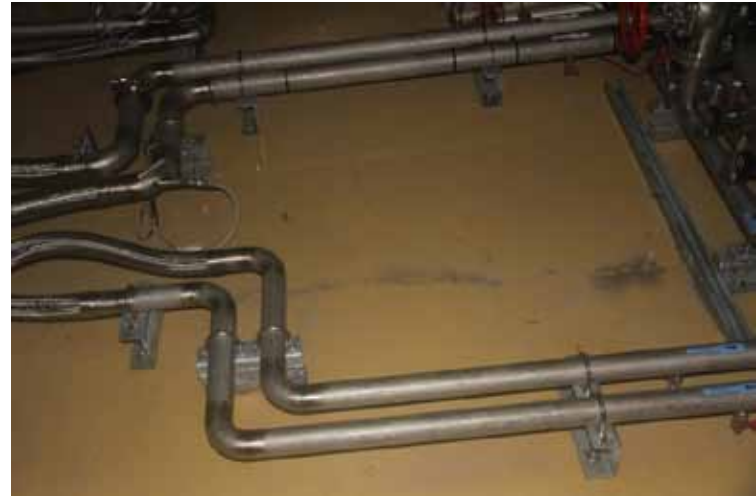
Crack observed on March 28 after pumping water.

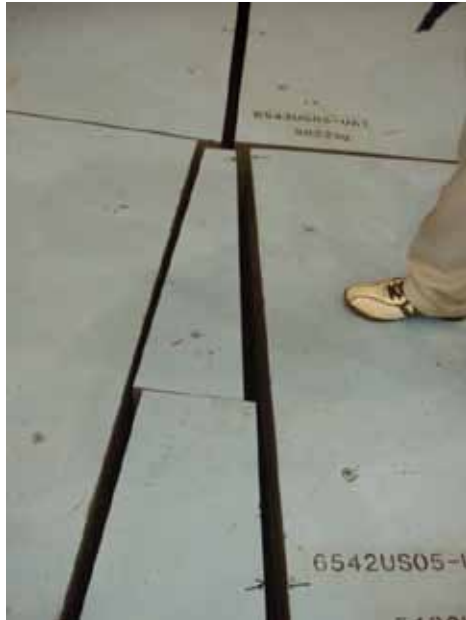
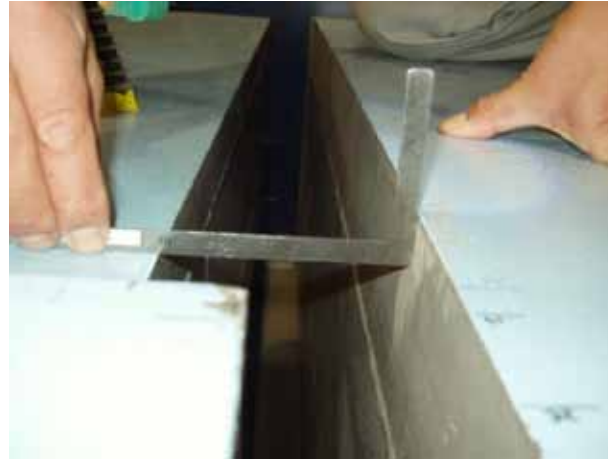
Displacement of shielding wall in MLF.
The 2nd Hall: BL20 Area (upper)
The 1st Hall: BL04 Area (left)

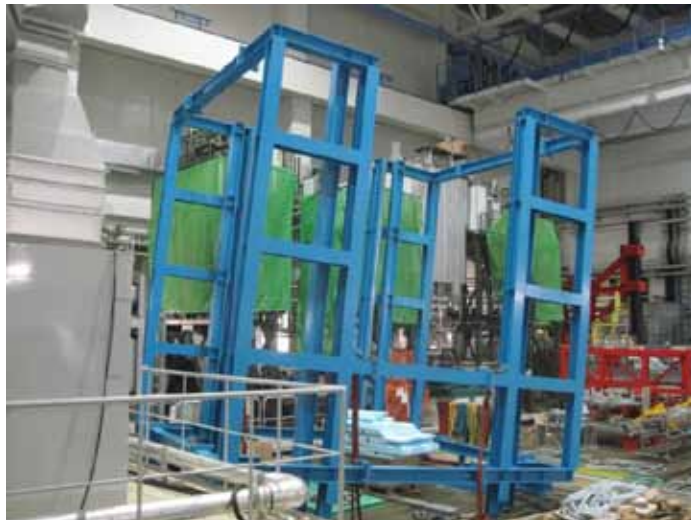
Remote maintenance guide cell for Neutrino Horn.
Very dangerous situation.

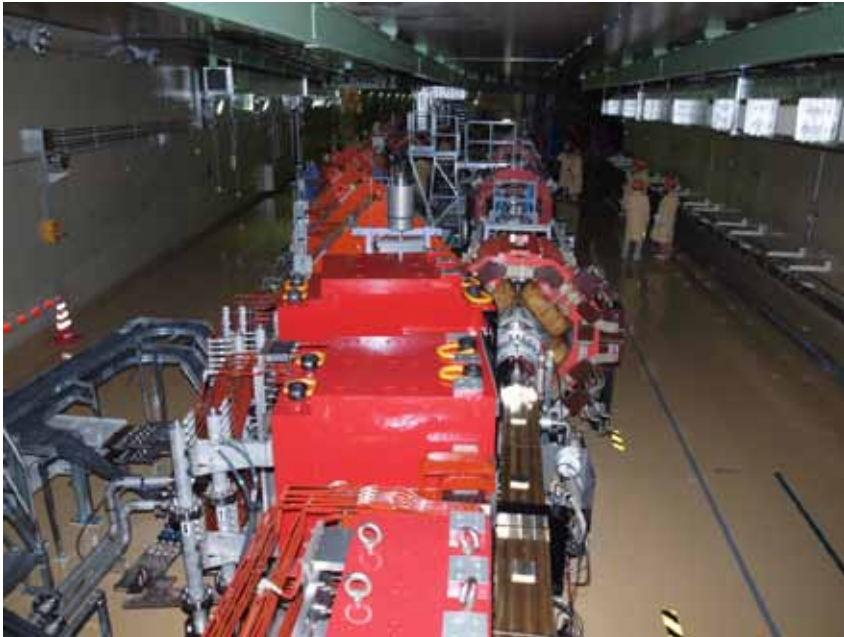
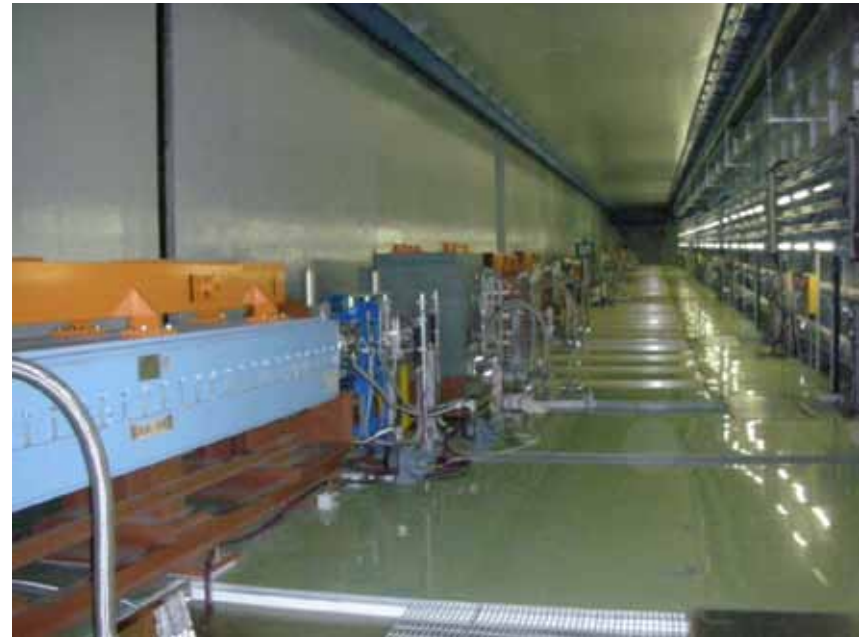
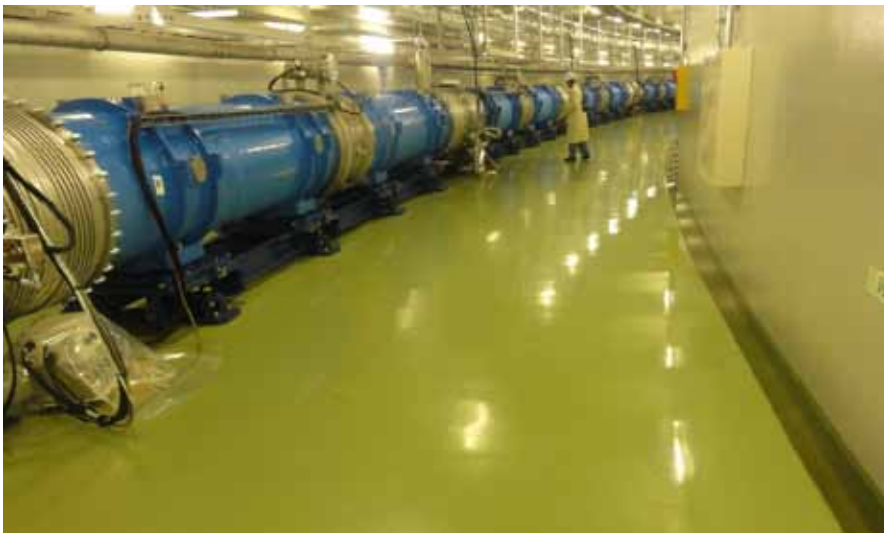
After lights are on, healthy looking areas.
Detailed check will be performed soon.

- 1) 3 GeV Main Ring (upper left).
- 2) Beam line from switch yard to Hadron Hall (upper right).
- 3) Superconducting primary beam line for Neutrino (left).

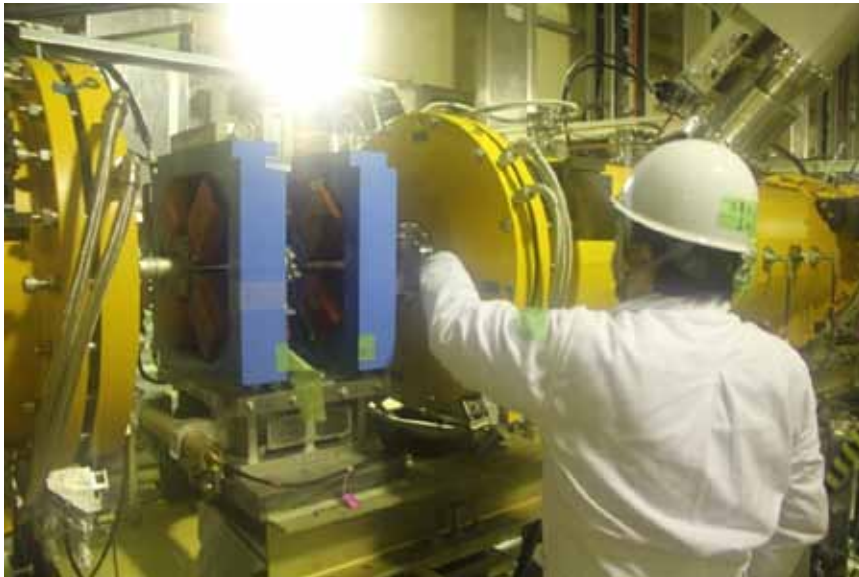
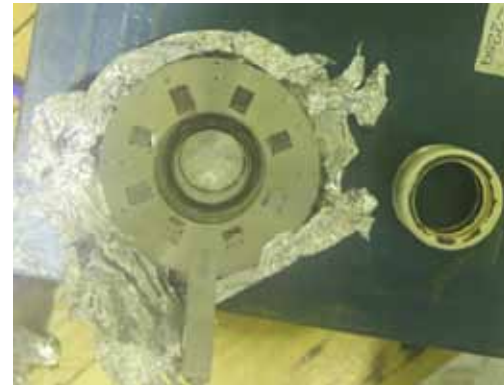
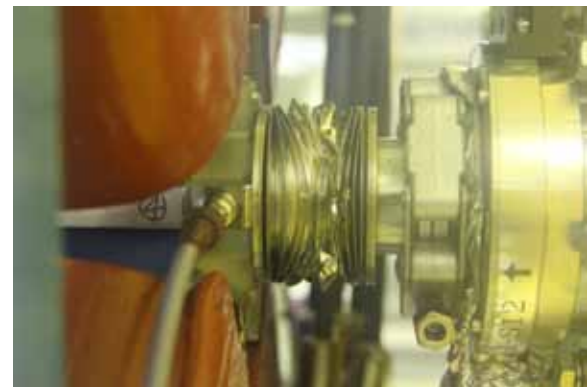
Ceramic Vacuum Current Transformers located between the cavities (upper and upper right). Over 20 of them were destroyed.
Sharply bent joint bellows (right).
