**Status Report
May, 2011**

J-PARC Center

J-PARC Recovery Schedule (@2011.5.20)

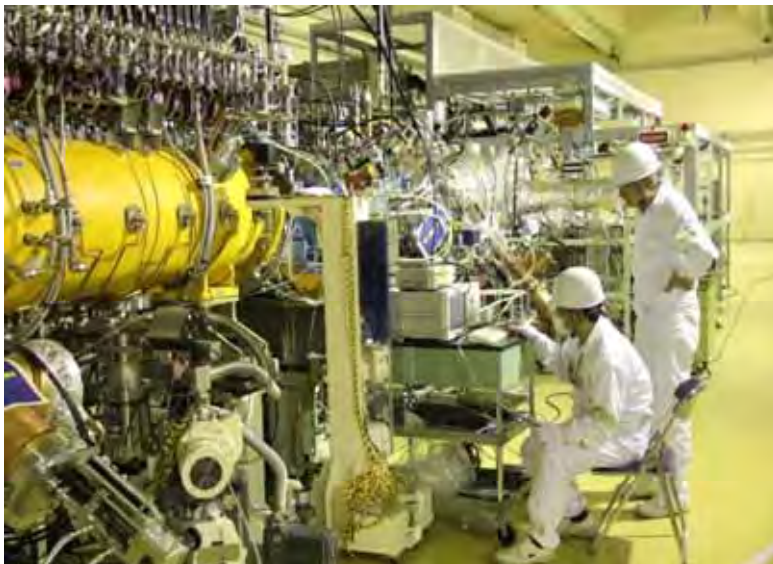
- Test of the vacuum. No serious problems. Mass spectroscopy detected H₂O.
- Q-value and Frequency for DTL measured. No serious problems.
- Inspection of the cavity has been continues. No serious problems.

Low power test for DTL.

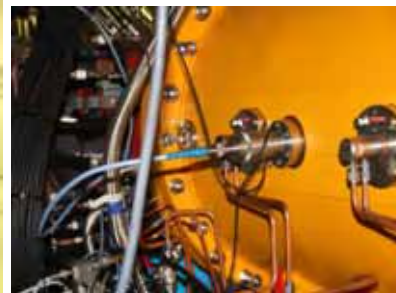
Using pick-up board , tests for high frequencies with low power is tested.

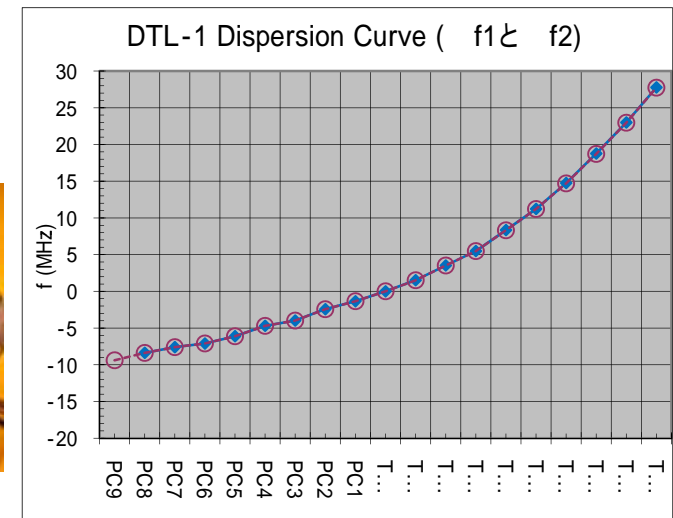
Red Before the earthquake.
Blue: After the earthquake.

No significant change observed
Before and After.

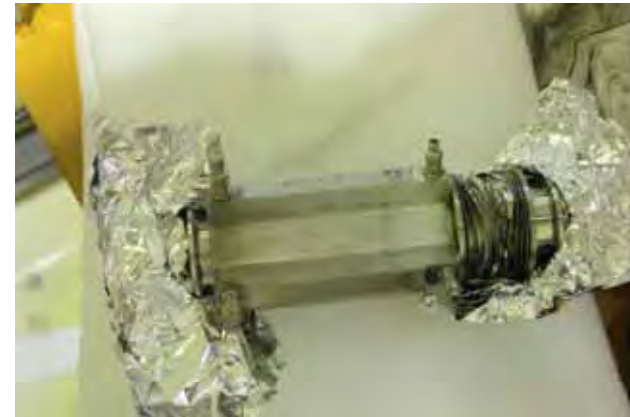
- Many CT's (Current Transformer) and BPM's (Beam Profile Monitor) were damaged.
- Vacuum leak test for individual BPM was done. Test for wire movement, etc performed.
- Purchase orders for damaged CT's and BPM's done.

BPM (Beam Profile Monitor) extracted from Q-Magnet. Bellow was destroyed.

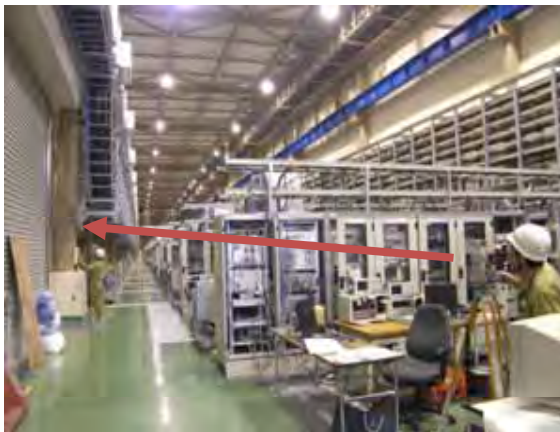
Measurement by laser for Klystron (10 mrad distortion toward west side was observed) .

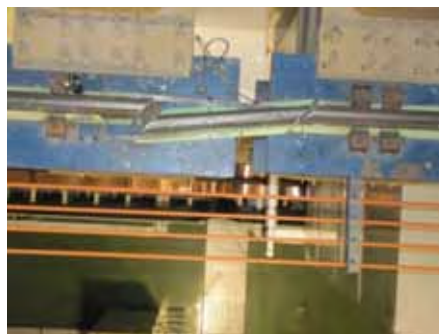
- Electric cables were partially damaged, so that electric supplies are still very limited. Low-voltage systems are OK though. Using low-voltages many investigations are in progress.
- Crane on the ceiling and crane rail are distorted. Limited usage of the crane.

Crane rail in the Klystron Gallery (partial damage detected).

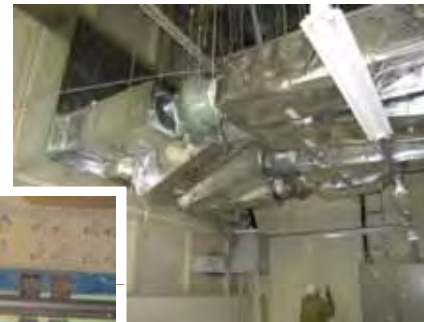
Air conditioning Pipe is falling down.

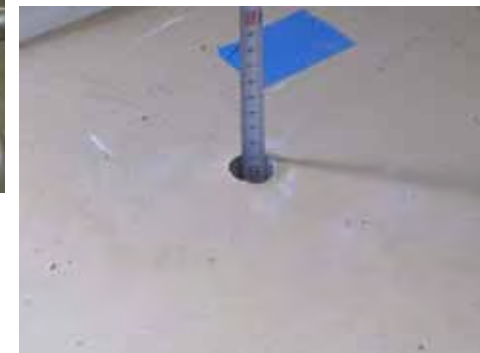
One room on the side. By digging a hole, 50 cm hole (gap) was detected.

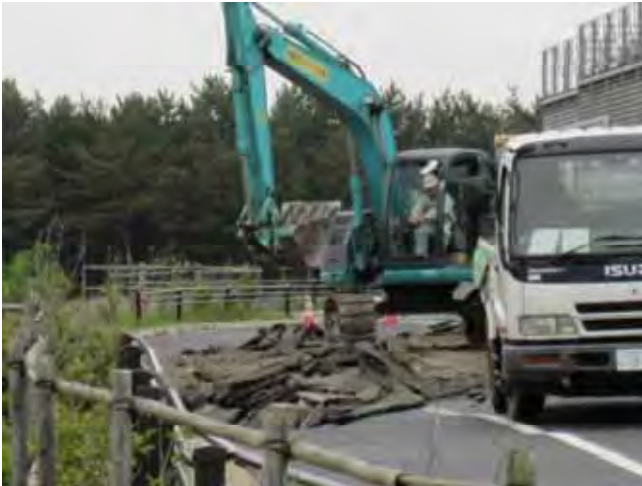
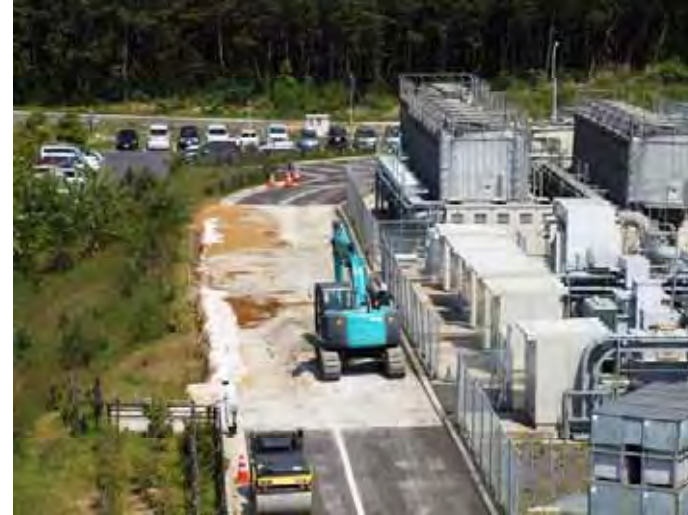
- Repair started. This place is important to fix cooling tower and electric power stations.

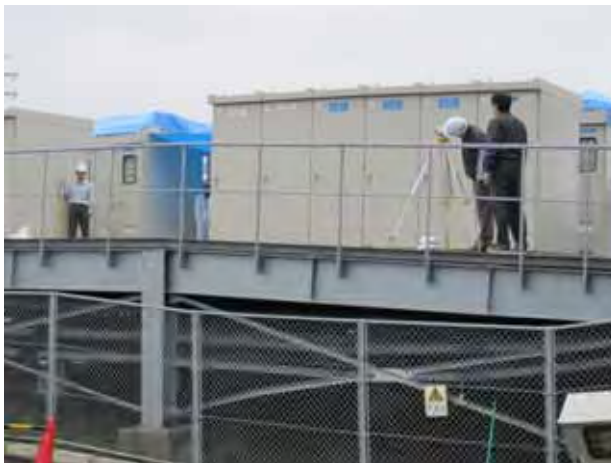
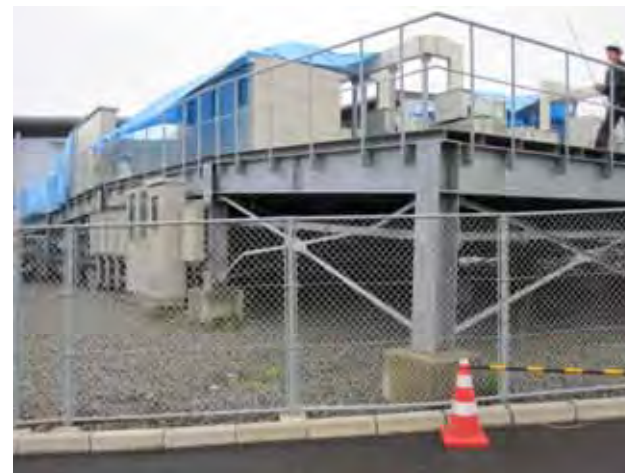
- Leaned electric power supplies. Jacking up the entire floor will be tried.

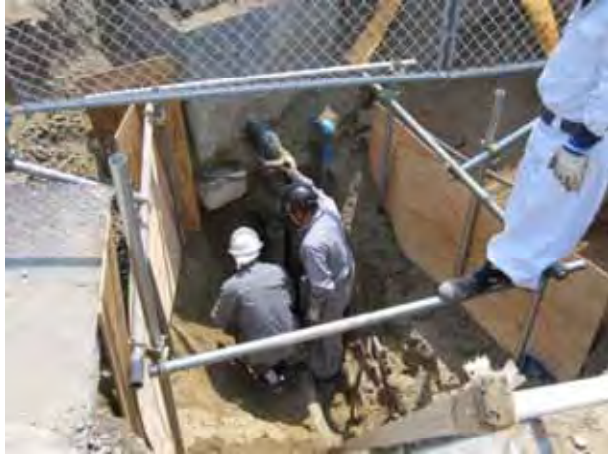
5/18

Temporarily fixed.

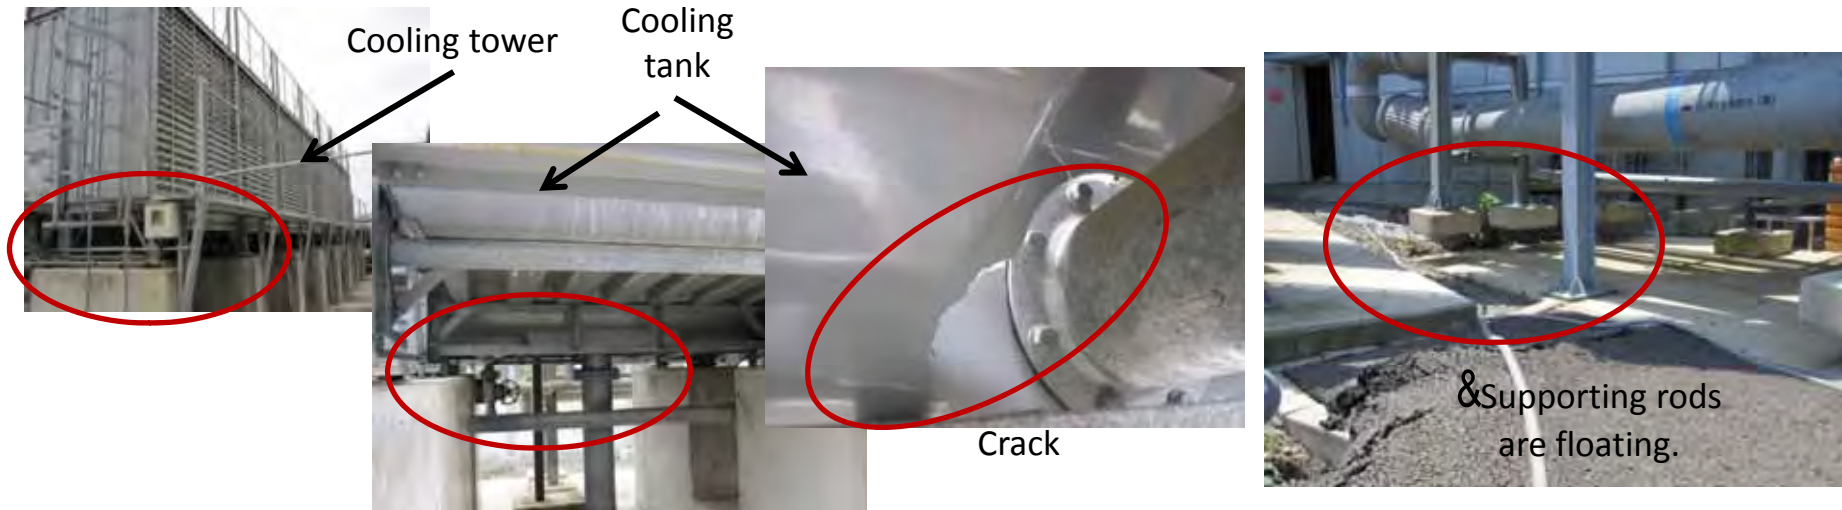
· Several places are damaged. Need to replace to a new one.

Crack

& Supporting rods are floating.

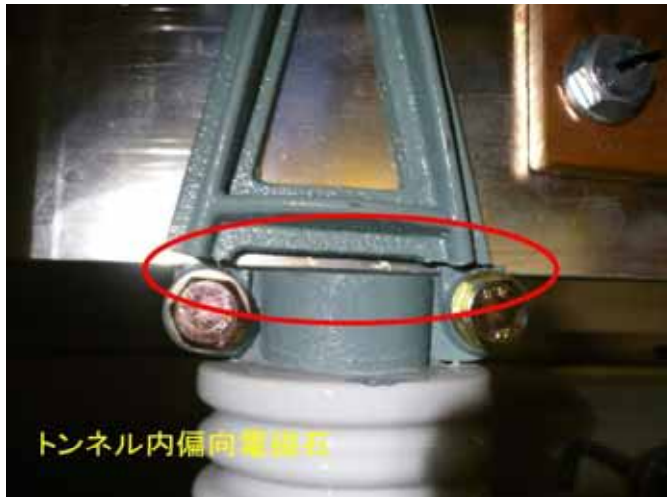
- In some dipole magnets ceramics or castings had certain damage, as shown below. All of them are changed to new spares.

Casting that was broken (Dipole magnet)

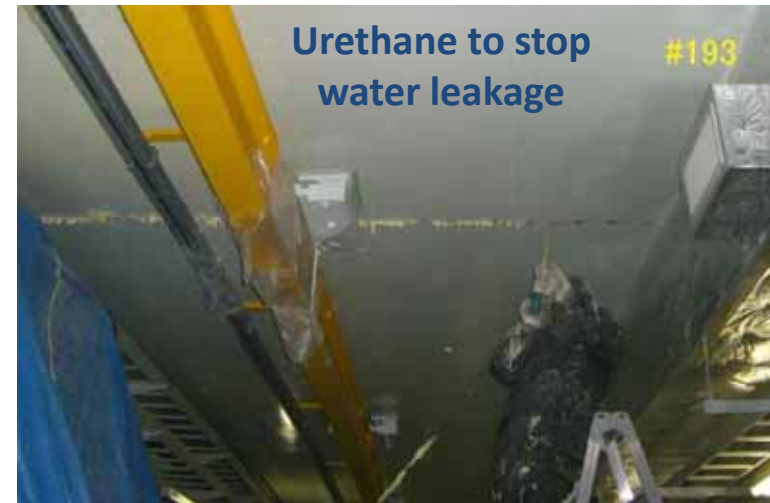
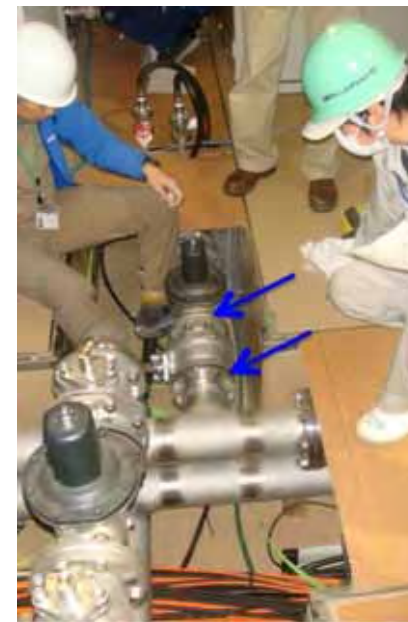
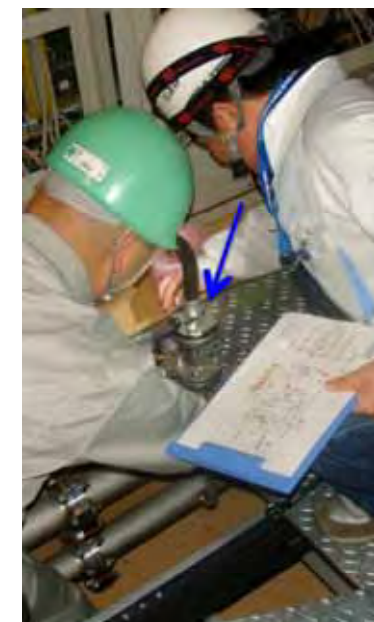
Test cooling water. Arrowed are the places to be fixed.

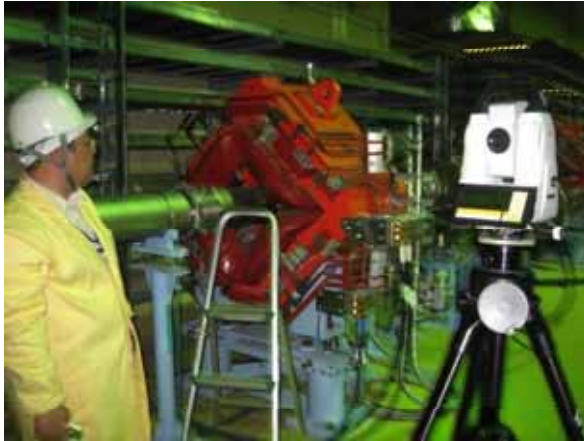
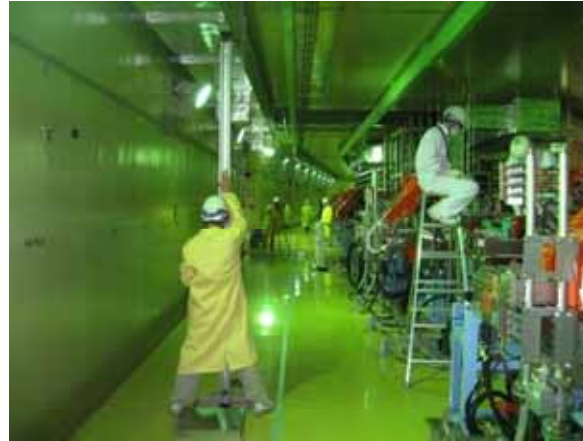
3NBT tunnel

- From RCS (3 GeV Synchrotron), MLF is dropped by 12mm.

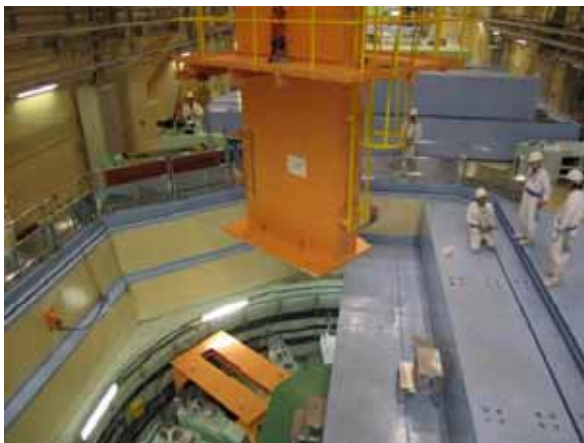
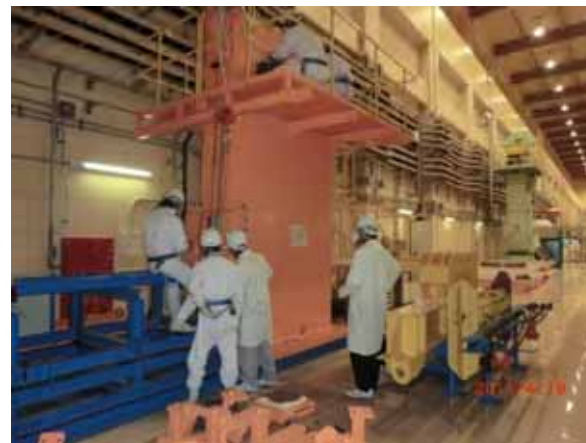
- Shutter has some problems.
- Due to strong earthquake, bolts were either damaged or unscrewed.

Inspection of Shutter blocks with crane.

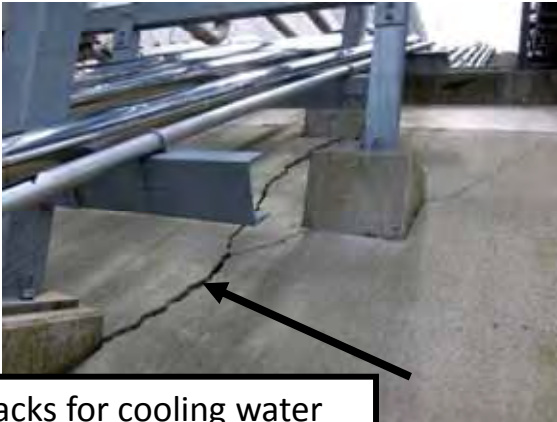
Cracks for cooling water

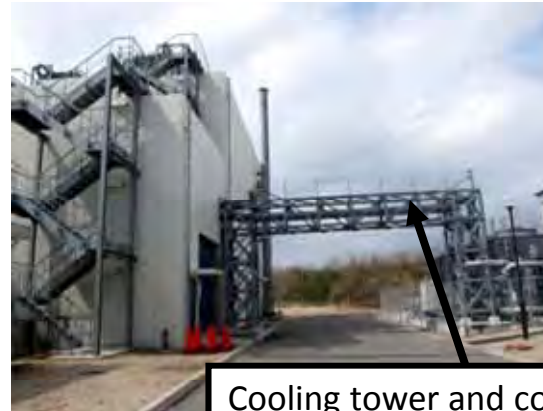
Cooling tower and cooling pipe (both bent, but possible to use as it is.)

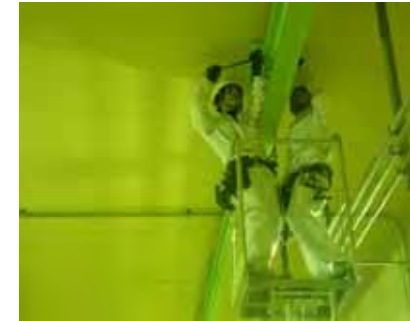
Inspection off crane rail on the ceiling at Linac.
