# Status of LINAC Facility in July-1

## Restoration Work of Building

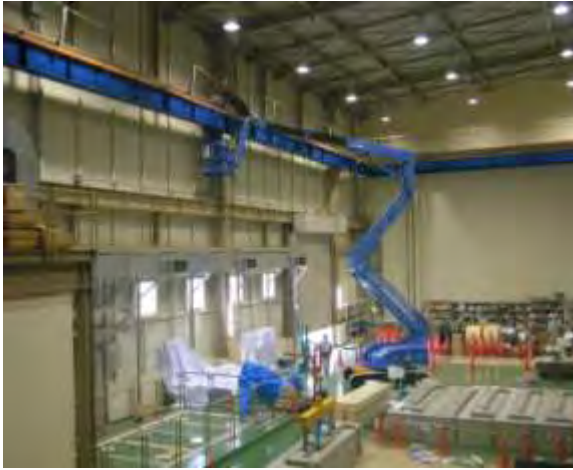
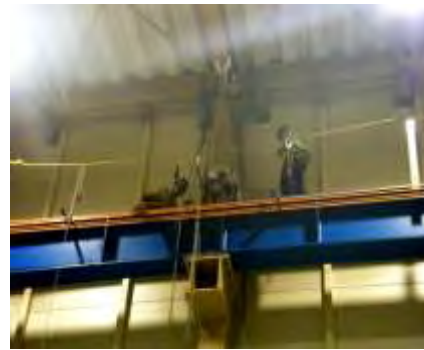
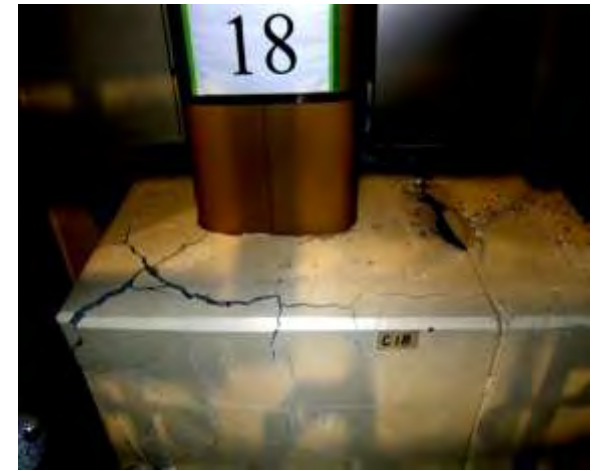
After evaluating damages (e.g., crack width) in concrete-bases for roof-poles in Klystron gallery, the restoration plan has been made (Right photo).

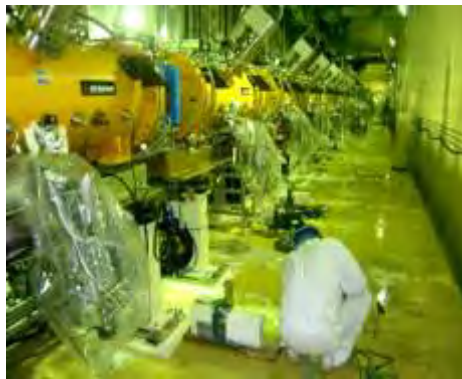
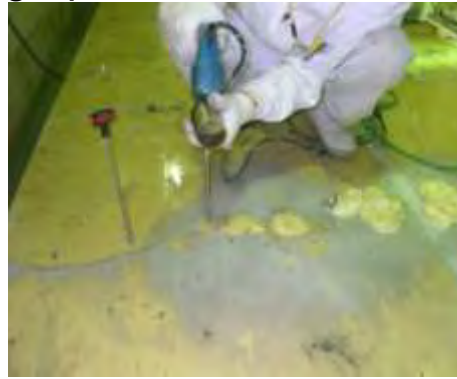
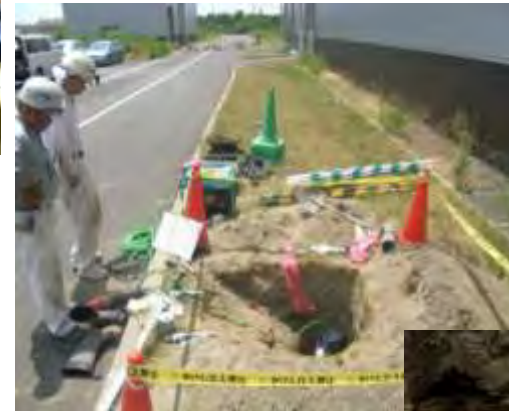
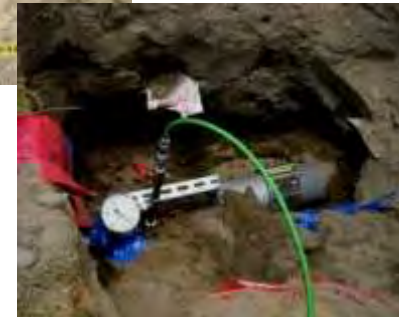
Restoration work of the crane with using a special construction machine for high-position work.

Repairing water leaks in the tunnel is going smoothly.

Investigating the plumbing for outside fire hydrants, and replacing damaged pipes.

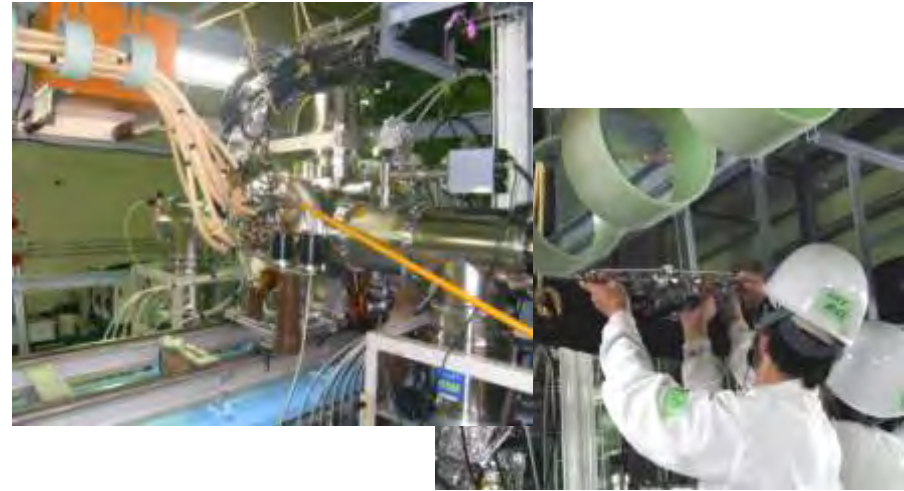
- Realignment is not necessary. This is also confirmed through the calculation of RFQ beam.
- Installation of the plasma production room, and wiring and plumbing work have been conducted.

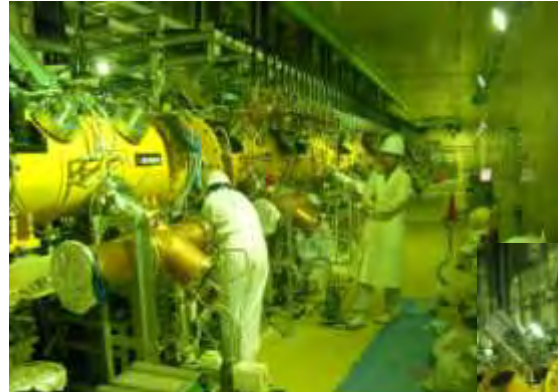
- Realignment of the chambers of DTL and SDTL is continued.
- Misalignment of each axis of three chambers of DTL appeared to be within 0.1 mm.

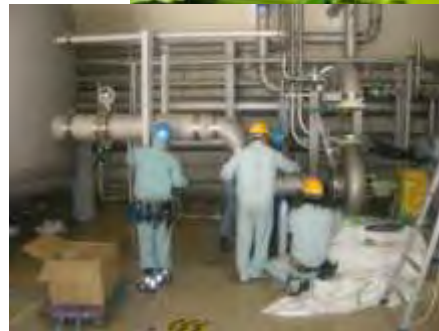
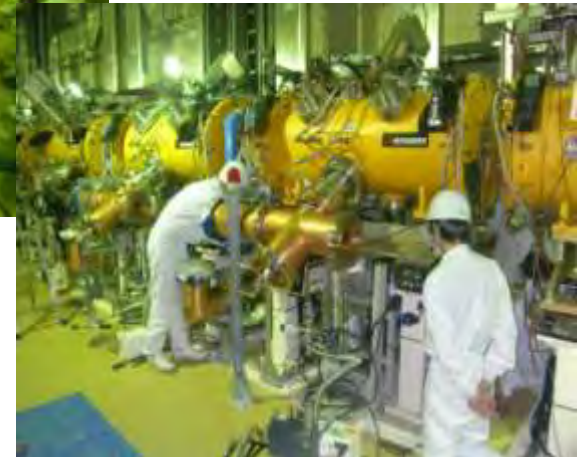
- Restoration work of the plumbing and pumping system is continued.
- CRYO pumps were removed and inspected.

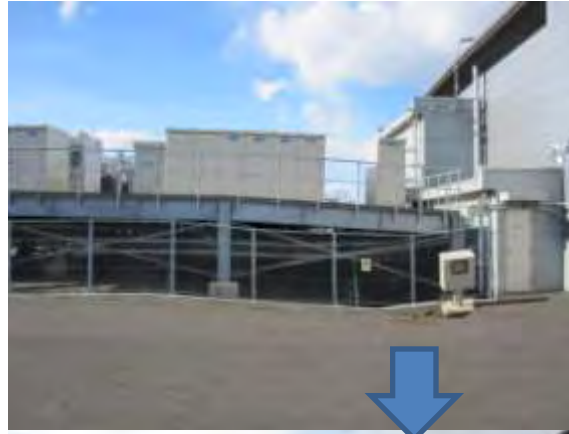
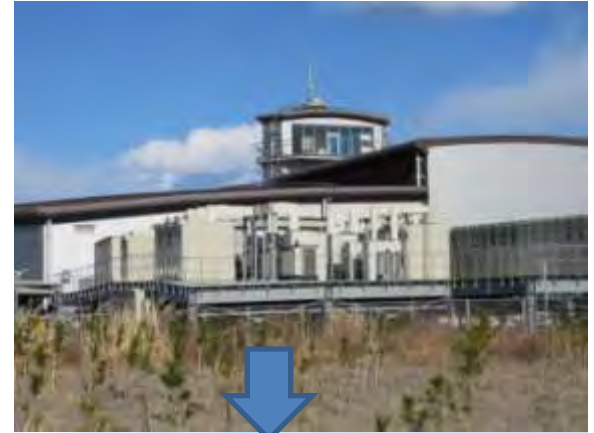
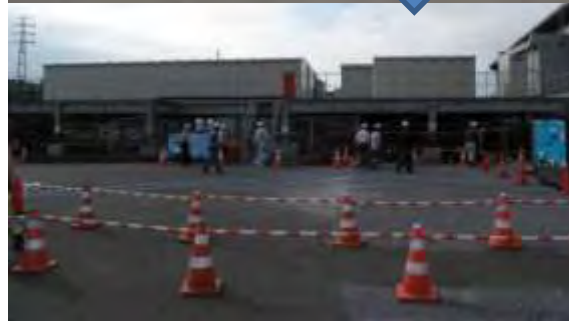
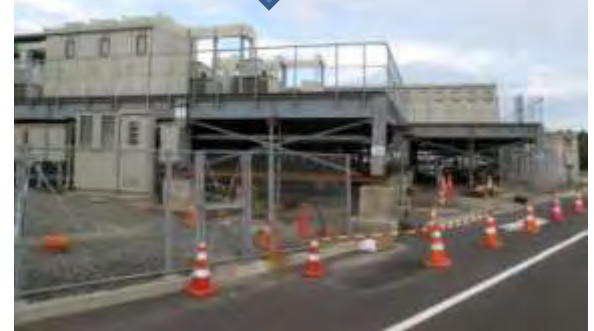
- Stages for the equipment to receive high voltage power were jacked up to maintain their level.
- After confirming its soundness, continuous current tests have started.

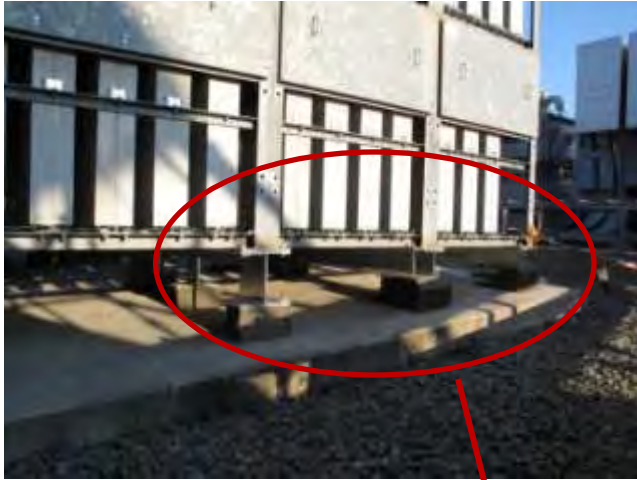
Primarily restoration work of the condenser and transformer has been conducted.

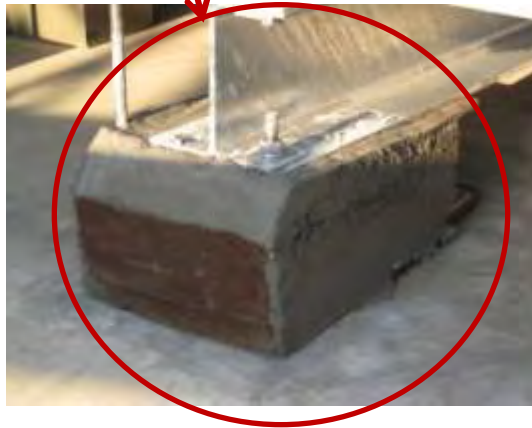
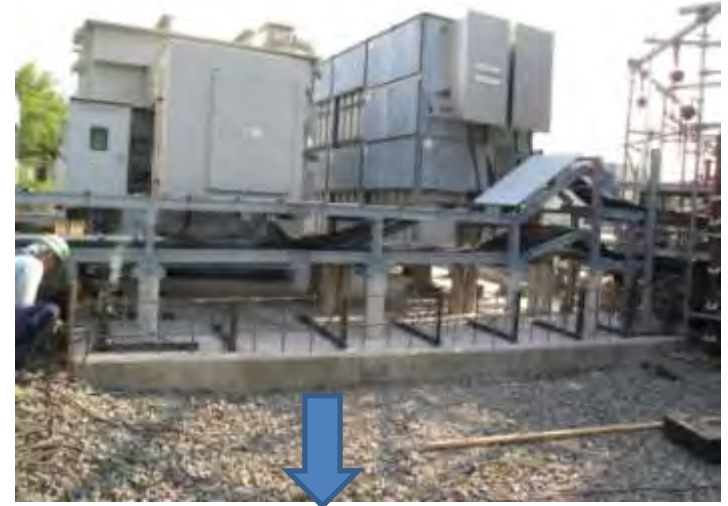
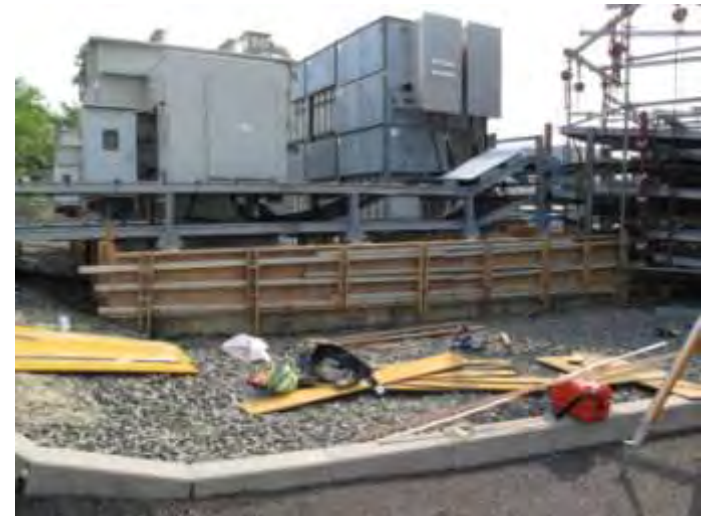
Placing concrete blocks to maintain height of the condenser.

The tilted condenser was straightened.

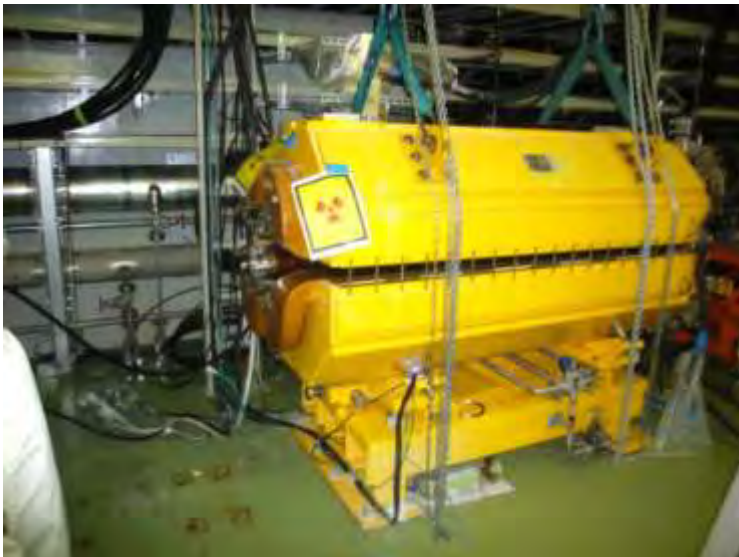
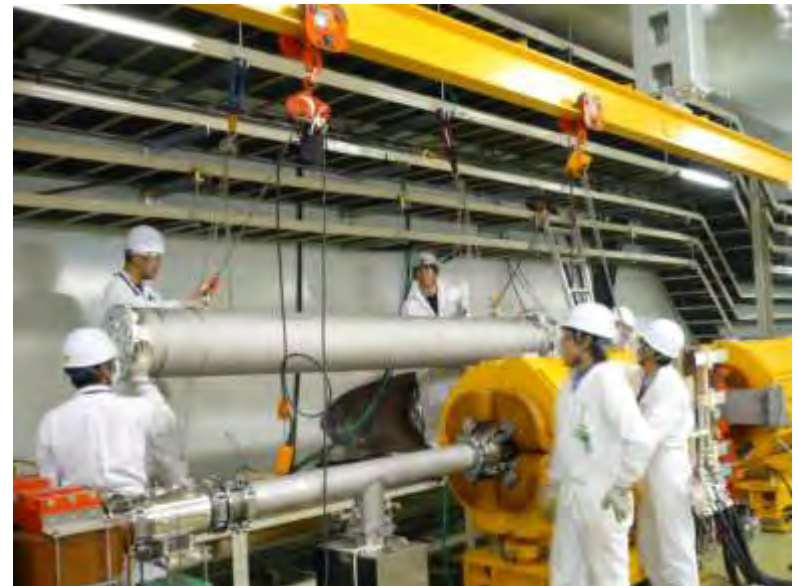
Revamping work of equipment, including improvement of shielding around the ring collimator area, has started. The lower photos show the work for removing beam pipes.

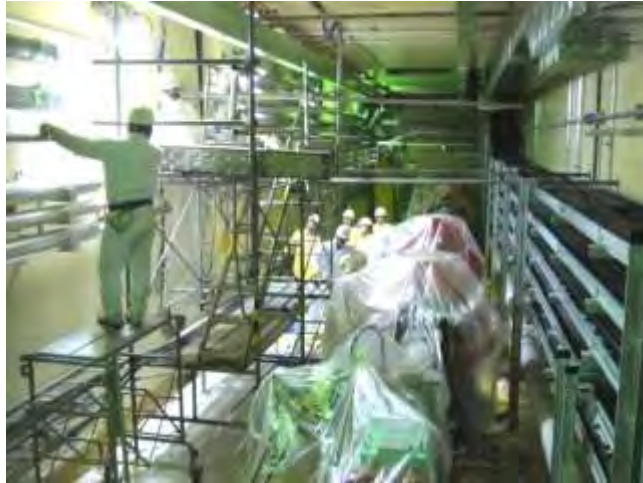
All pipes mounted on walls were removed prior to restoration work.

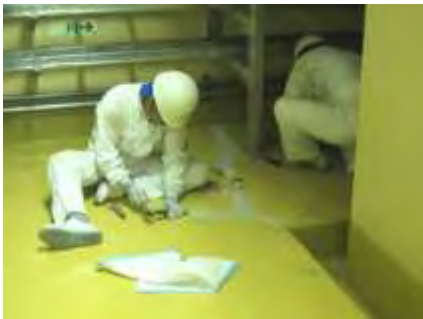
Floor in a tunnel has been repaired.

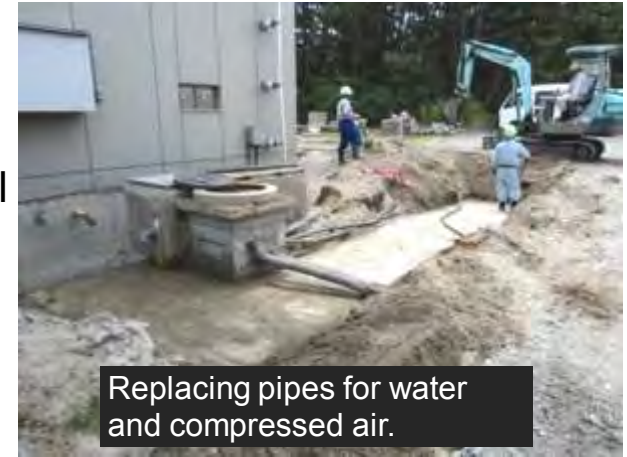
Replacing pipes for water and compressed air.

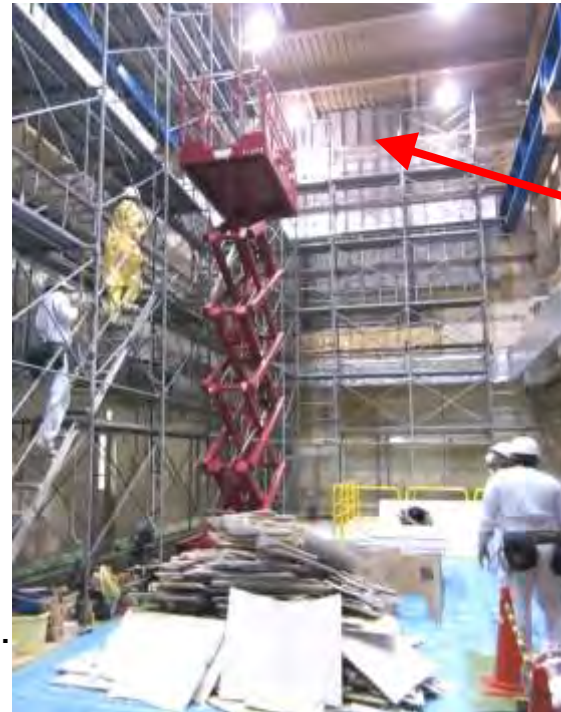
Damaged wall boards were replaced.

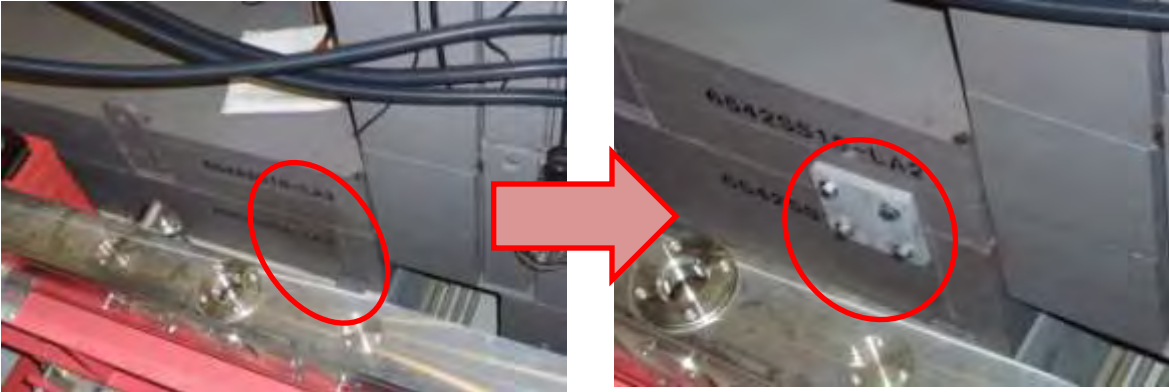
- Realignment of shielding materials has been continued with using a connection plate appropriately.

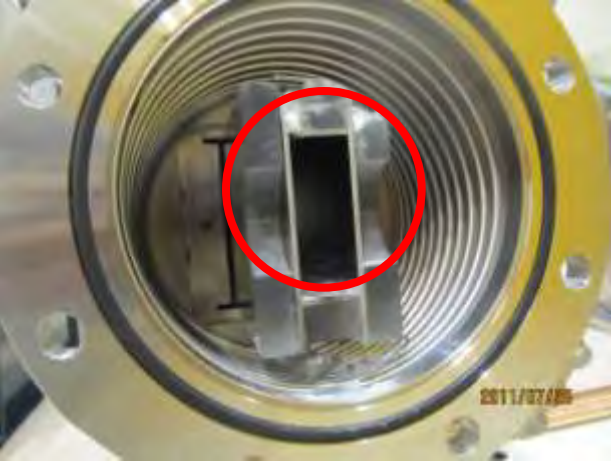
Super mirror was broken.

- A guide pipe was damaged at attached part of an additional building, and replacement parts have been already ordered.

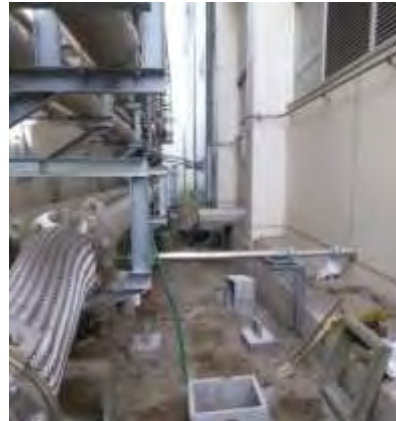
South Side of the 2nd Machine Bldg.

- Damages around the buildings have been restored.
- Restoration work of beams and walls in the experimental hall goes smoothly.

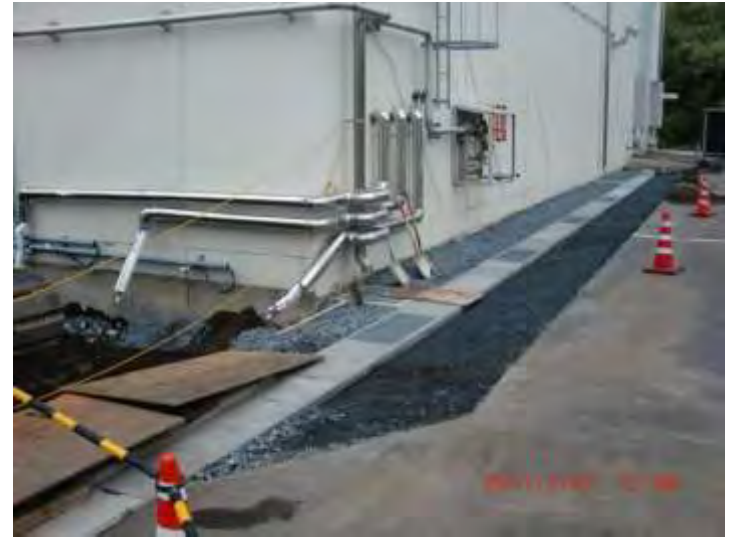
Current Status around the Target Station

- Ground/road conditions around the target station have been almost restored.
- Crane at a bring-in entrance has got back in operation. No damages were found in shielding blocks and gaskets.
