Current Status of J-PARC Facilities

September, 2011

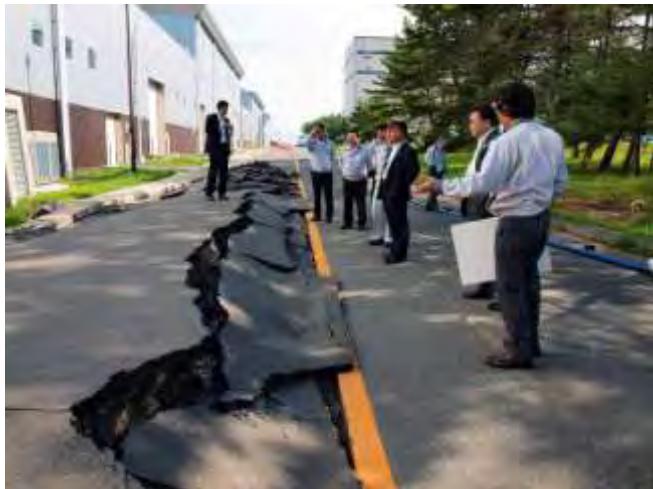
Immediately after the Earthquake

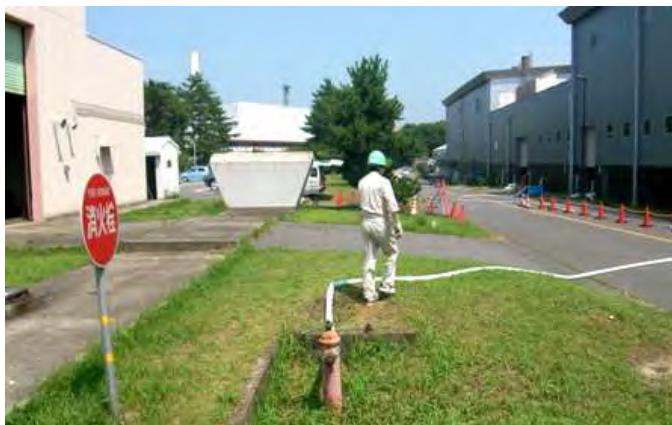
Outside of LINAC building is also heavily damaged.

We are getting water from an outside fire-hydrant, as original cooling water system has not yet been fixed.

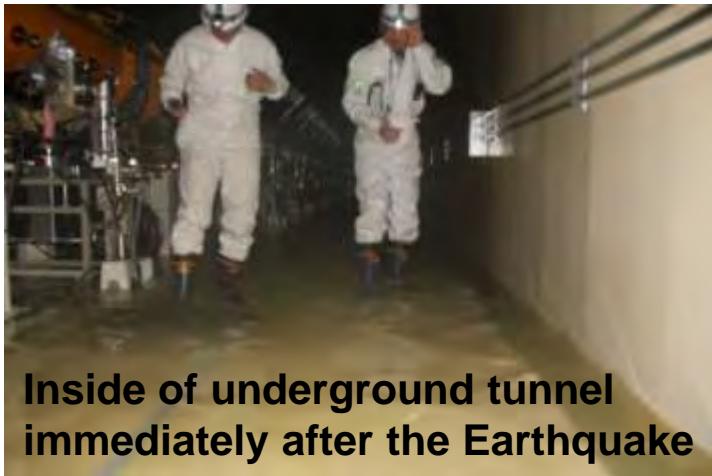
Inside of underground tunnel immediately after the Earthquake

- Many spiles reached to a basement rock minimized a direct damage to the tunnel. However, groundwater leaked into the tunnel and the water depth increased to 10 cm (100 tons) within two weeks after the earthquake.

- Repairing water leaks in the tunnel is almost completed.

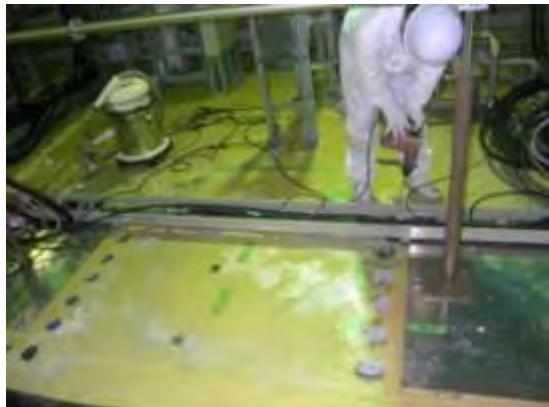
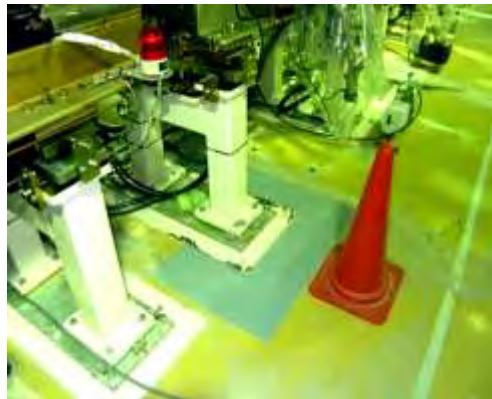
- Many damages on partitions and ceiling boards of the building.

- The restoration work continues.

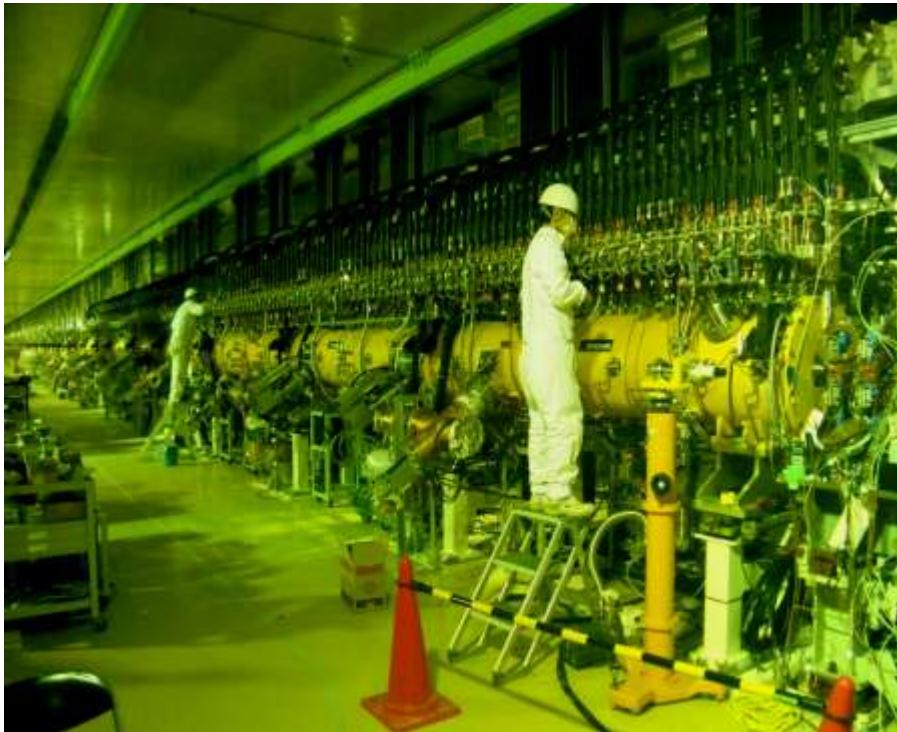
- Fortunately, there were no severe damages on the equipment/instruments, except some monitors, in the tunnel. Damaged monitors have already been replaced.
- The floor level sagged 4 cm downward in the tunnel. Because accelerator cavities should be aligned within ± 1 mm to each other along the beam line for the operation, they have been leveled and realigned where necessary.
- Restoration work on the cooling water system and power supply is going smoothly.

Realigned accelerator cavities of DTL and SDTL were tested for water-tightness.

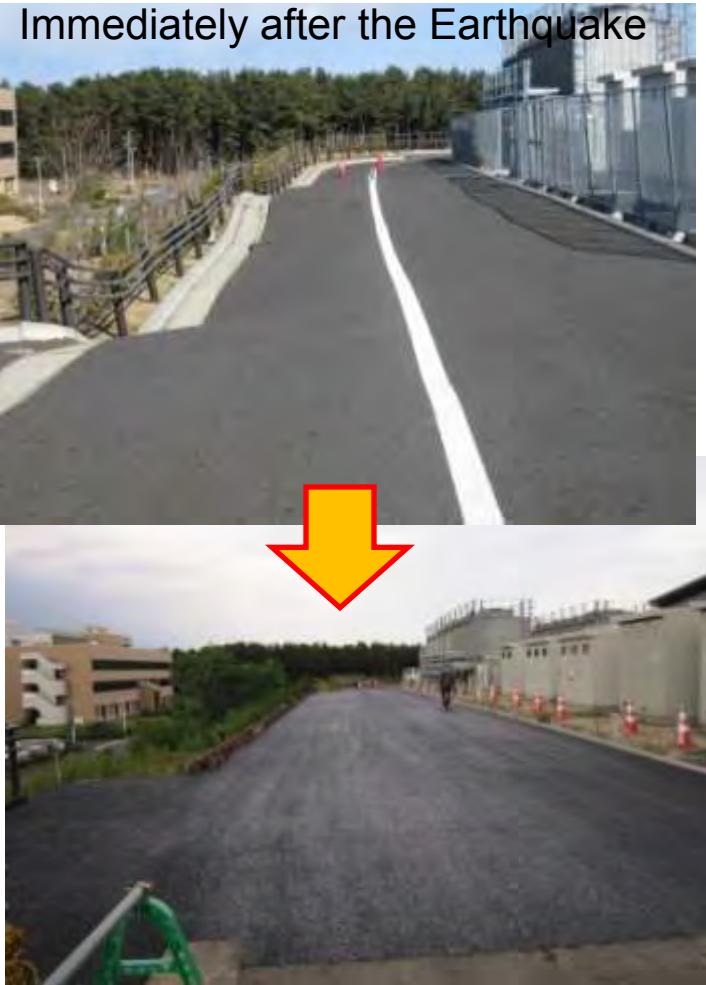
- There were severe damages on many facilities around the RCS building.
- The restoration work was started after repaved roads for carrying in materials and instruments for the work. The work is progressing smoothly.

The road was repaved.

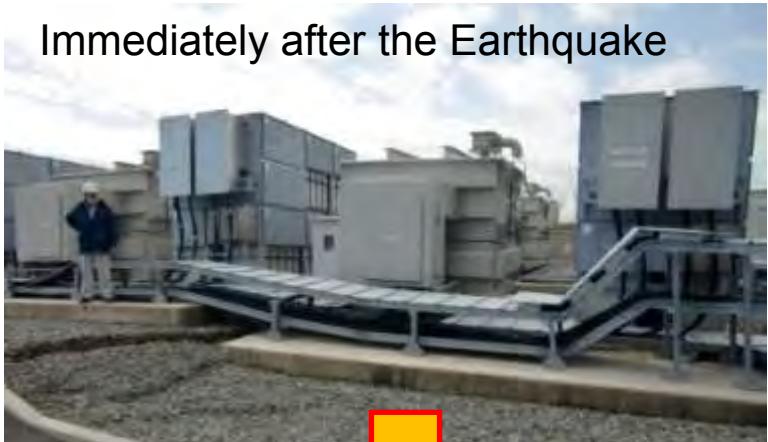
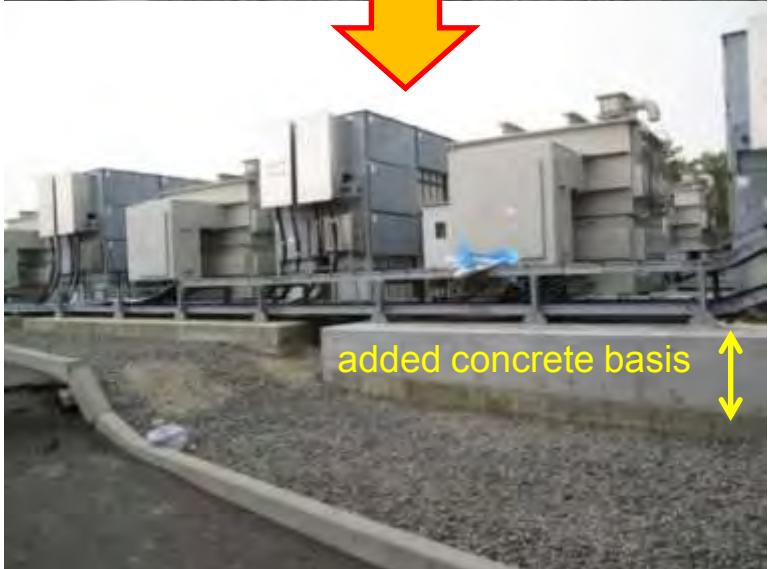
Immediately after the Earthquake

Tilted condensers were straightened after relabeling the bases.

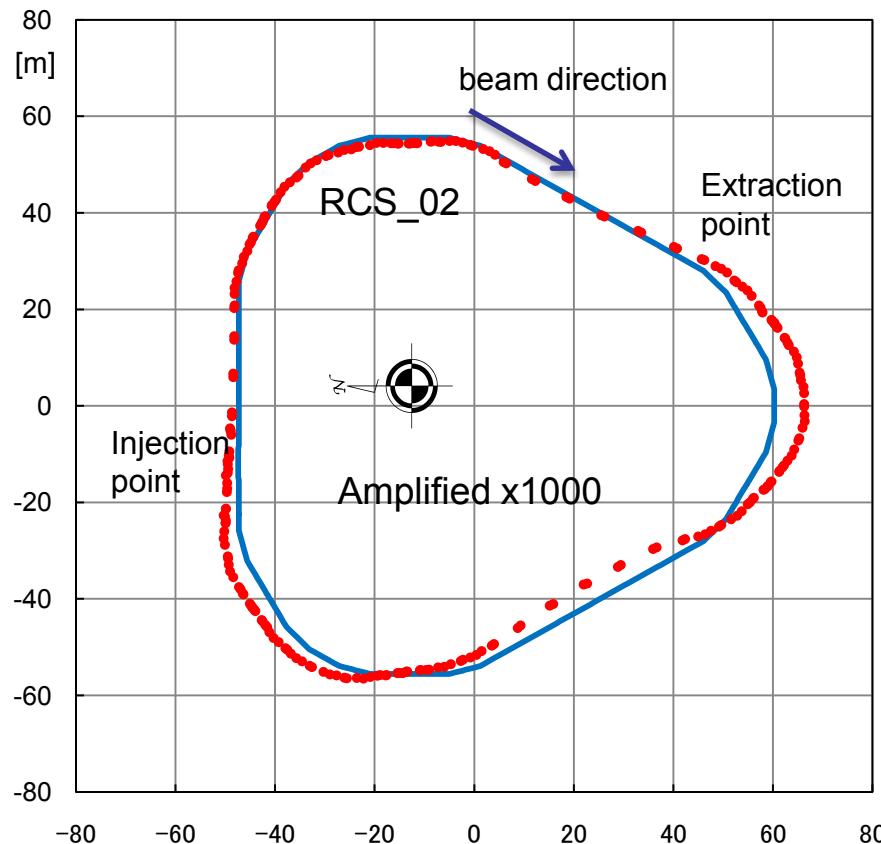
- No serious damages on the equipment/instruments in RCS tunnel.
- Position of all equipment/instruments, such as electromagnet, were precisely measured. It appeared they misaligned ~3.7 mm vertically and up to ~10 mm horizontally.
- However, realignment work is not needed, because we can adjust a beam orbit position with correction electromagnets.
- The restoration of power supply system is going smoothly.

Blue: Reference positions of electromagnets
Red: Actual positions after the earthquake
(Please note the magnitude of displacement is amplified x1000.)

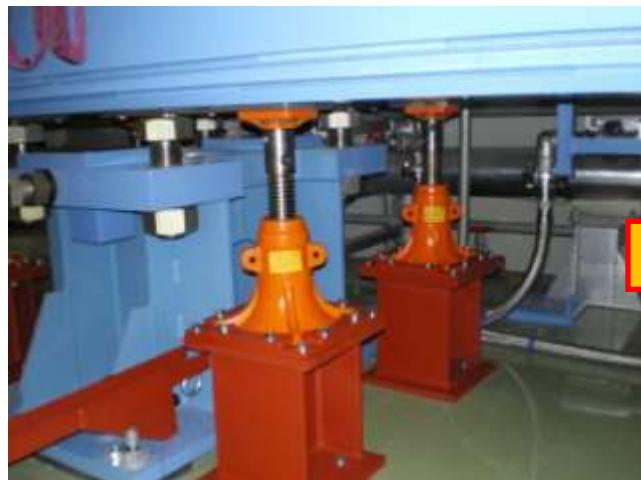
- Repair of water leaks has been done. The facilities for electric power supply and cooling water supply have been restored as well.
- All electromagnets (~400) are being realigned at 5 magnets/day.
- Magnets moved more than 1 cm are realigned to change a stage position (Photos).

Jacking up an electromagnet to make a space between the magnet and the stage

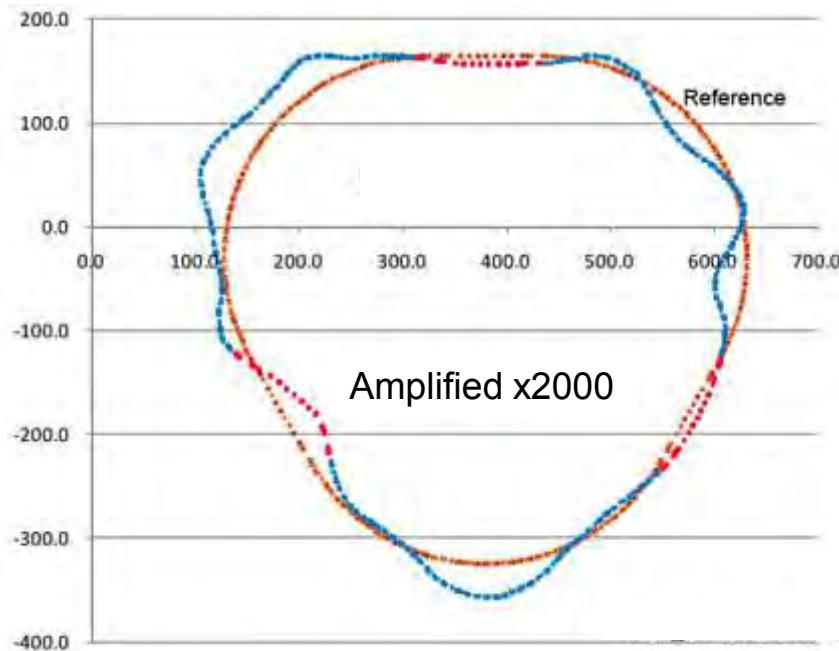
- There were no serious damages on all MR equipment/instruments, such as electromagnets. It, however, appeared they misaligned in both vertical and horizontal directions.
- Some electromagnets that misaligned greatly are realigned with replacing a stage and/or an anchor part.
- Inspection of the high-frequency power amplifying system has been completed.

Red: Reference positions of electromagnets
Blue: Actual positions after the earthquake
(Please note the magnitude of misalignment is amplified x2000.)

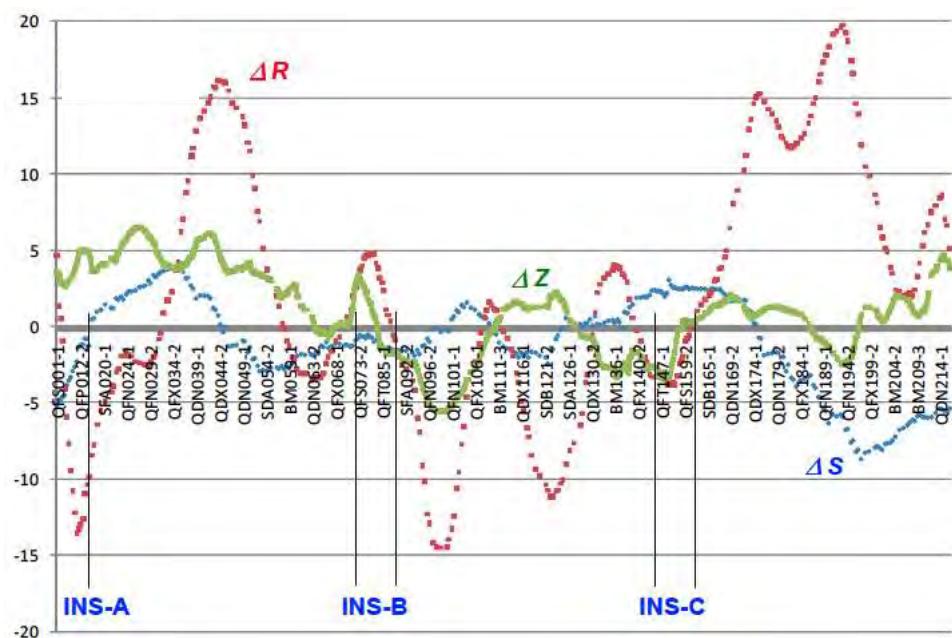
Electromagnet misalignment in a vertical direction

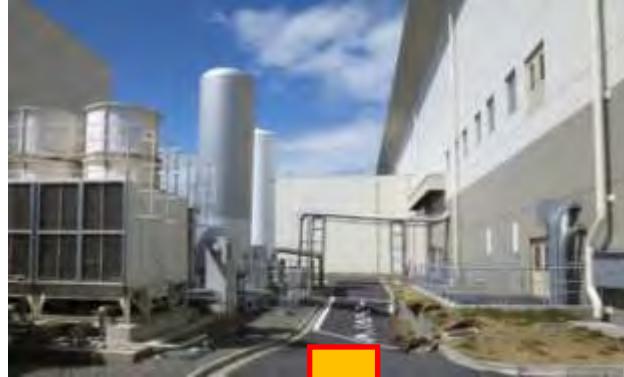
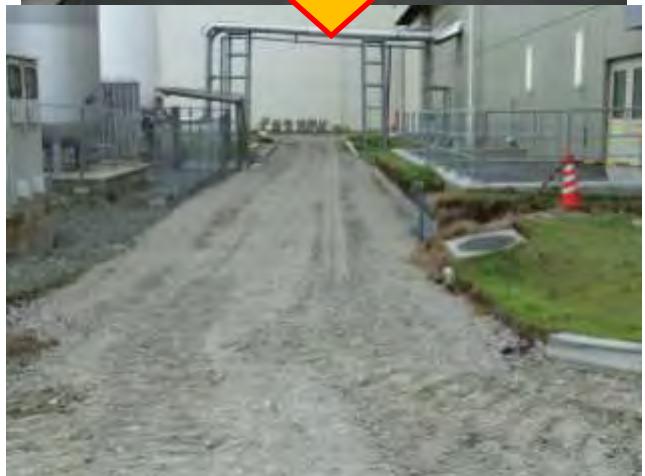
Immediately after the Earthquake

The road was re-opened after filling depressions with pebbles.

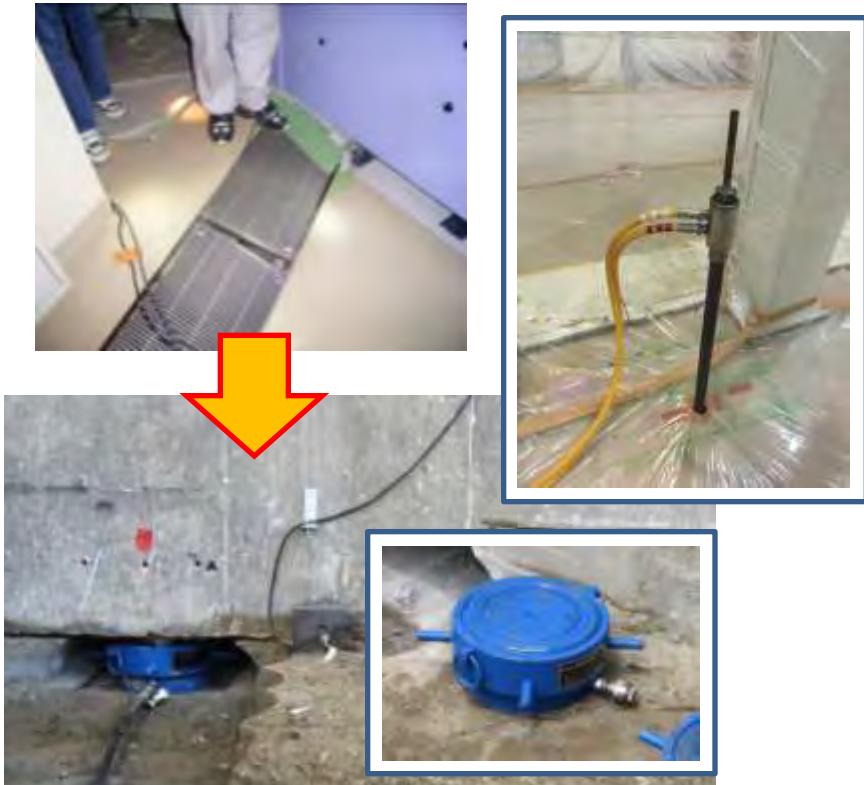
An attached building to the west side of the main MLF building sank ~20 cm. The building is jacked up with 24 hydraulic lifters (blue). Created interspace will be filled with cement injected from holes of the floor.

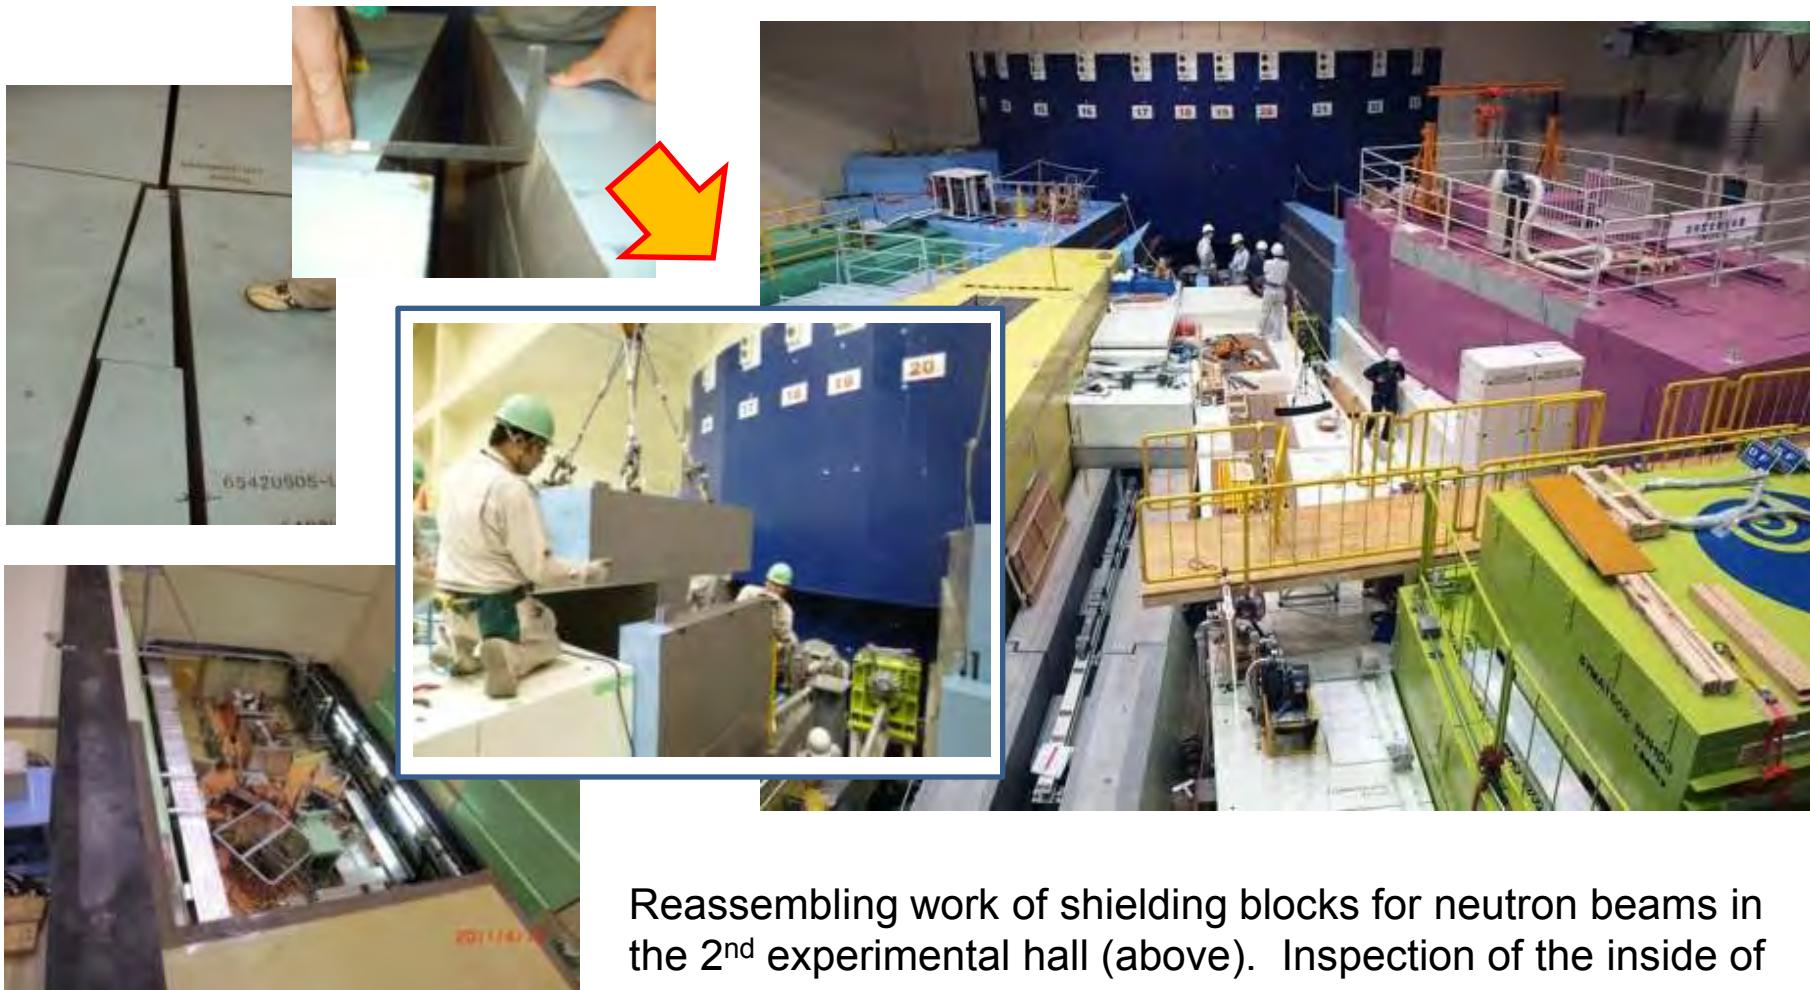
Reassembling work of shielding blocks for neutron beams in the 2nd experimental hall (above). Inspection of the inside of the muon beam facility after removing shielding blocks (right). This area does not have any serious damage.

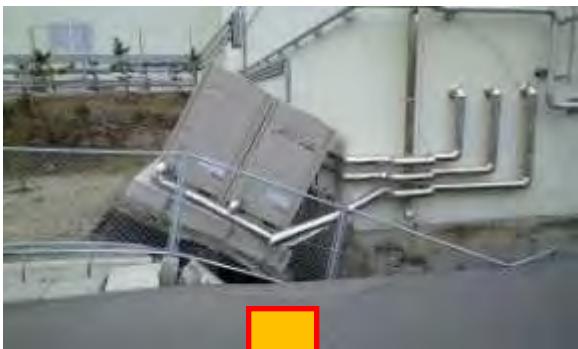
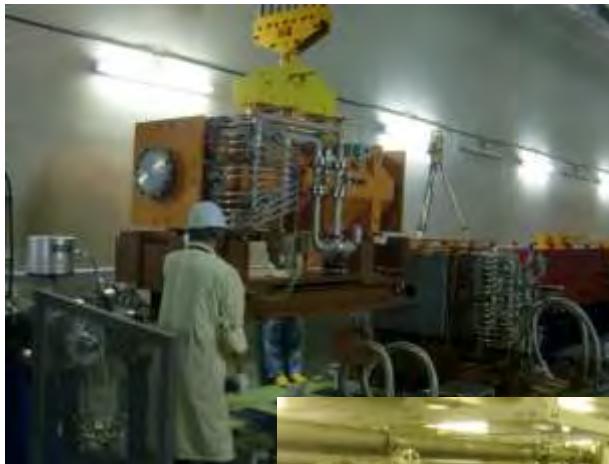
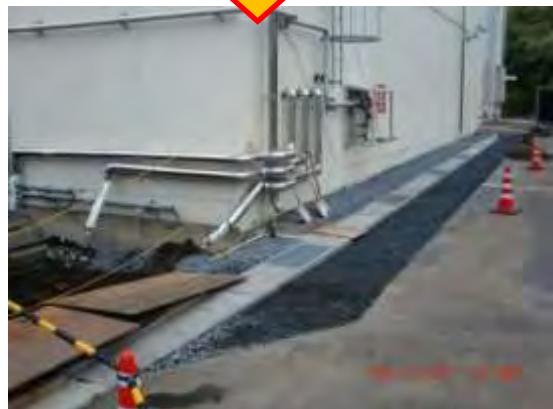
AC device tilted toward a depression of a road. Many pipes were damaged

Repairing roads and plumbing have been completed.

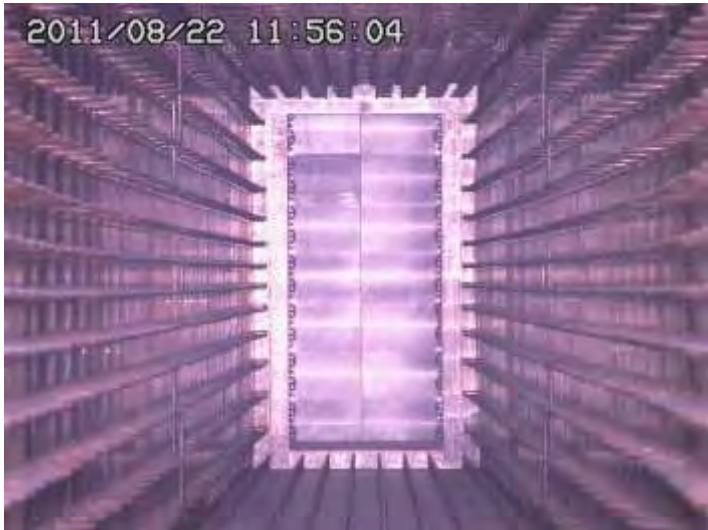
The soundness of Beam Dump and Decay Volume was visually confirmed. There were no water leaks.

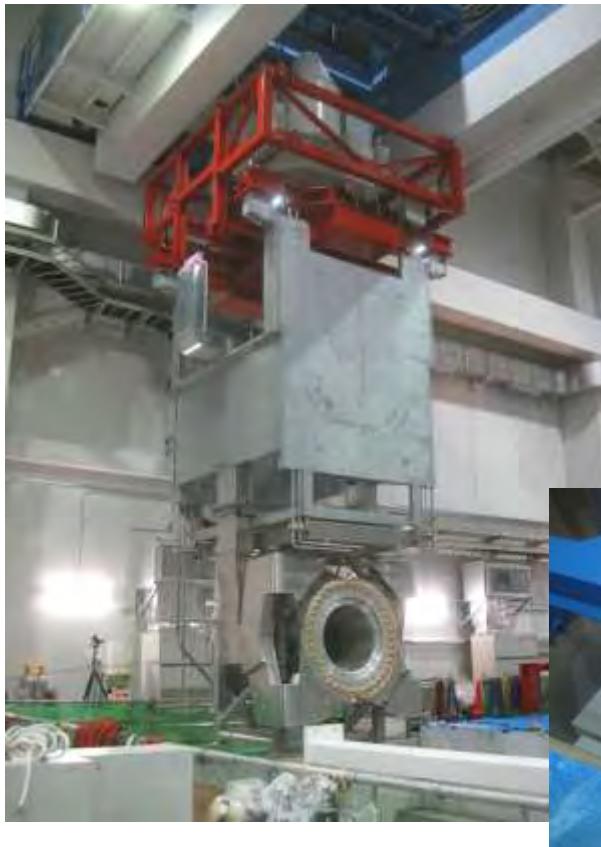
The 3rd horn hung by a crane for inspection (left) and the 3rd horn in a shielding maintenance area.

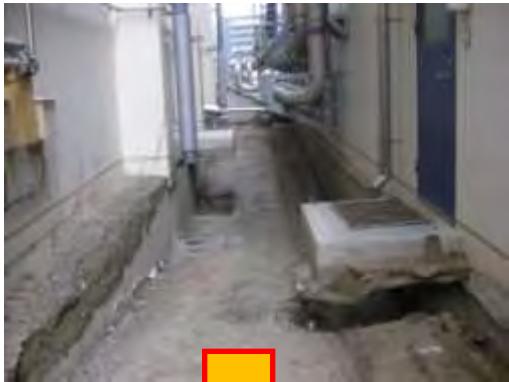
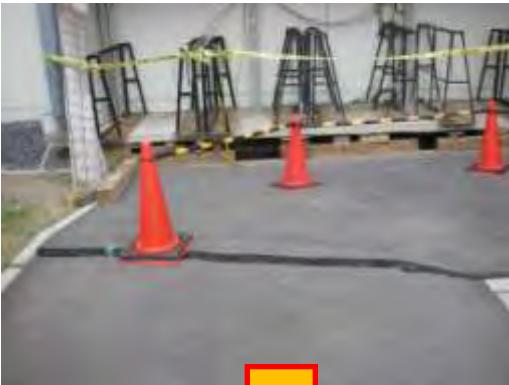
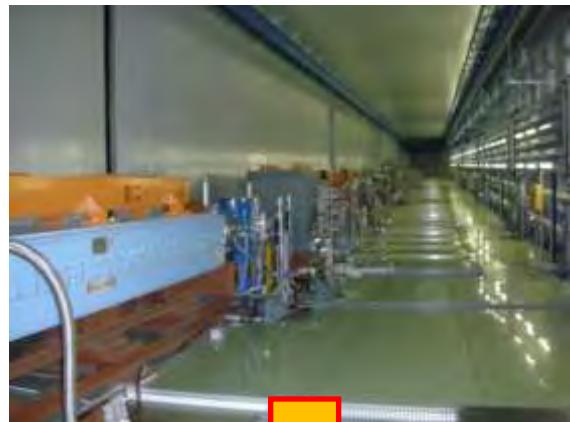
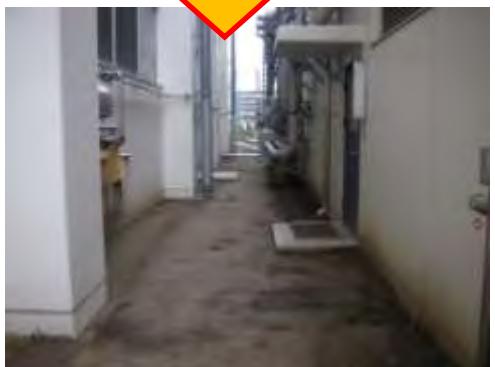
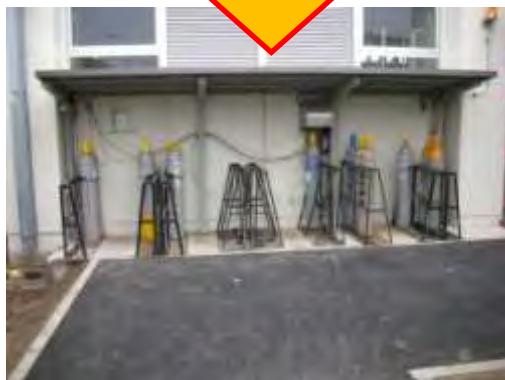
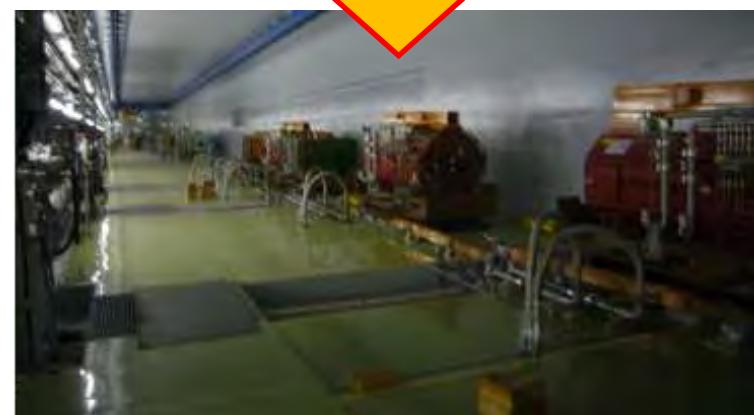
Immediately after the Earthquake

Electromagnets in the switchyard need to be realigned. The work is progressing smoothly.

Repairing roads and plumbing have been completed.

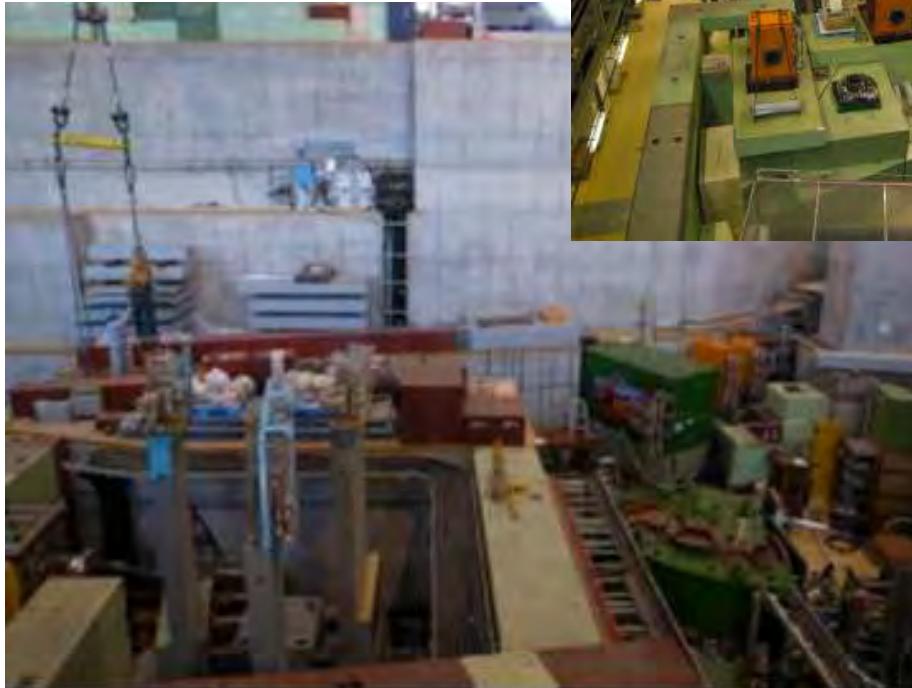
- After removing shields temporally, the soundness of all equipment and devices have been confirmed.
No realignments are required.

Inspection work in Hadron Hall

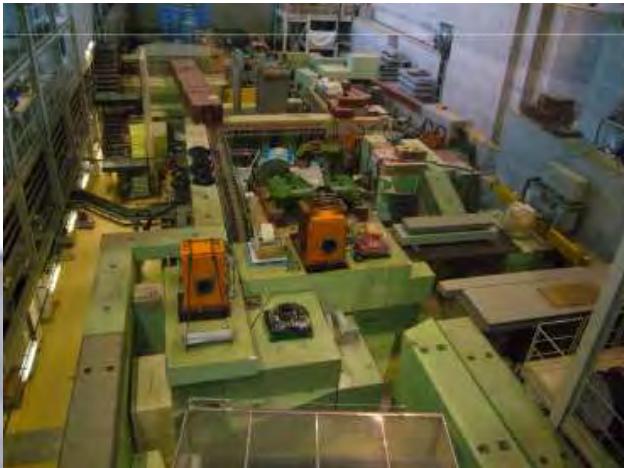
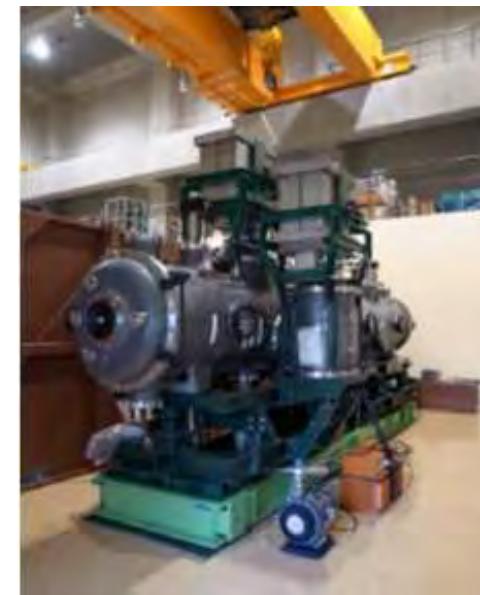
No damages in the device
