General Overview (2011.3.28)

- March 17 (Thu). Inspection of all buildings, utilities, and facilities for J-PARC
 - Photos are displayed in what follows. No electricity. Very limited inspection.

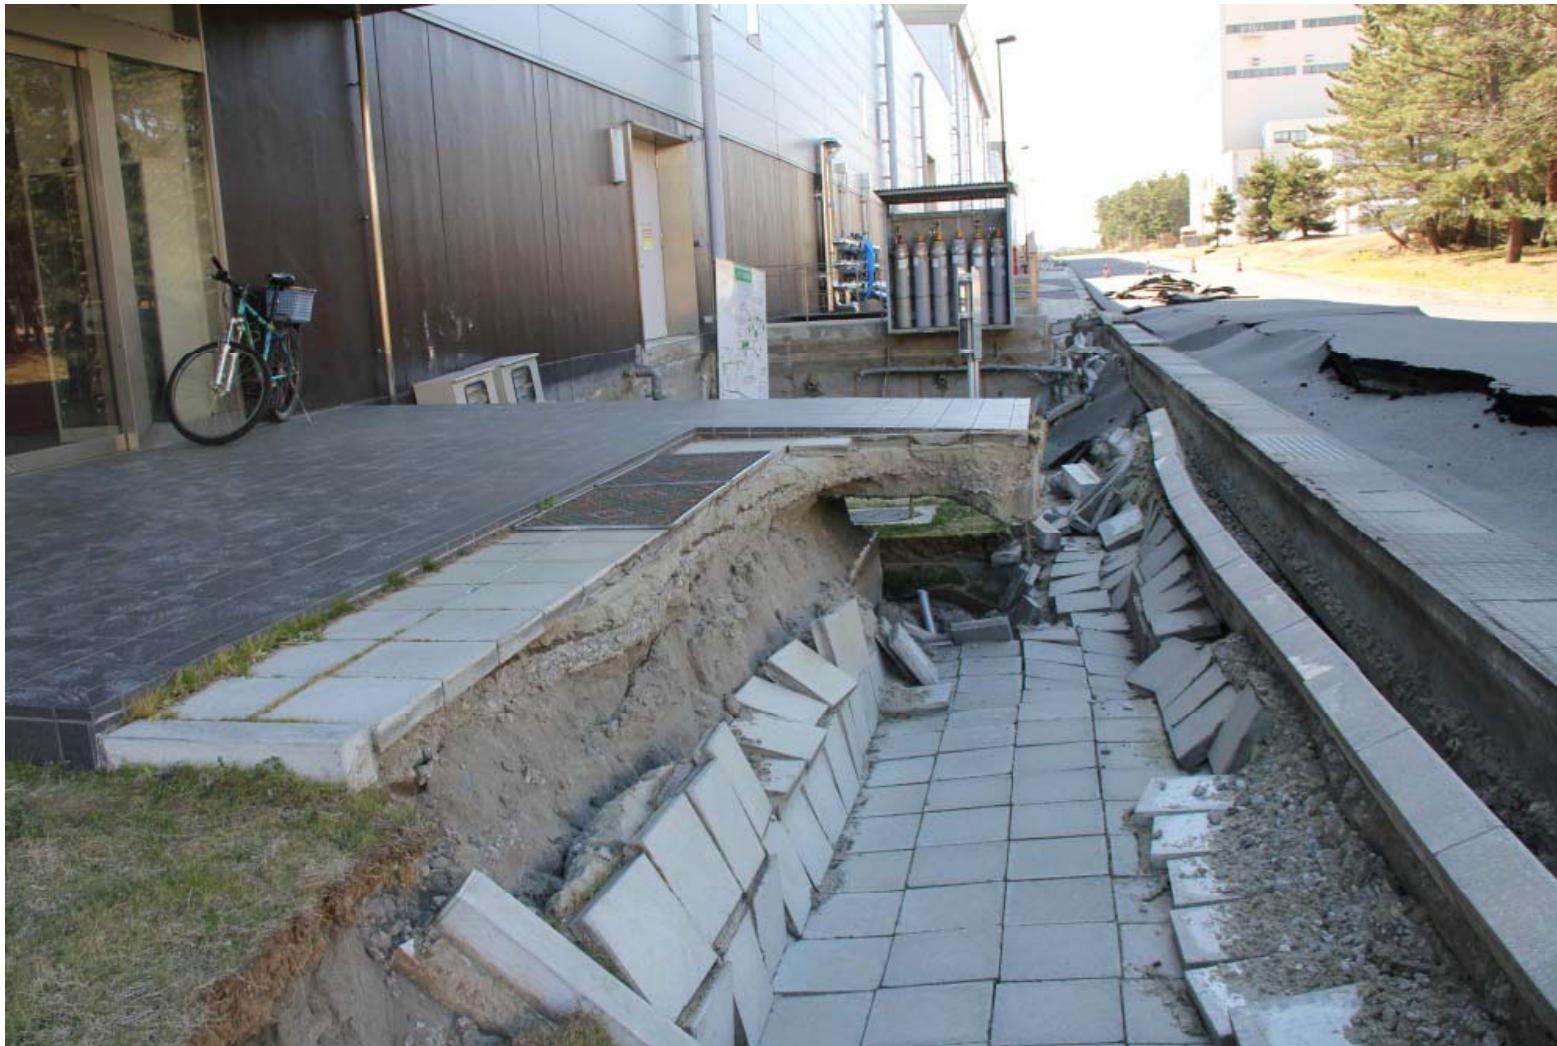
Entrance for Linac

About 1.5 m drop as seen above, over a wide area.
Electric wires and water pipes were all damaged.

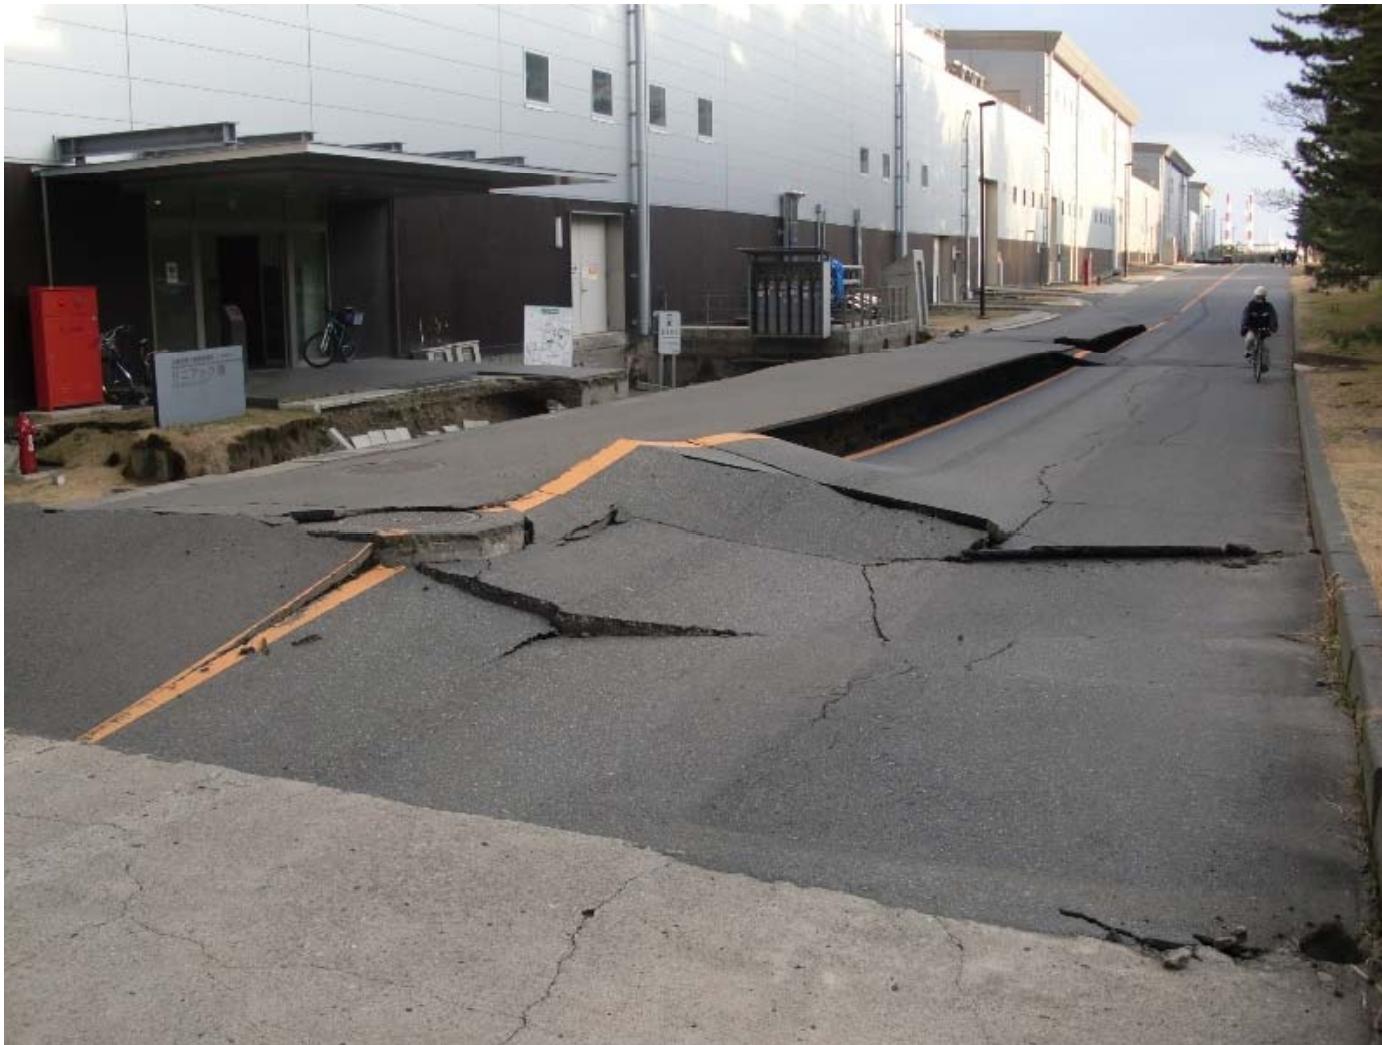
Road in front of Linac

Serious cracks on the road. This is a typical one and can be seen all over the J-PARC area.

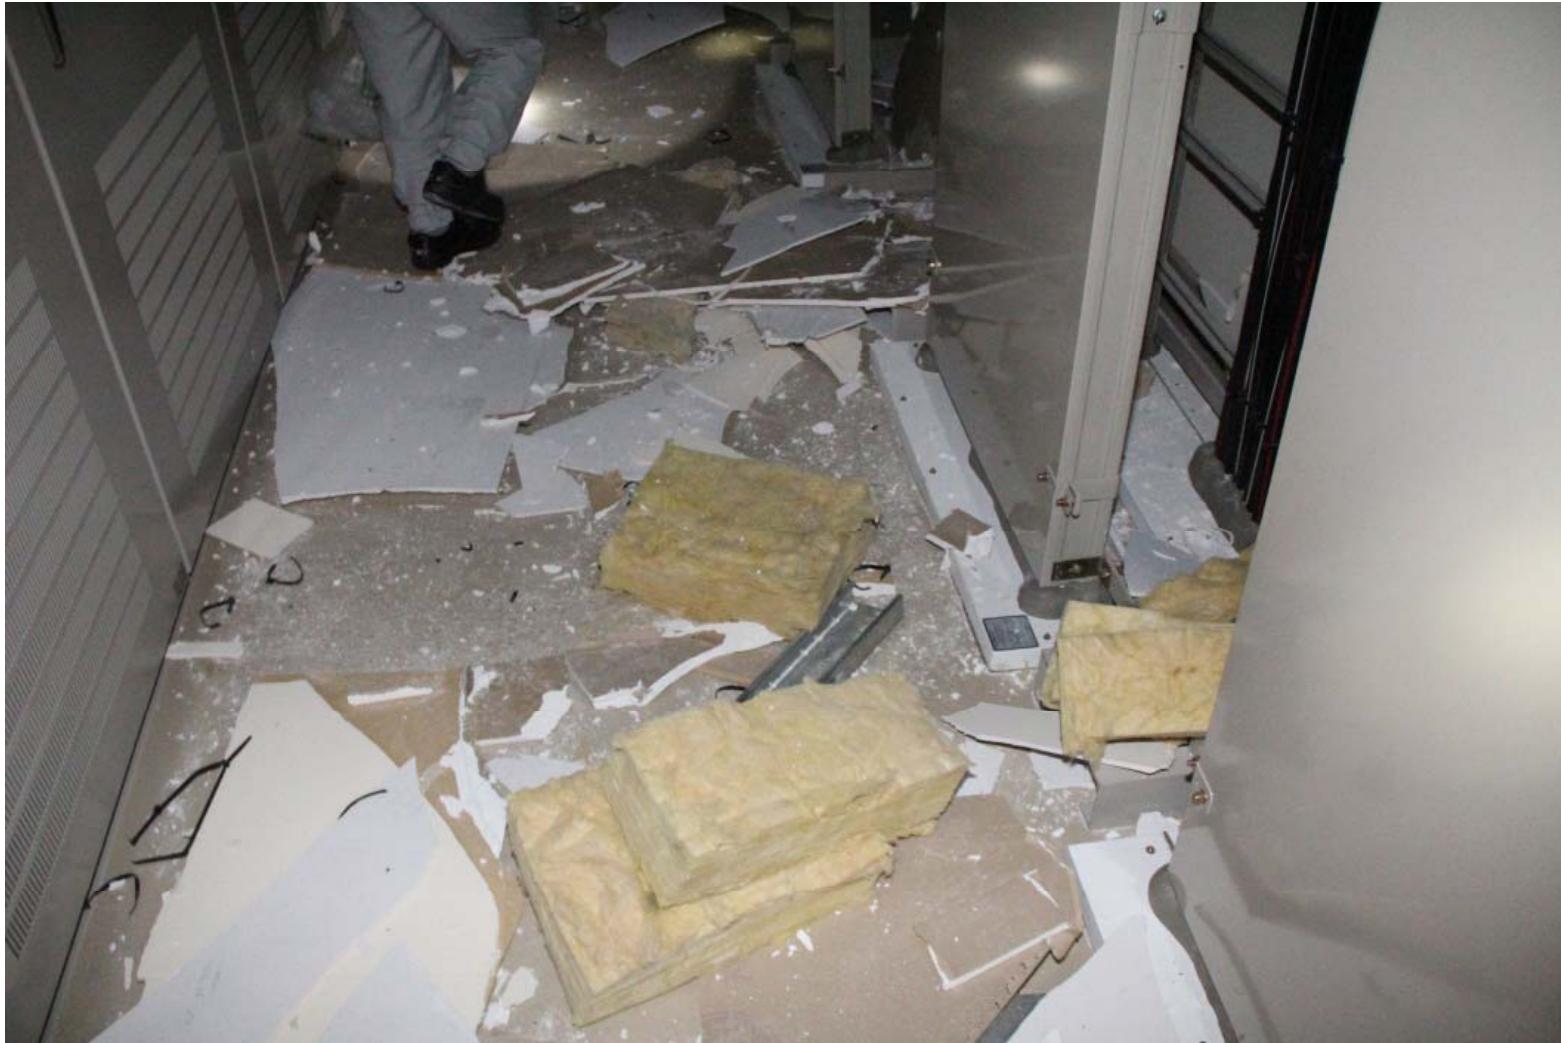
Electric Power Supply for Linac

Side buildings were severely damaged (due to less number of underpins), whereas central area for Linac had no damages including klystrons.

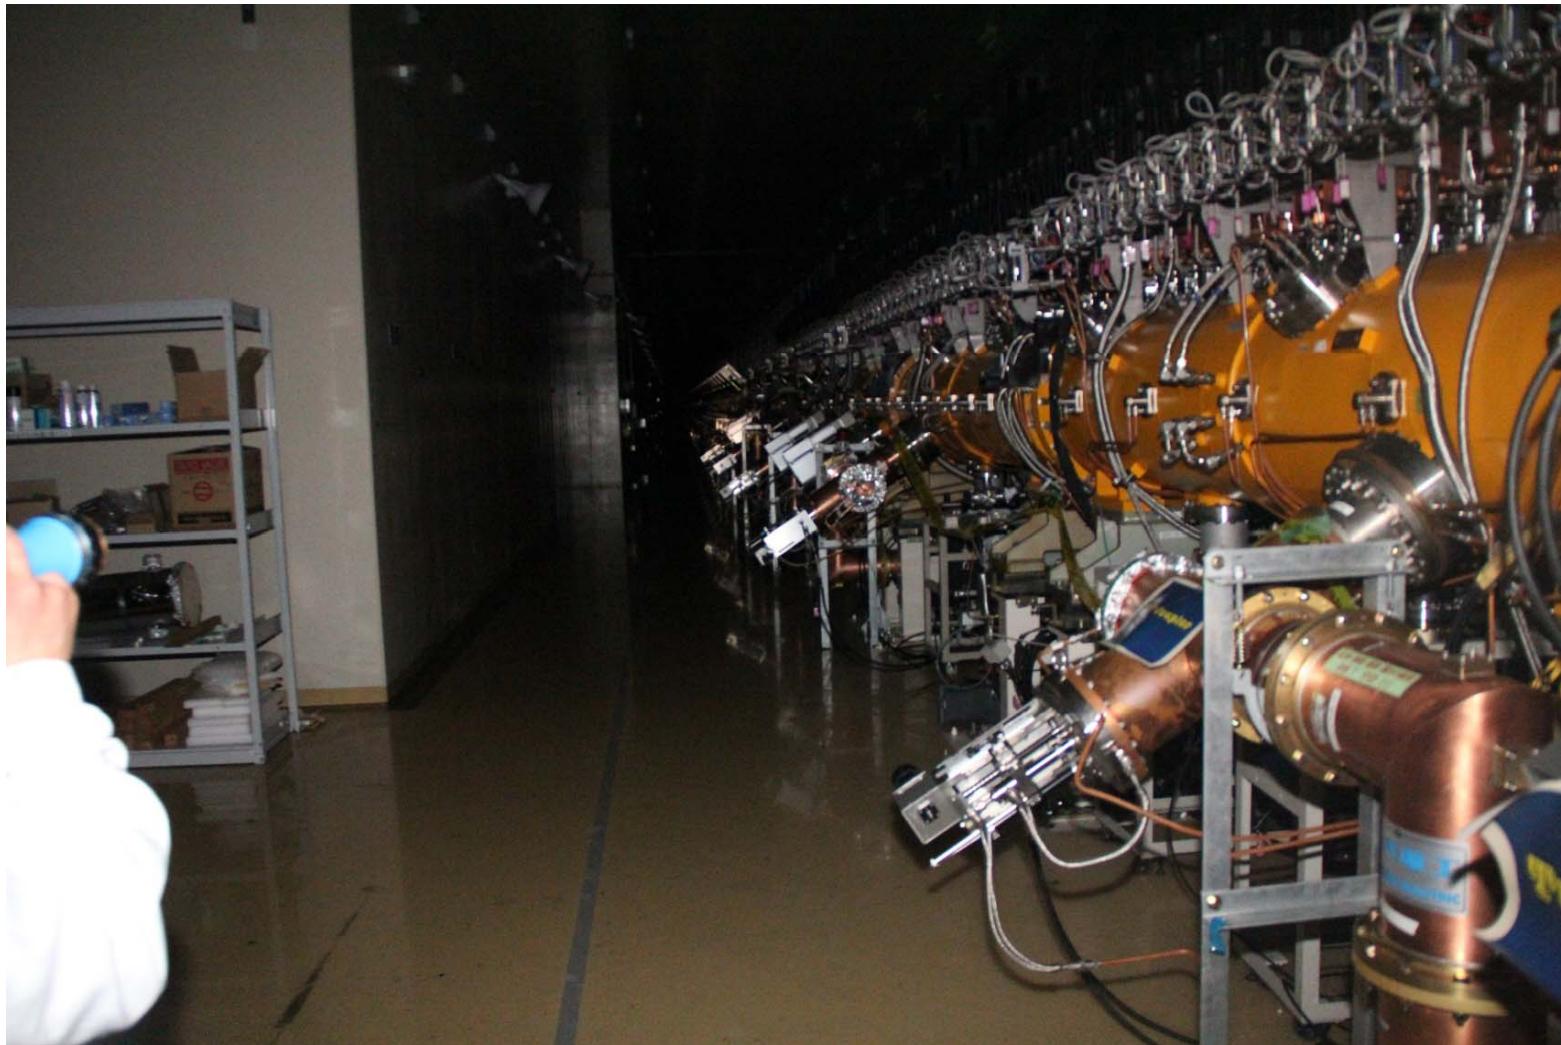
Inside Linac Tunnel

Concerning the central area of Linac, no serious damages were seen by looking from outside. As of March 17, 1 cm deep water was on the floor.

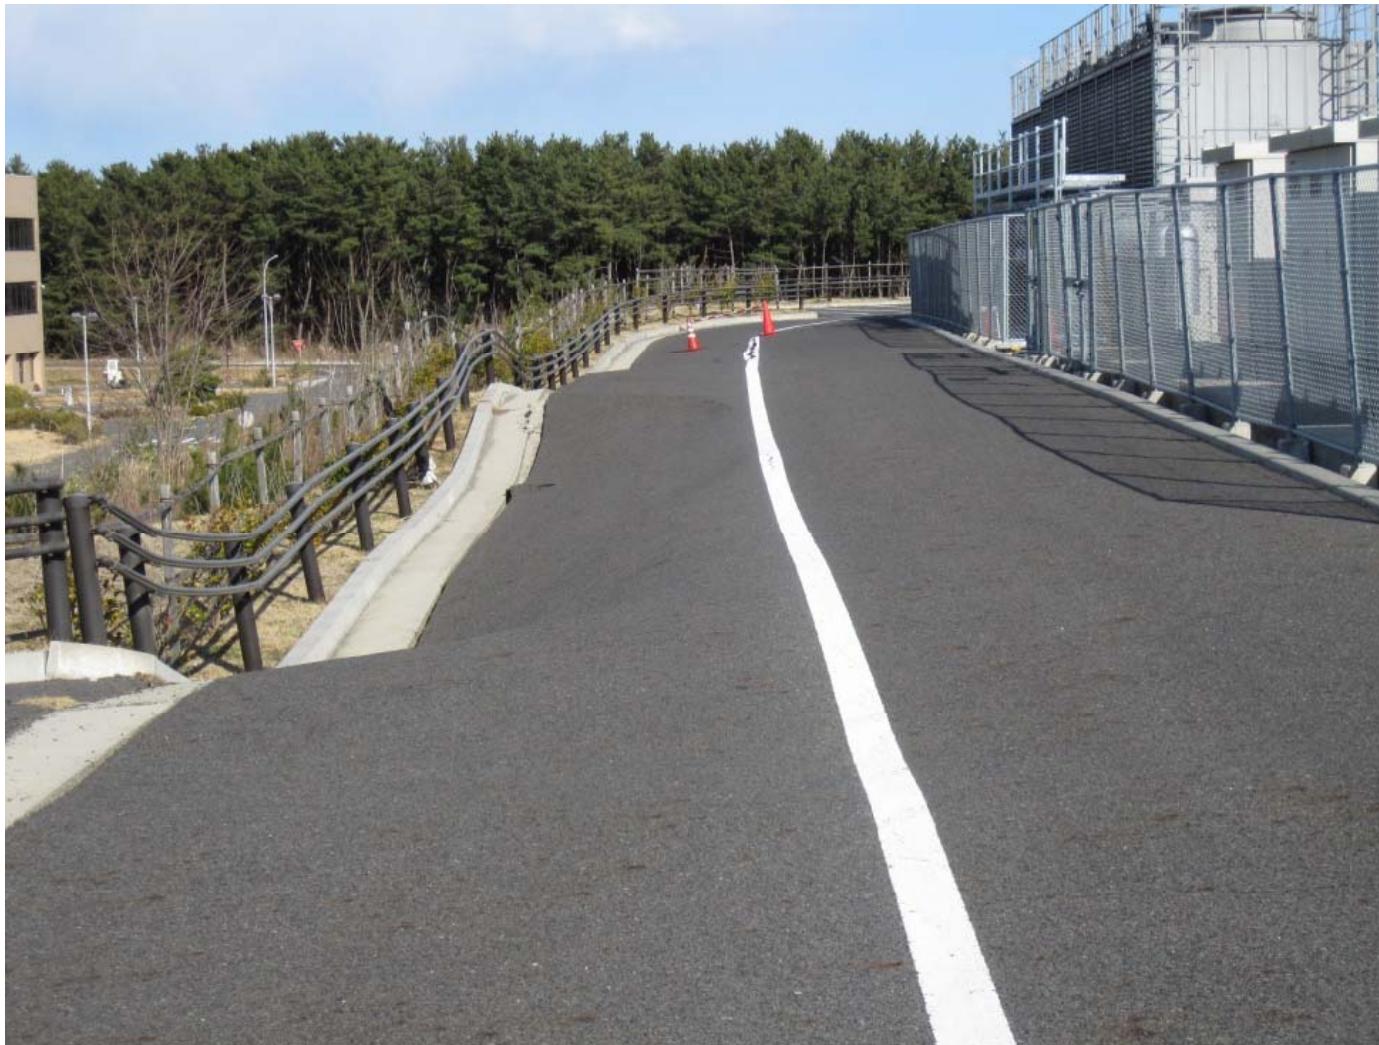
Road around 3 GeV

Wavy road. Bump in the middle means that beam pipe is underneath it. Both sides of the bump were sinking.

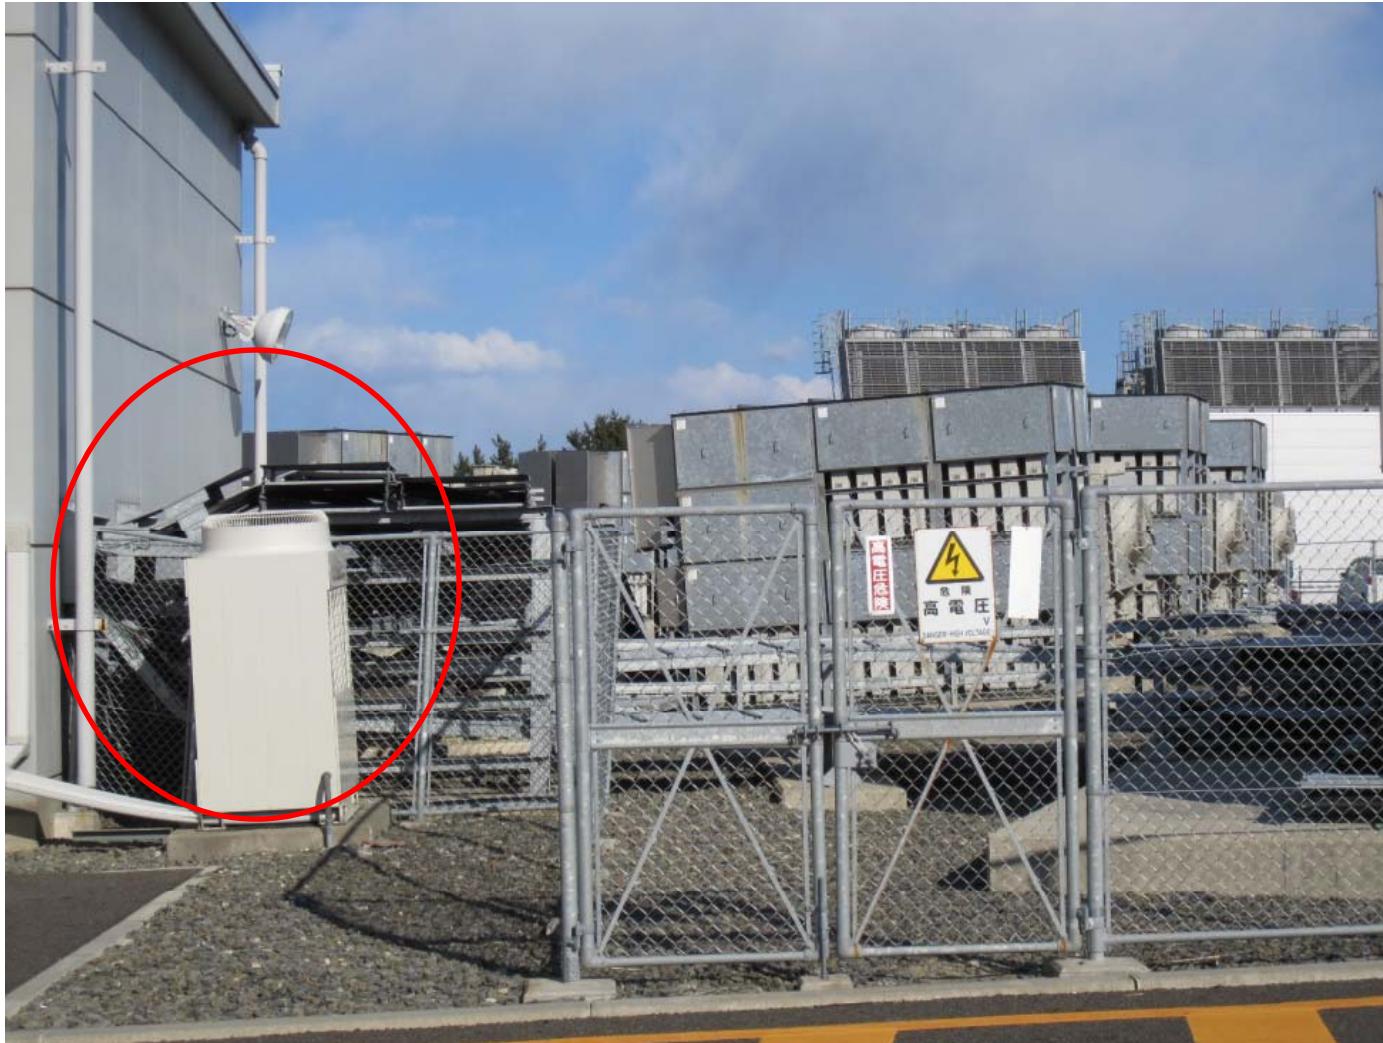
3 GeV Electric Power Supply

Leaning toward the left side. Around the place marked on red about 100 cables are there, which are all distorted.

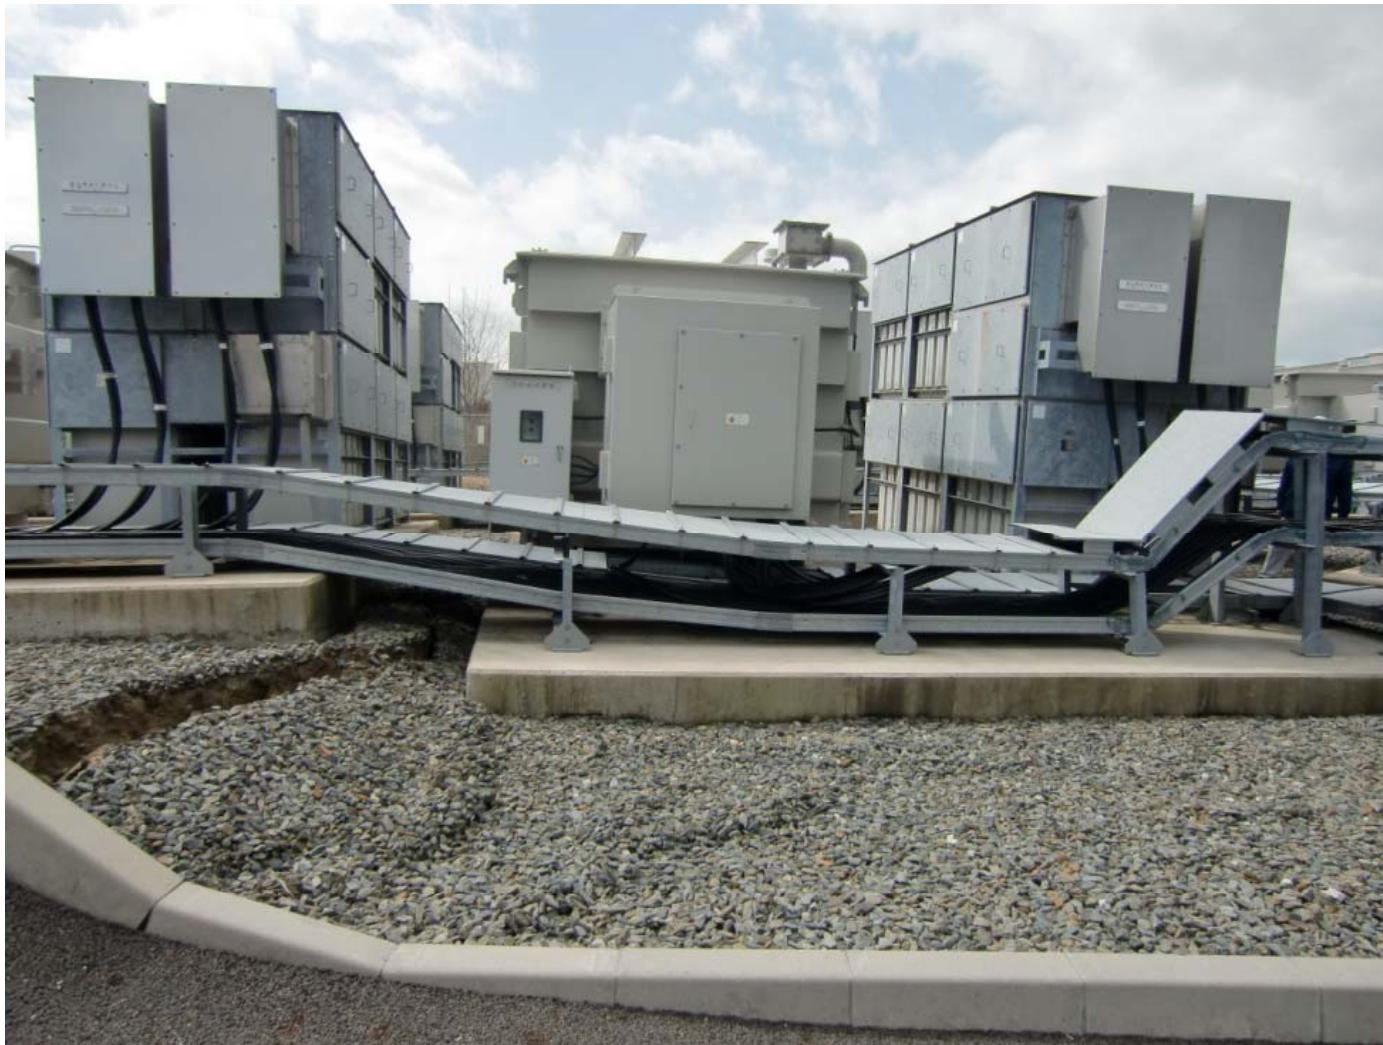
Condenser Bank for 3 GeV

Condenser bank was waved. Cables were distorted
with heavy weight on them.

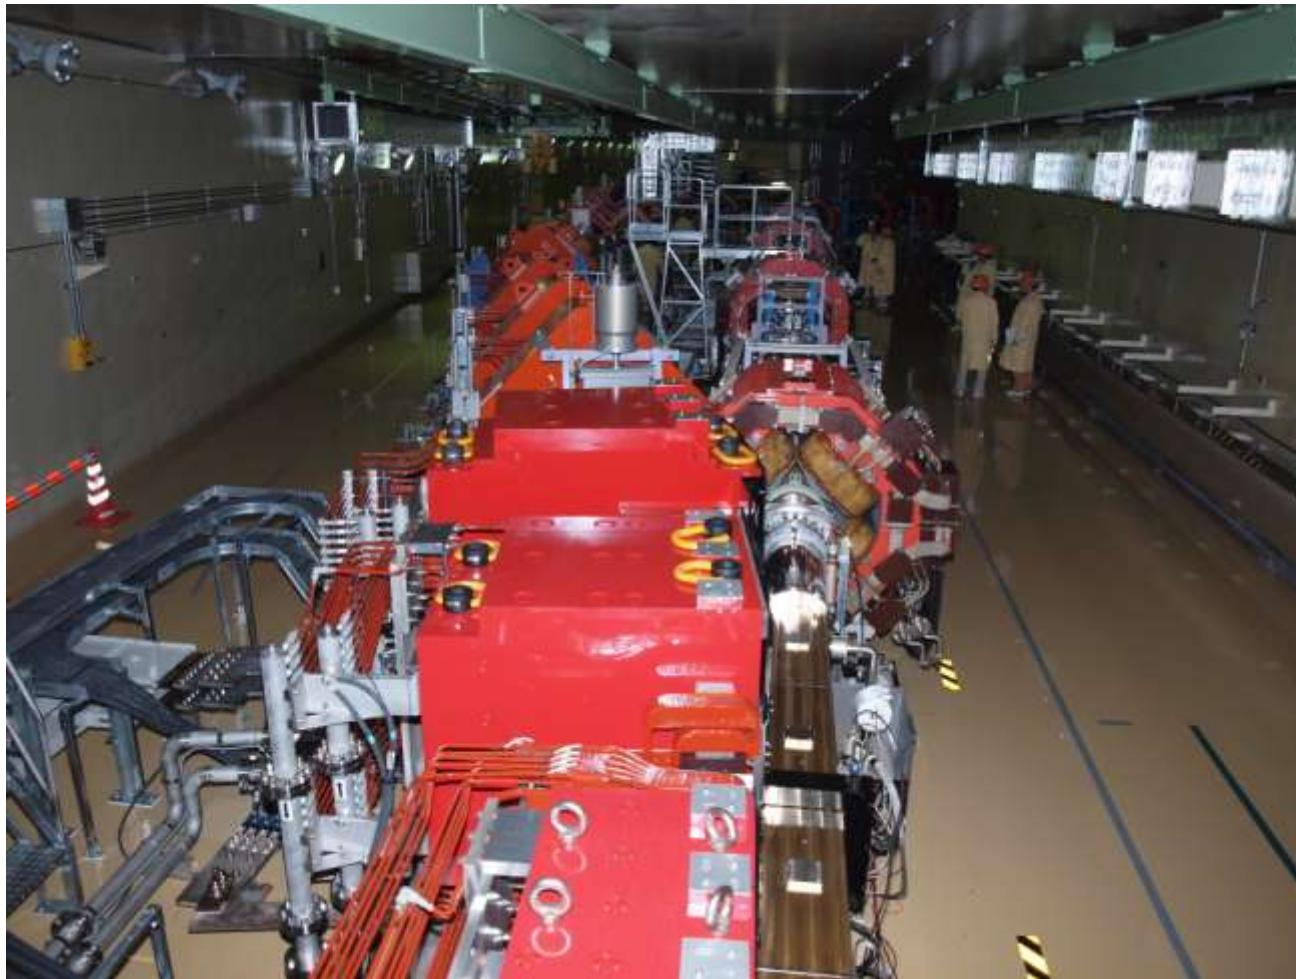
3GeV Main Ring

No significant damages.

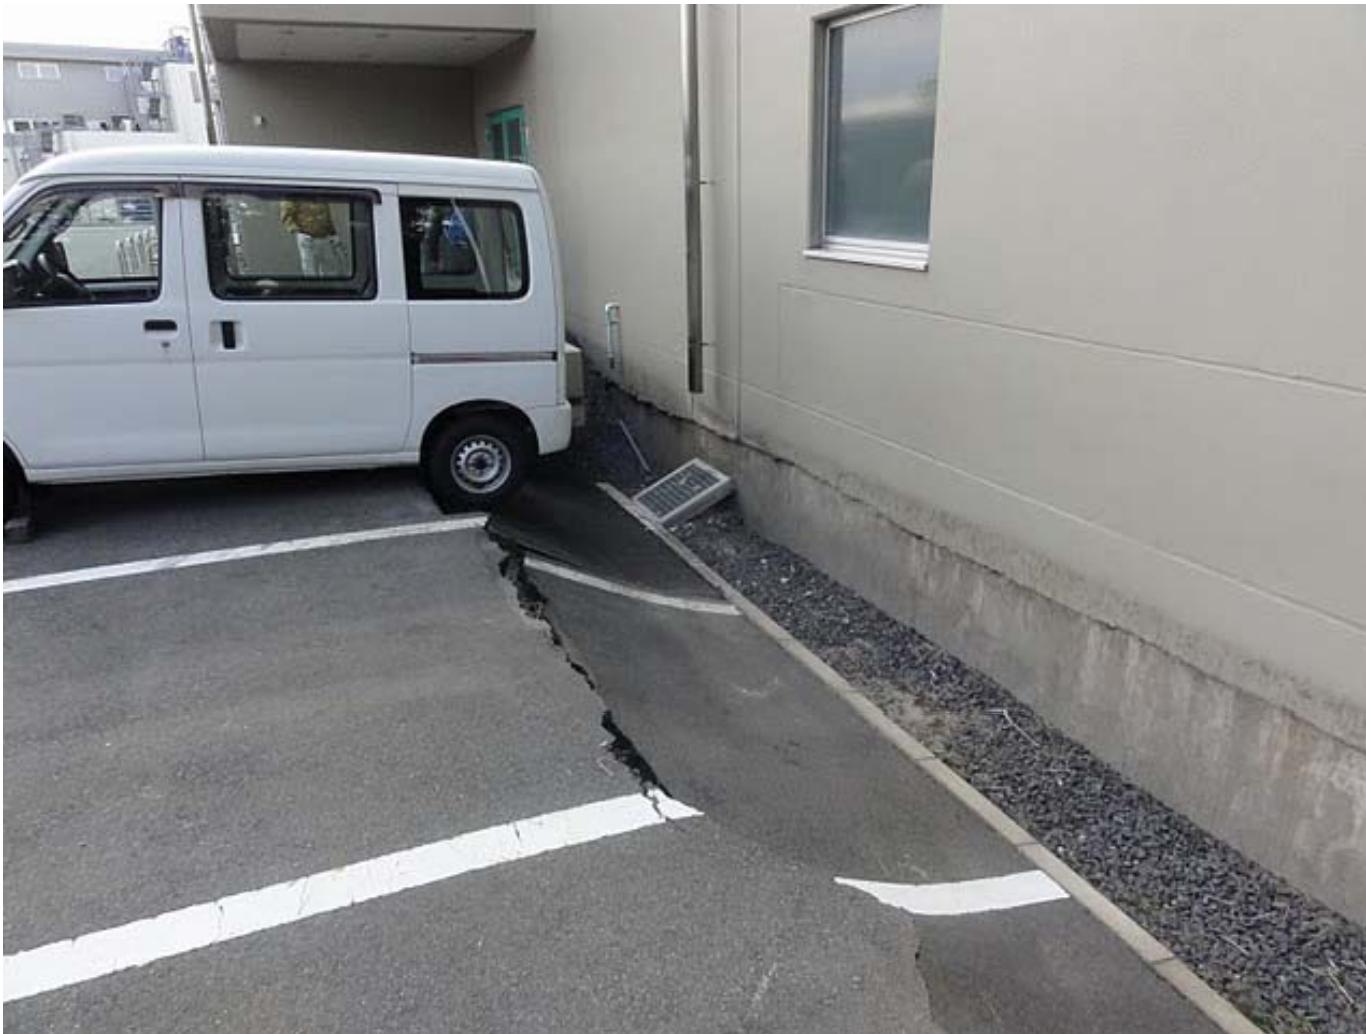
50 GeV The Second Entrance Area

Over the region of 1 m by 10 m
about 50 cm dropped.

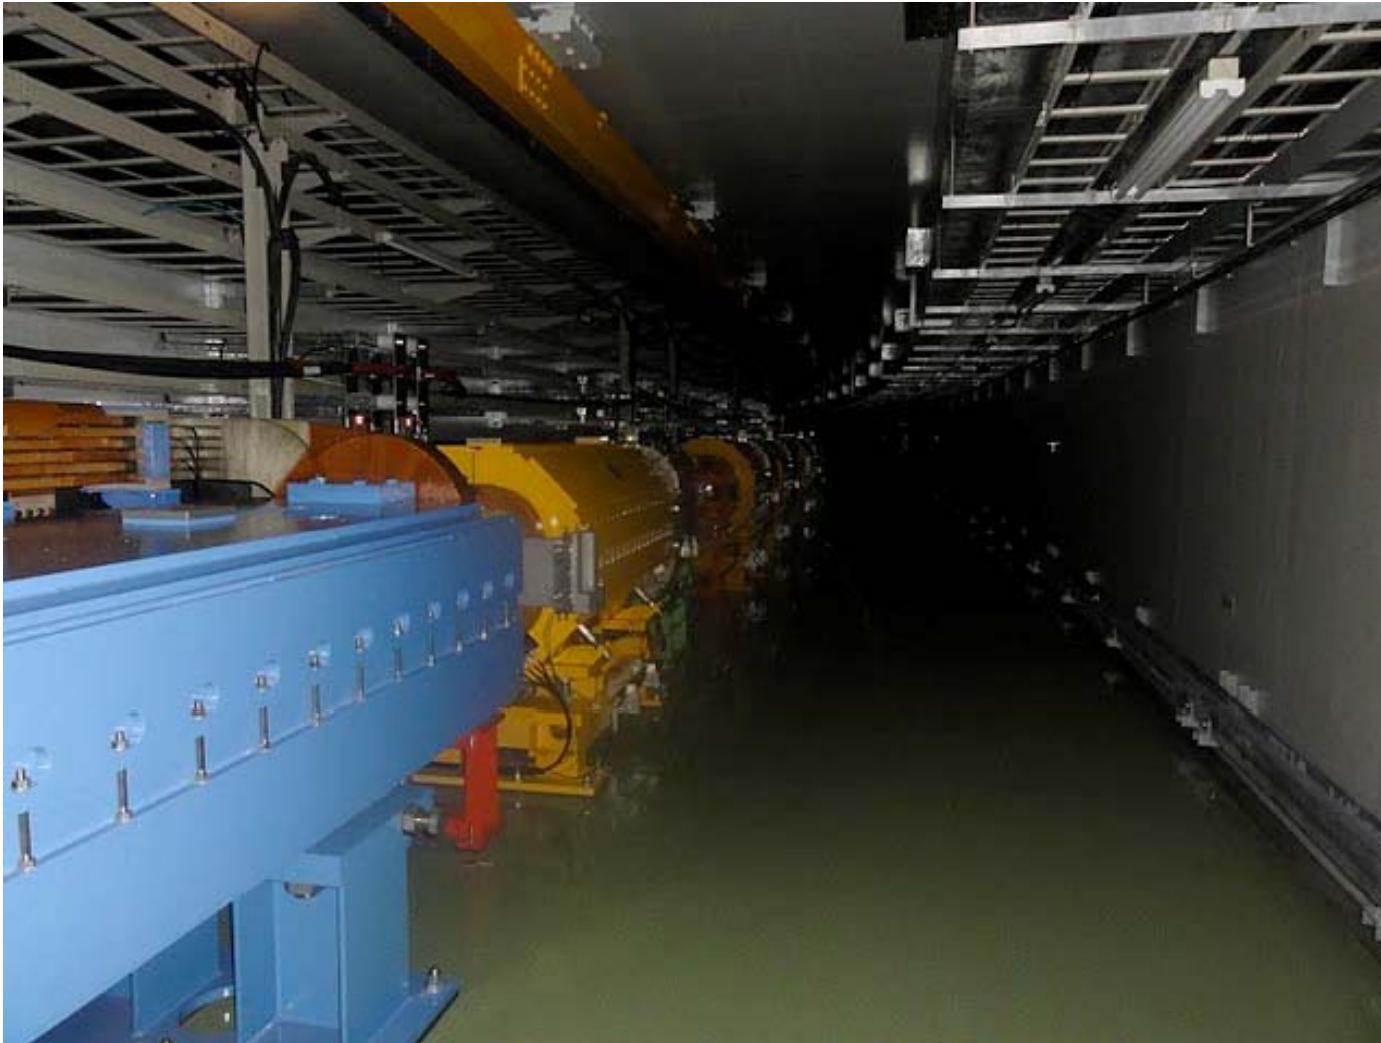
50 GeV Main Ring (1)

Although some distortion is observed for cable rack, the accelerator itself seems OK as viewed only from this area.

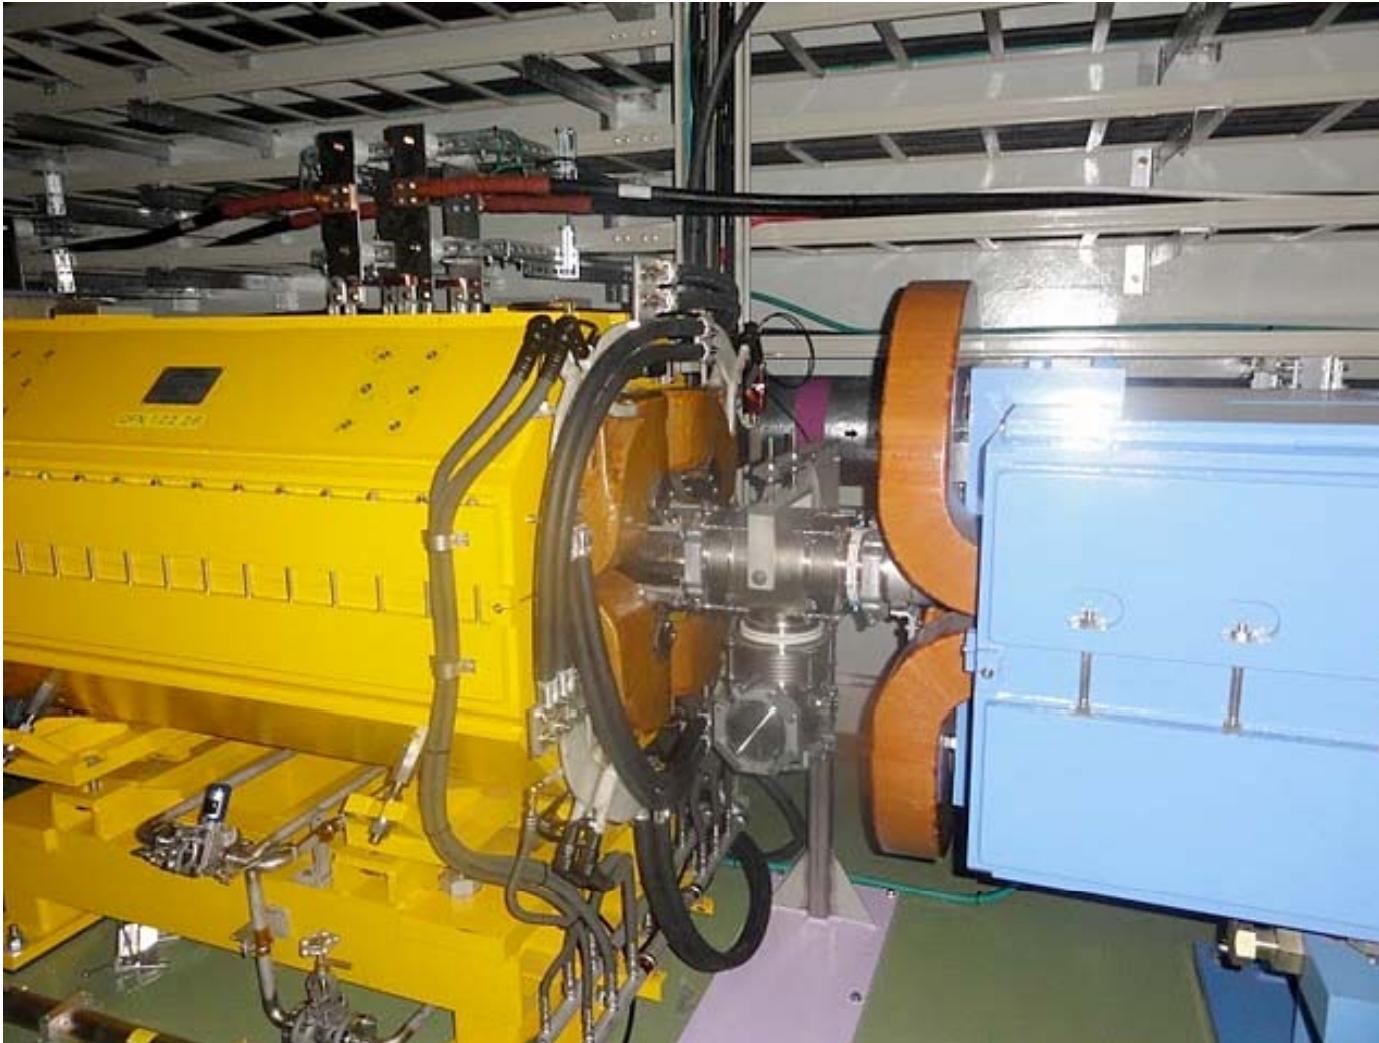
50 GeV Main Ring (2)

No damages are observed from outside alone.

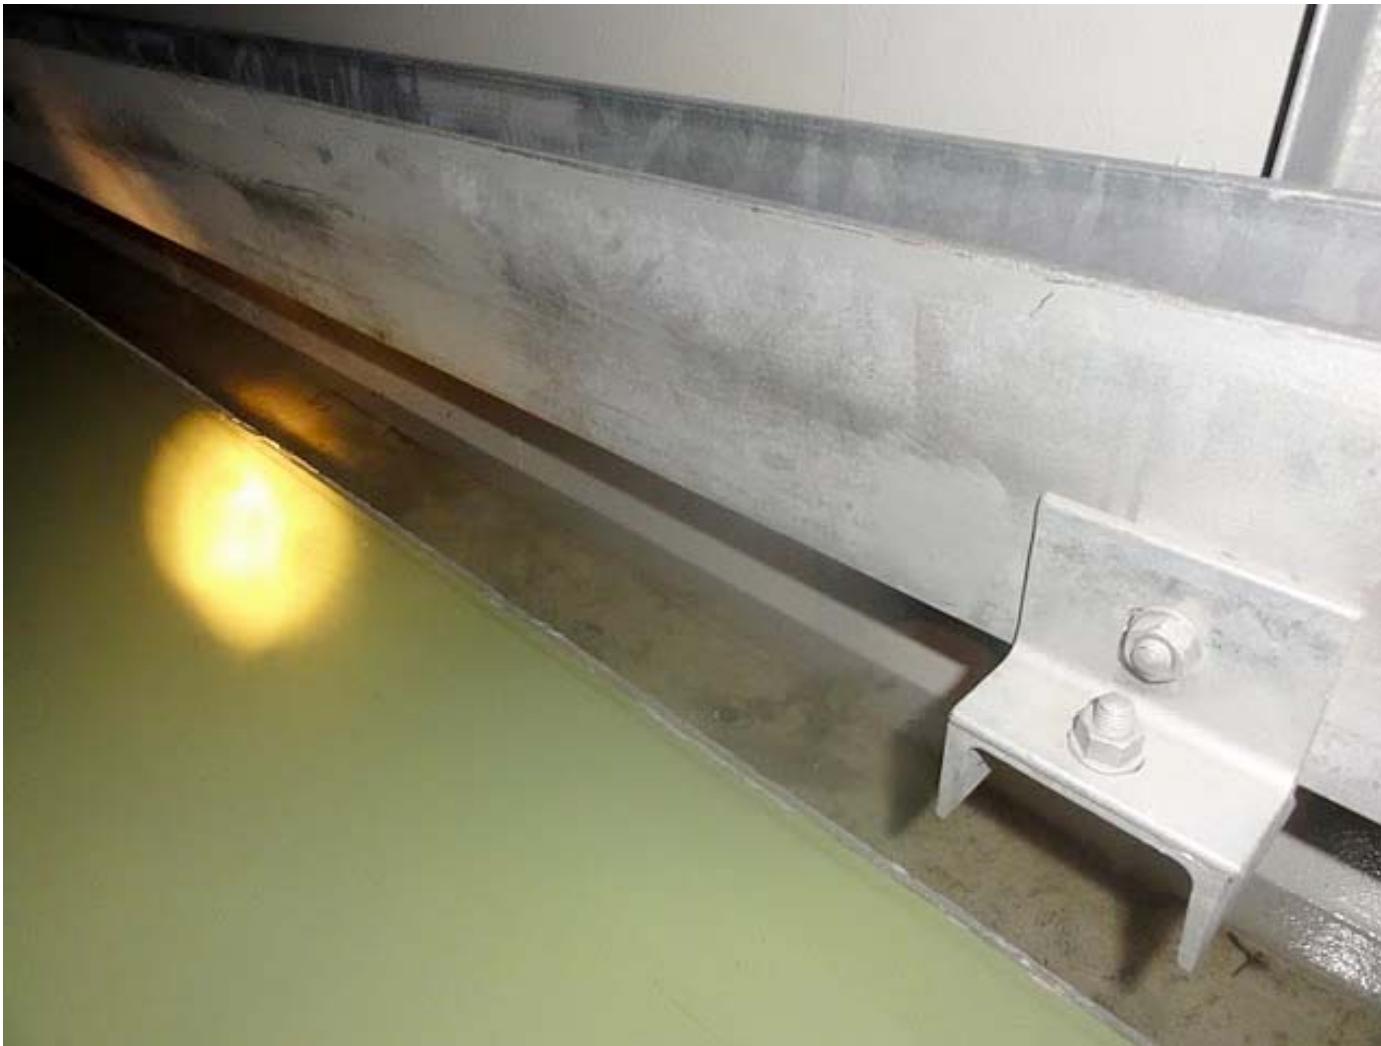
50 GeV Side Notch

A few cm deep water was accumulated. Need to pump the water as soon as possible. Humidity was very high.

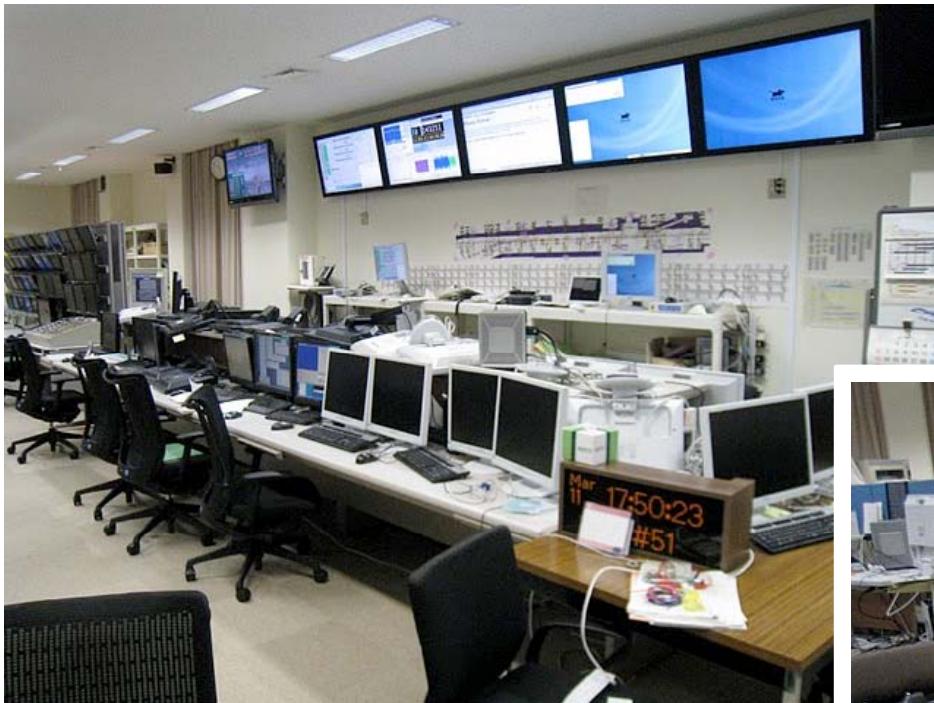
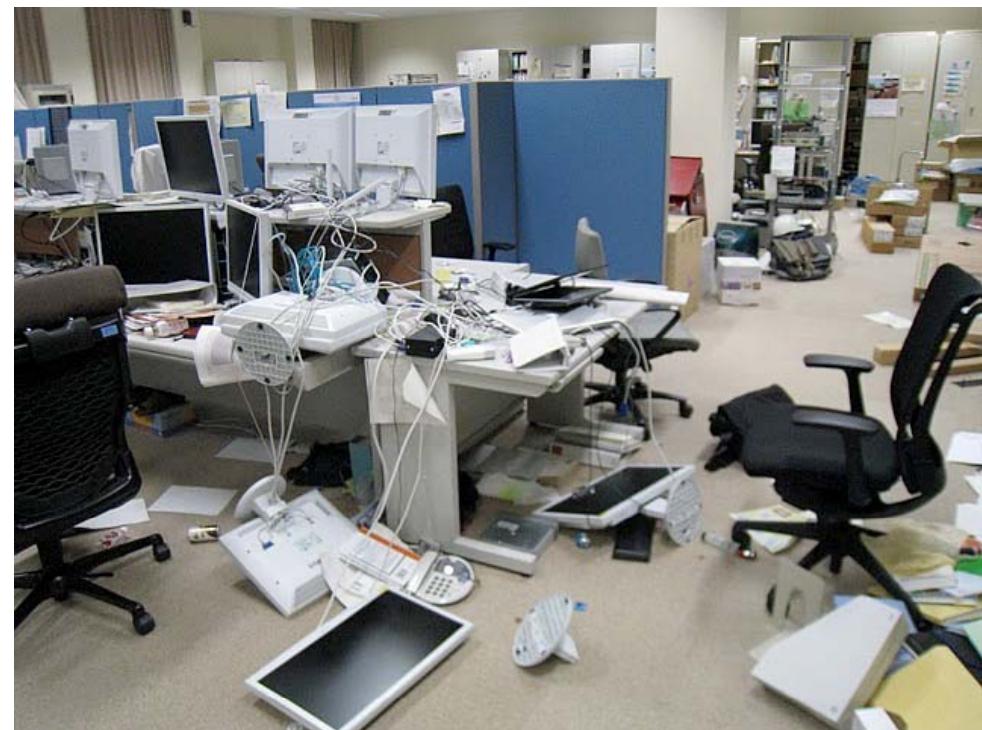
Main Control Room was in a reasonable shape.

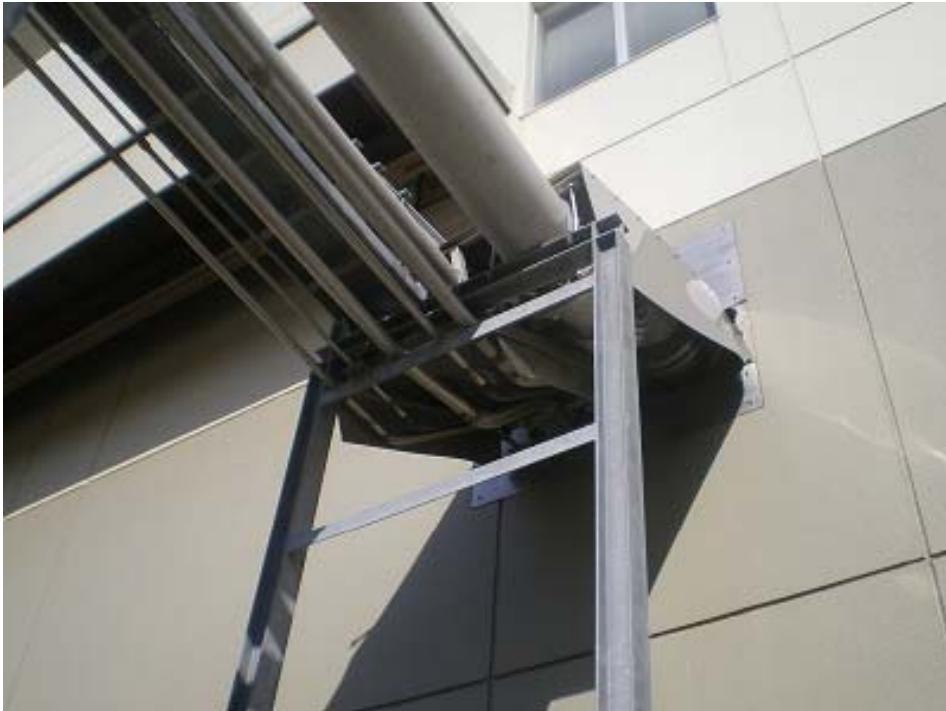
Materials and Science Area (MLF) (1)

Sinking caused a sharp bend in the piping system through the building (upper).

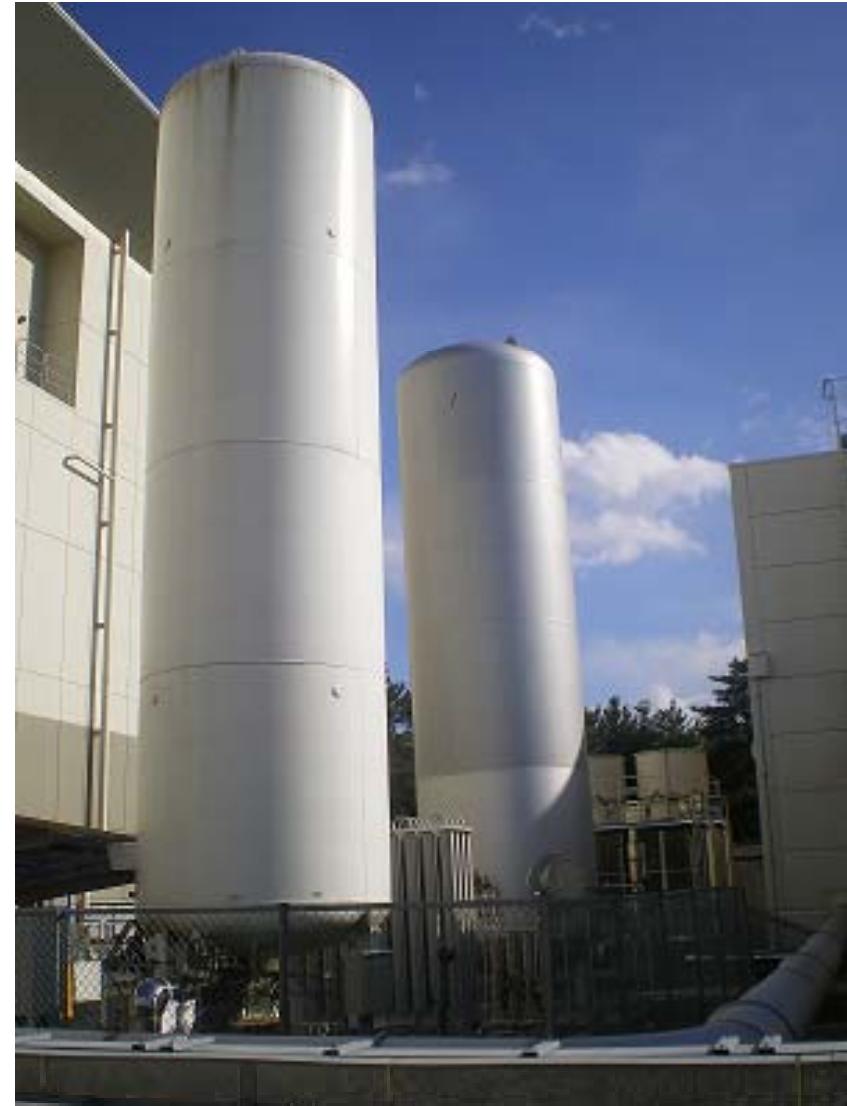
Helium tank is leaning toward left (right). Front is nitrogen tank.

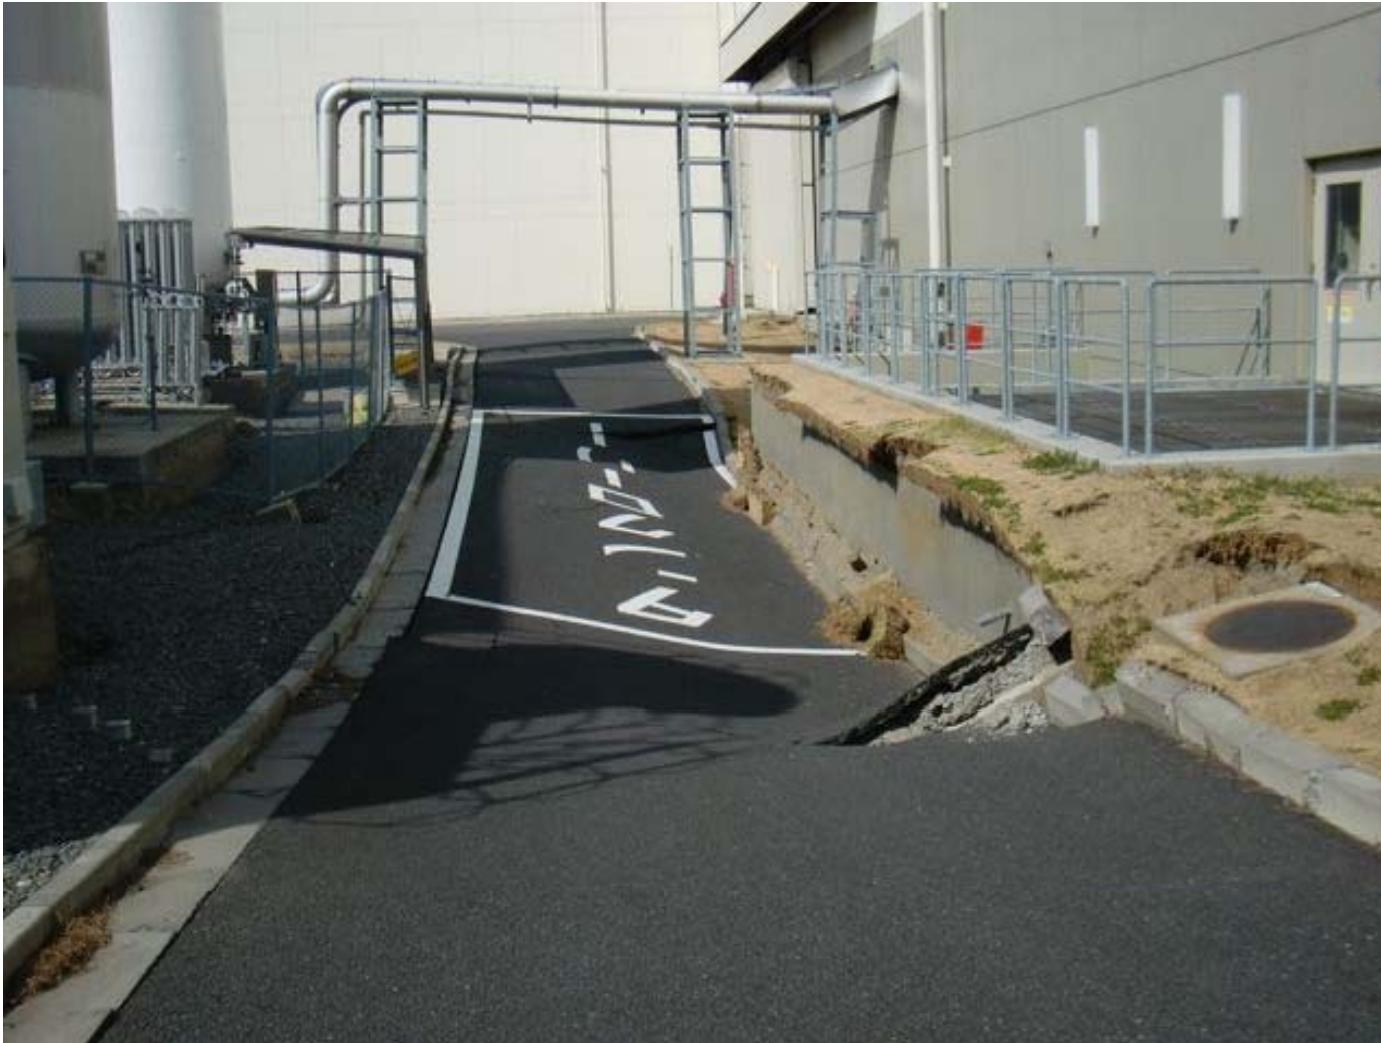
Materials and Science Area (MLF) (2)

West side road from MLF. About 1.5 m sinking was observed.
