General Overview (2011.3.28)

- March 17 (Thu). Inspection of all buildings, utilities, and facilities for J-PARC
 - Photos are displayed in what follows. No electricity. Very limited inspection.

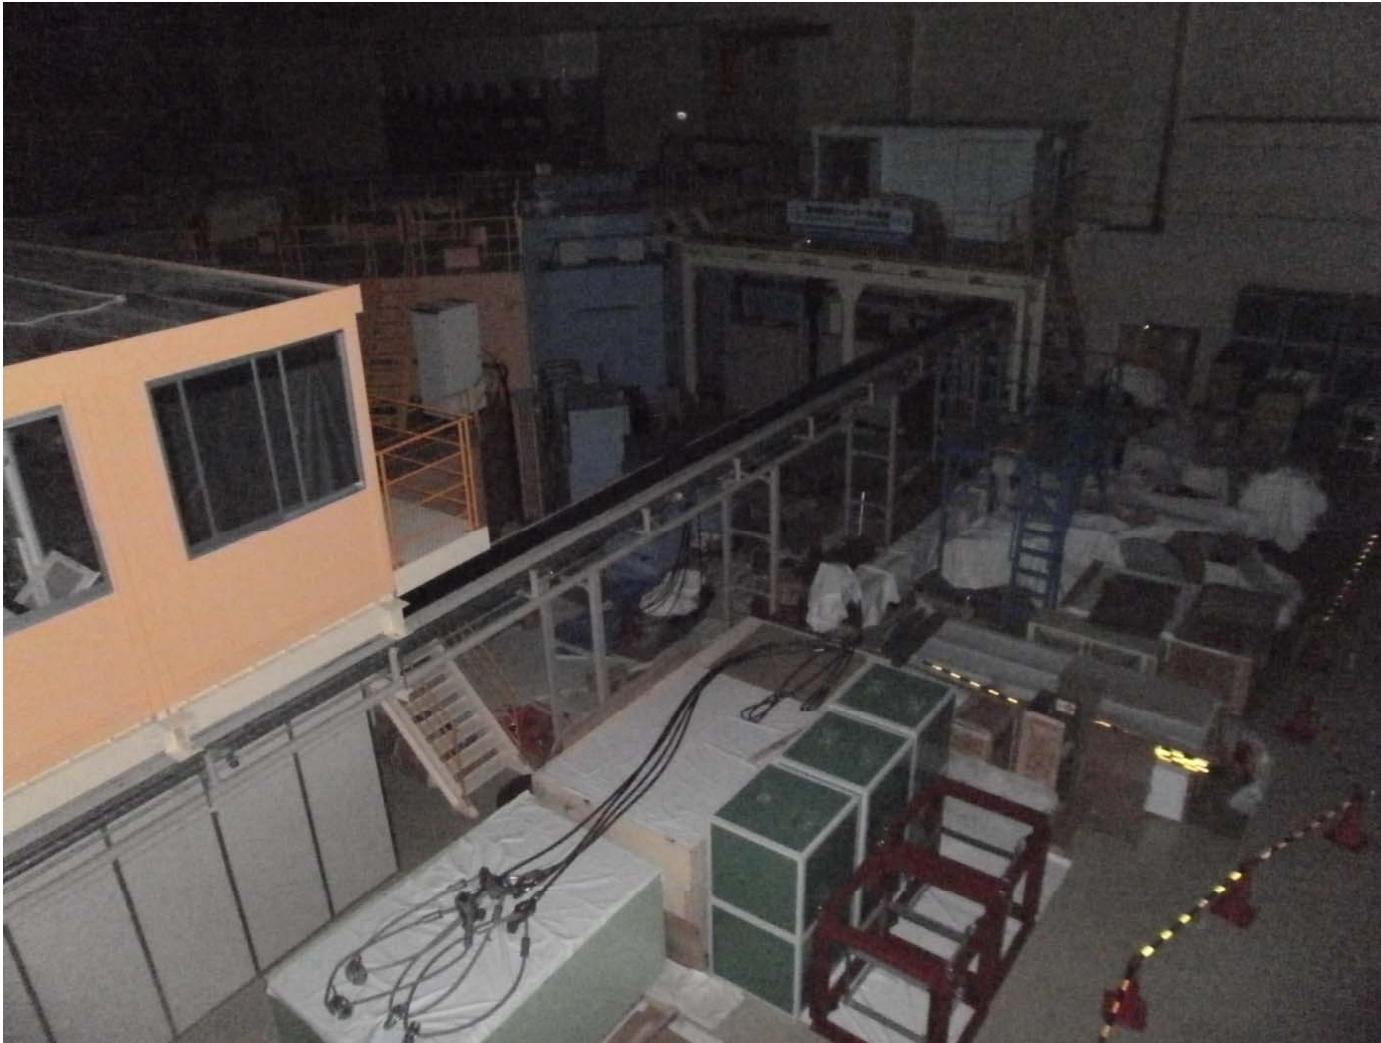
MLF First Hall and Second Hall

Interior part of the Hall 1 and Hall 2 are very healthy, thanks to many underpins for the building.

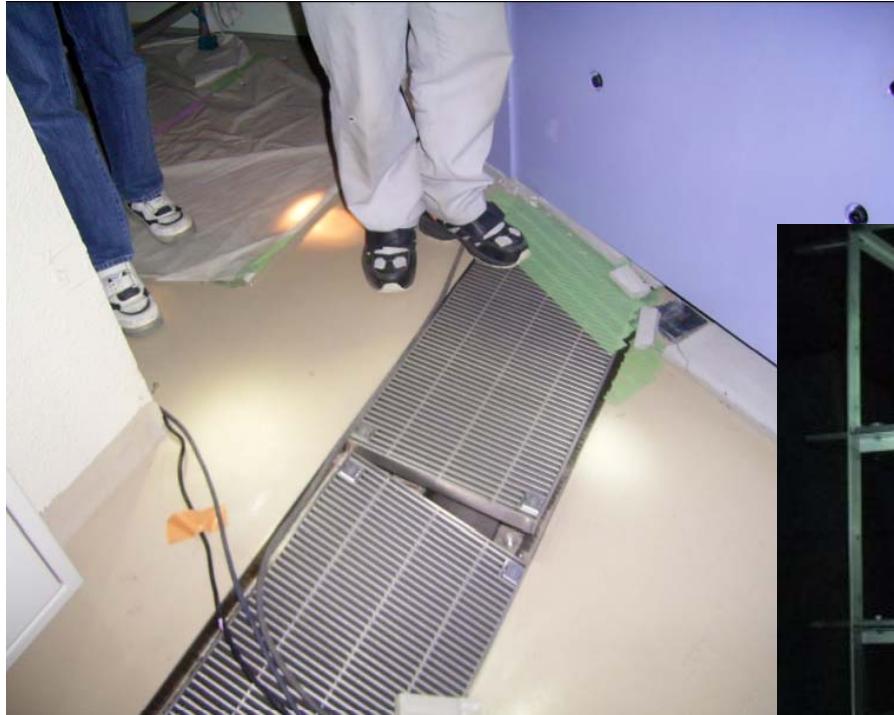
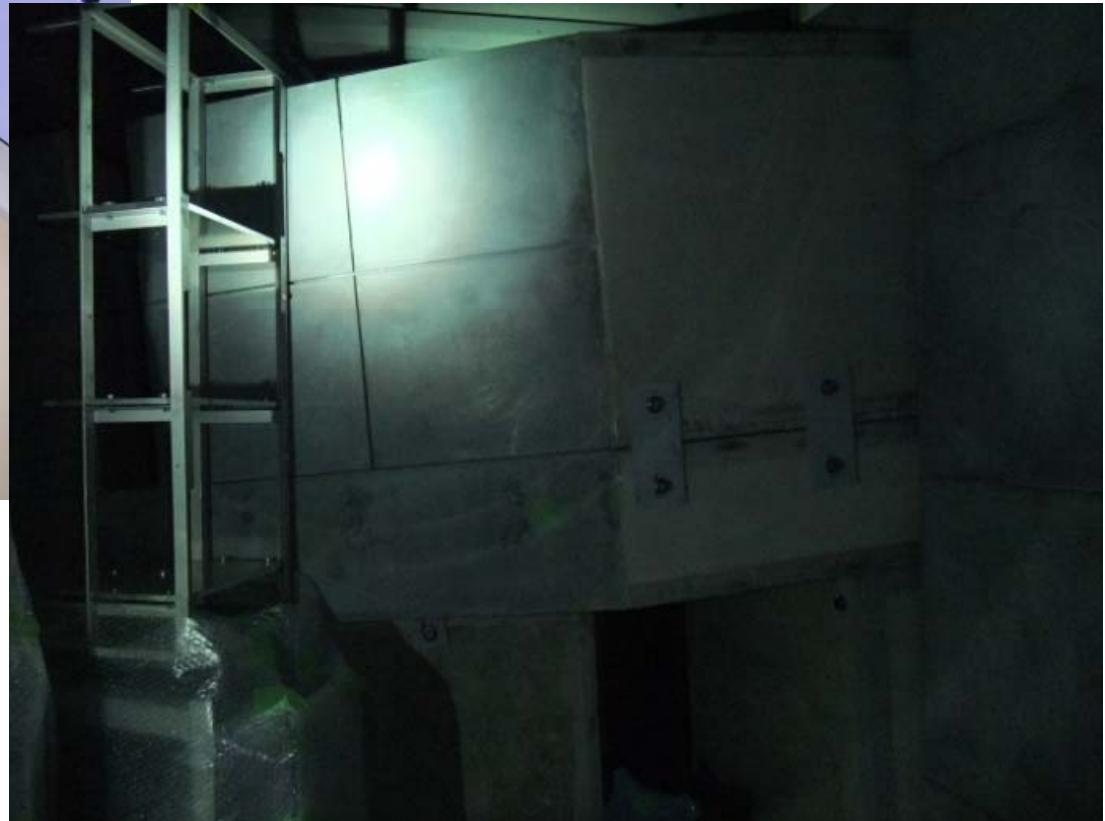
MLF West-side Added Building

30 cm dropped for the west-side added building (left). BL18,BL19 and BL20 were damaged. Vertical parallel lines are now leaning toward the left (right).

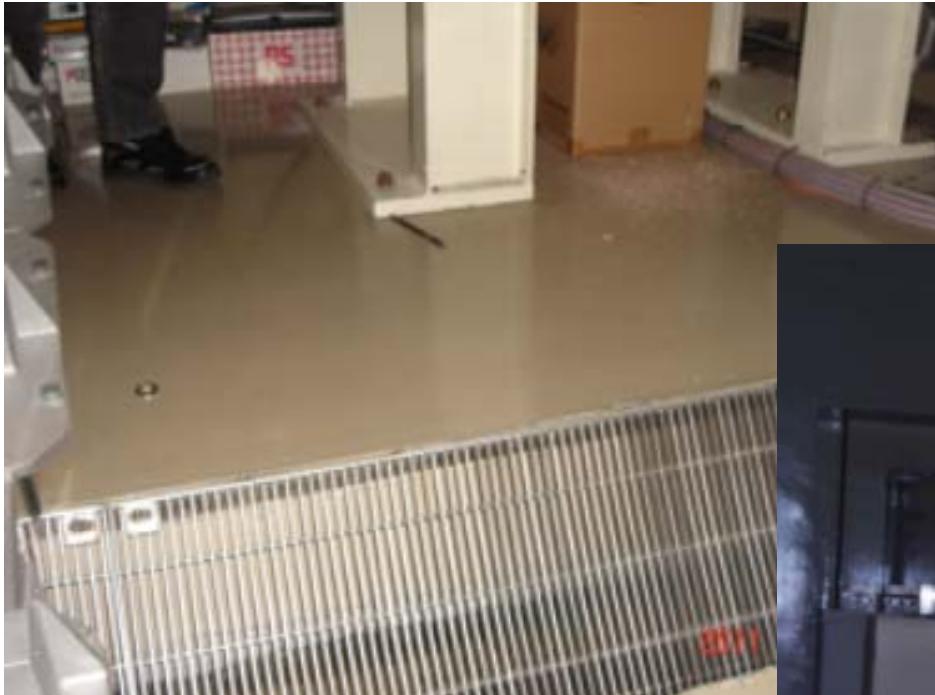
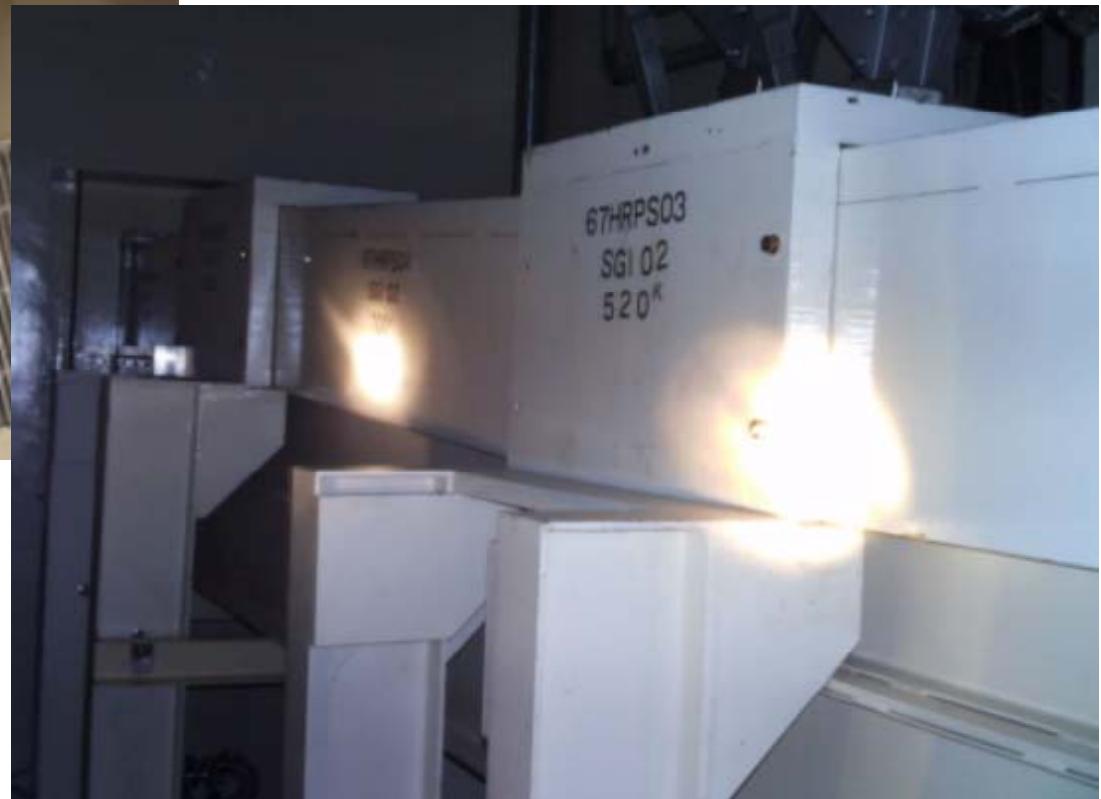
MLF East-side Added Building

30 cm dropped for the east-side added building (left). BL08 and BL09 were damaged. For BL08 all mirrors for the optical guide were broken (right).

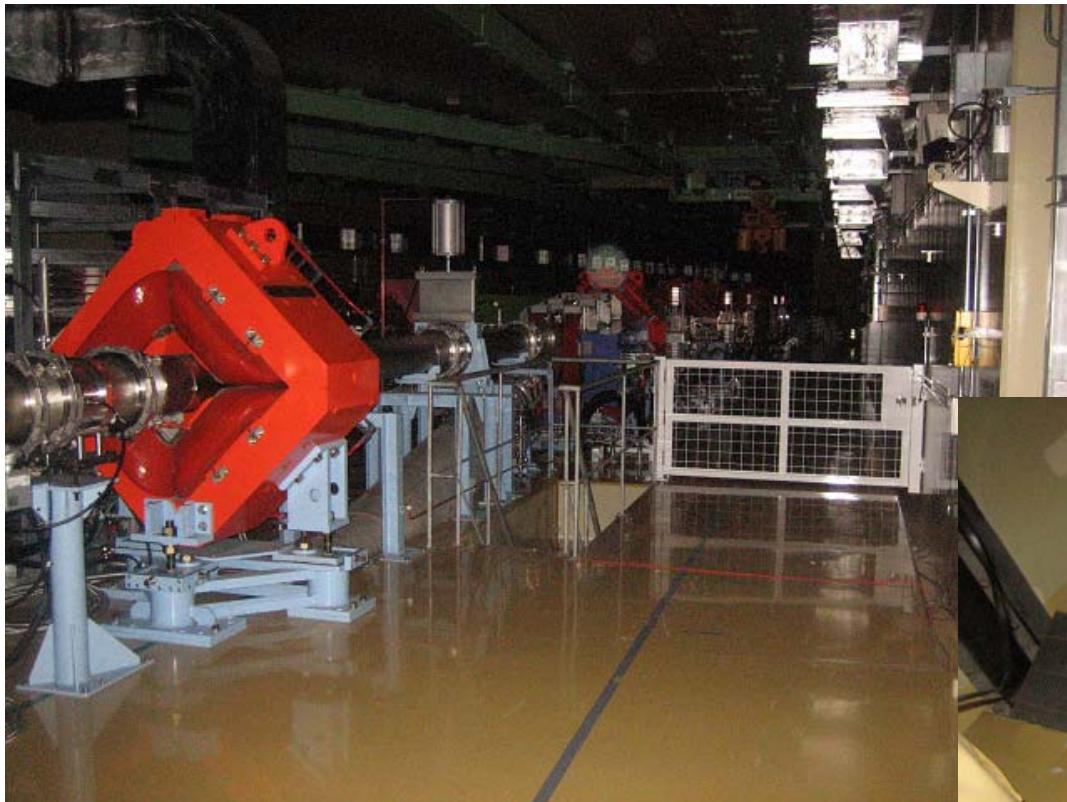
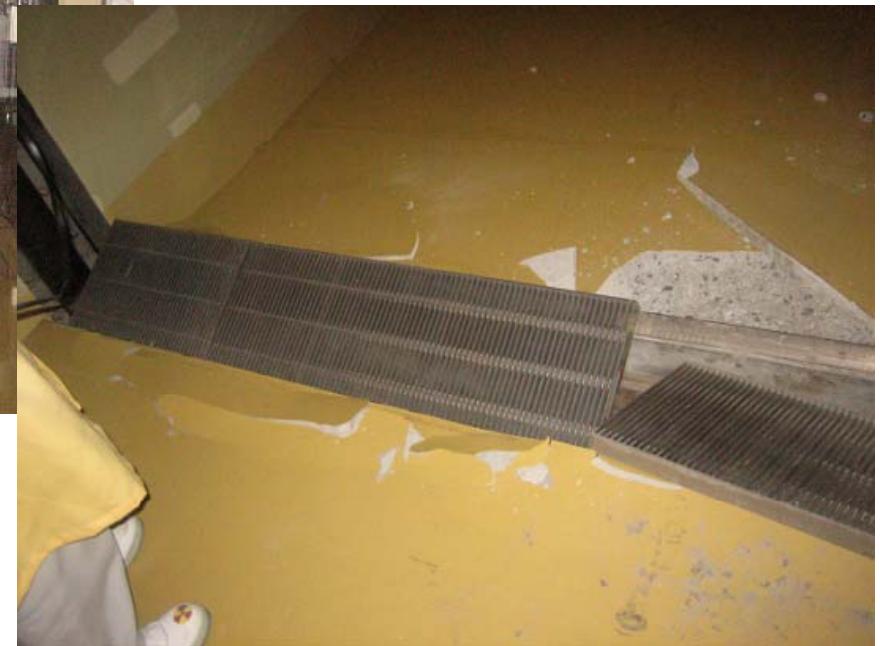
3NBT (Beam Transport from 3GeV)

3NBT itself seems OK. However, on the joint portion, there was a crack due to displacement.

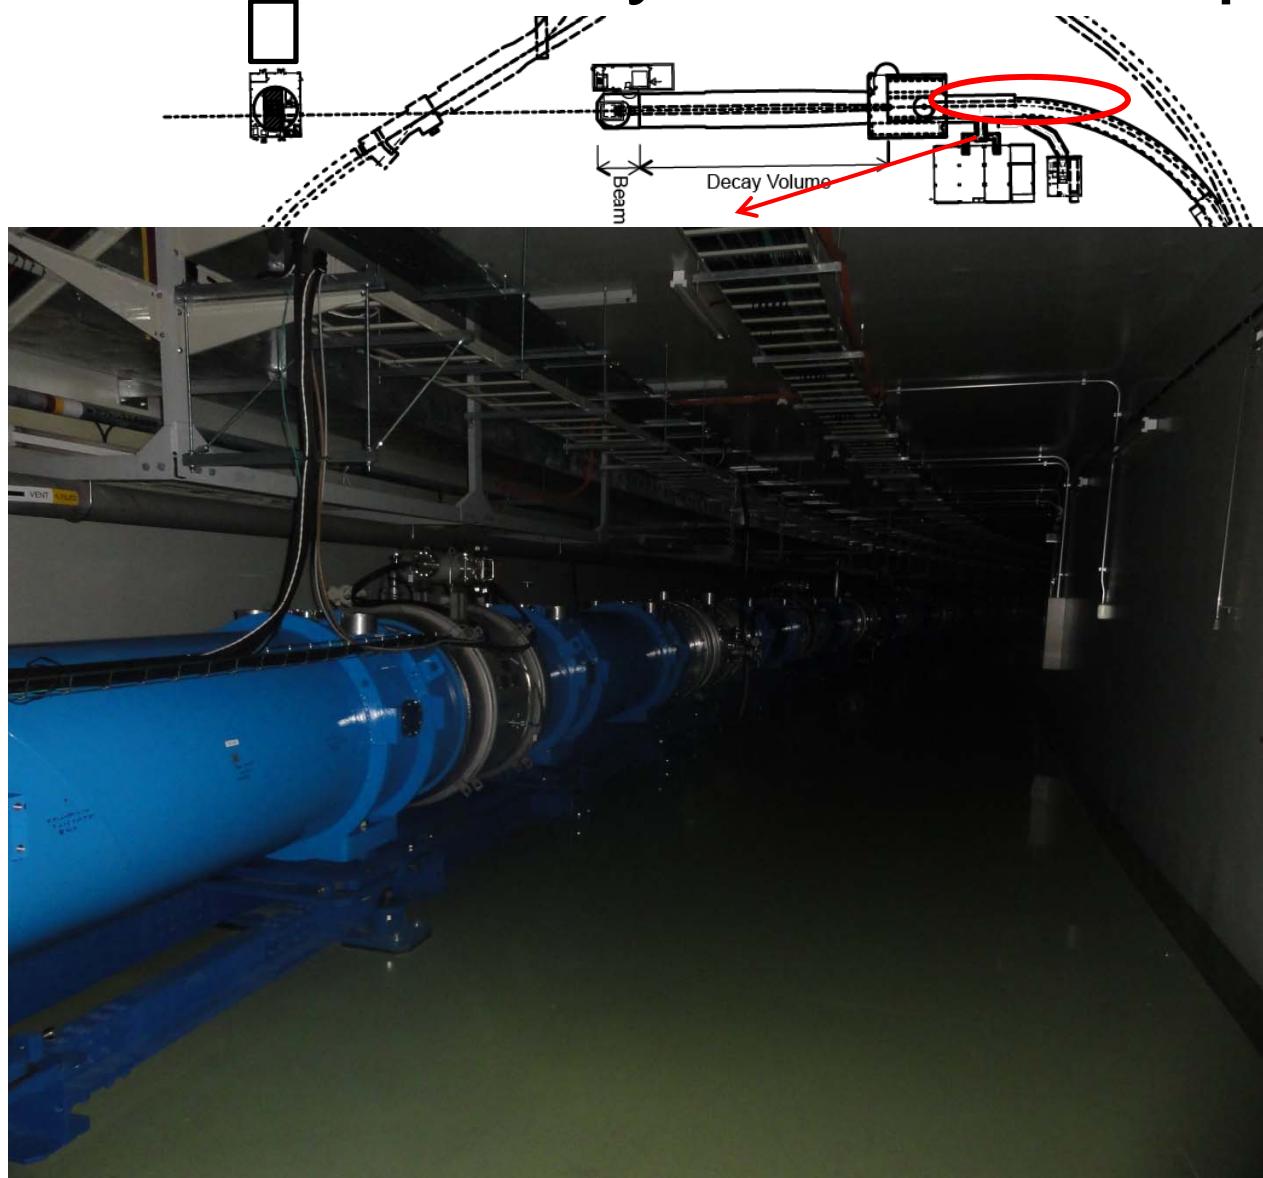
Neutrino: Primary Beam Transport

No significant damages from outside.

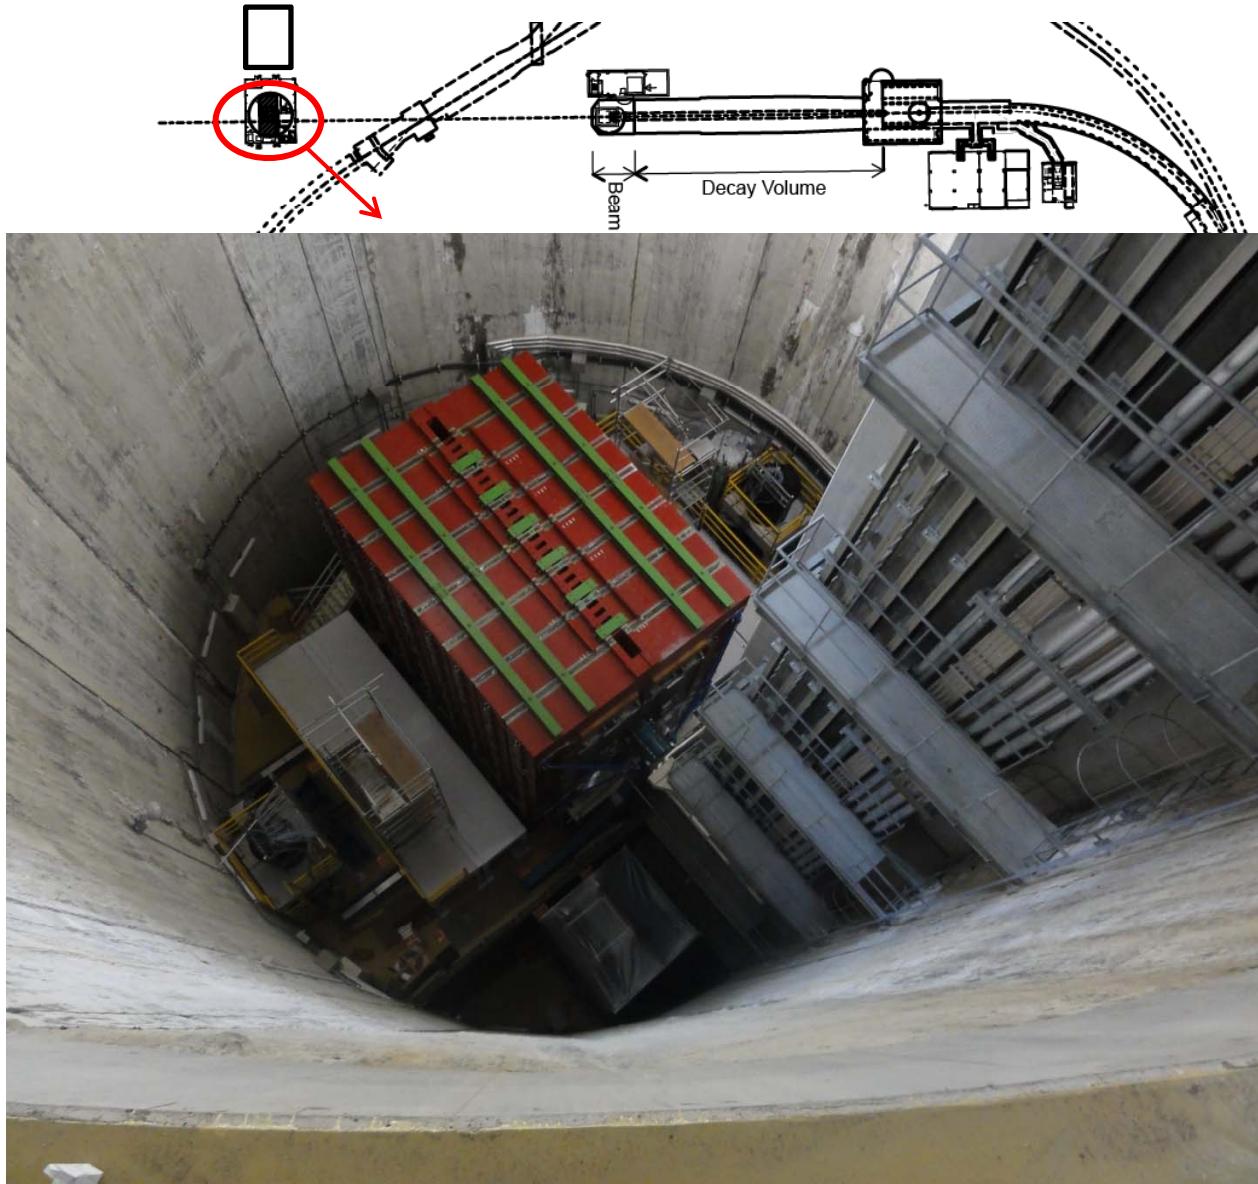
Neutrino: On Site Detector

No significant damages from outside. About 1 cm deep water at the bottom.

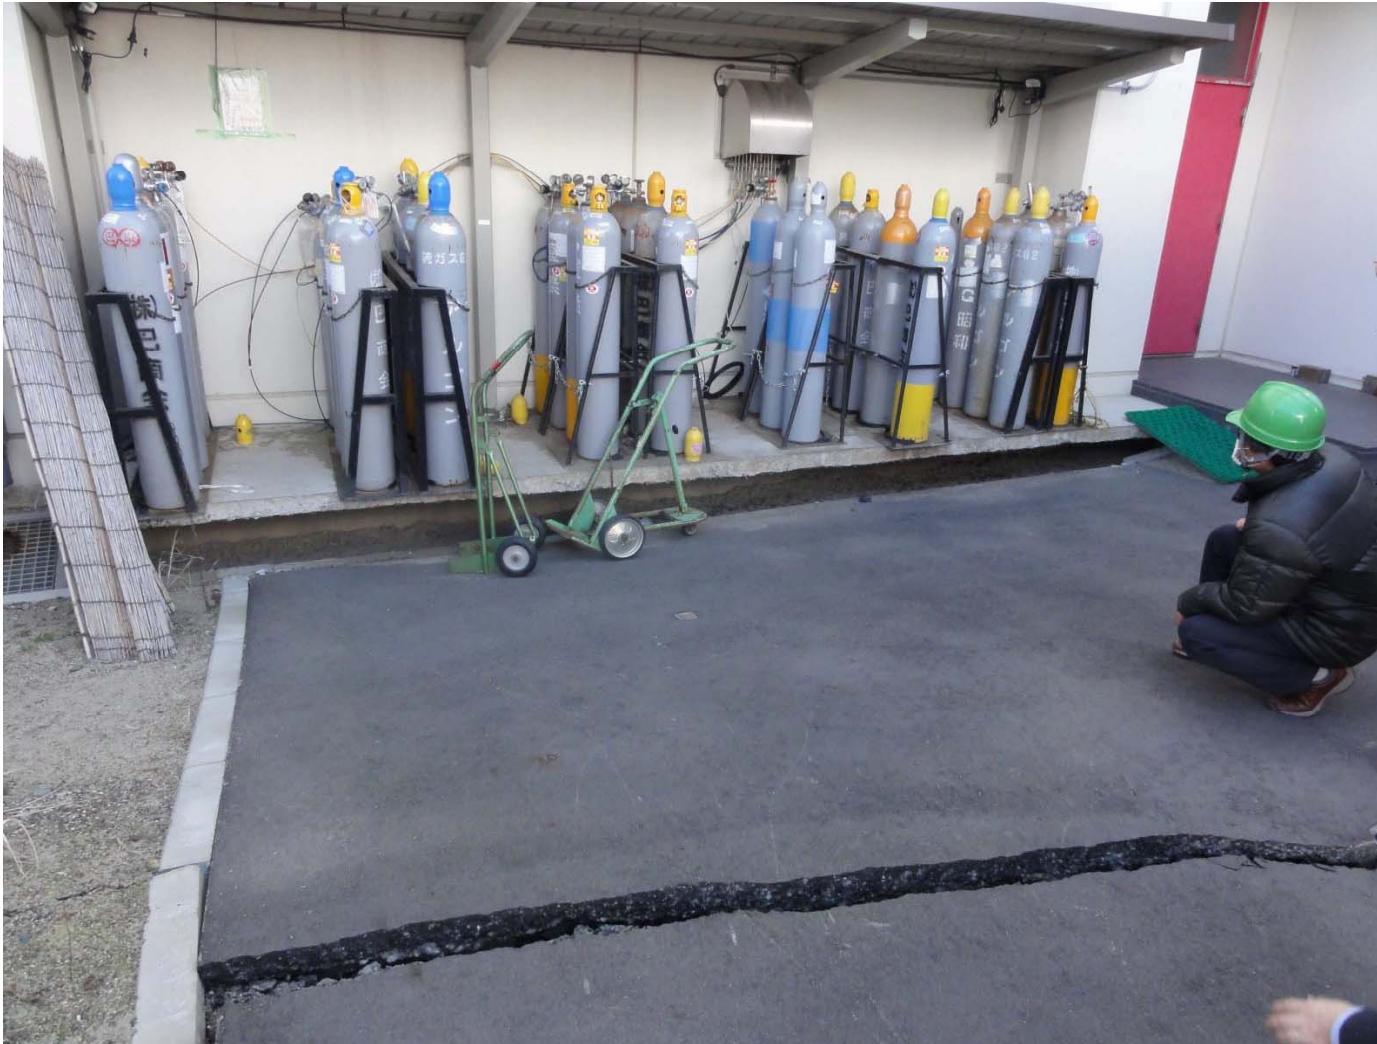
Hadron Outside Area (1)

About 30 cm drop all over the places. Gas storage stand is floating up on the air.

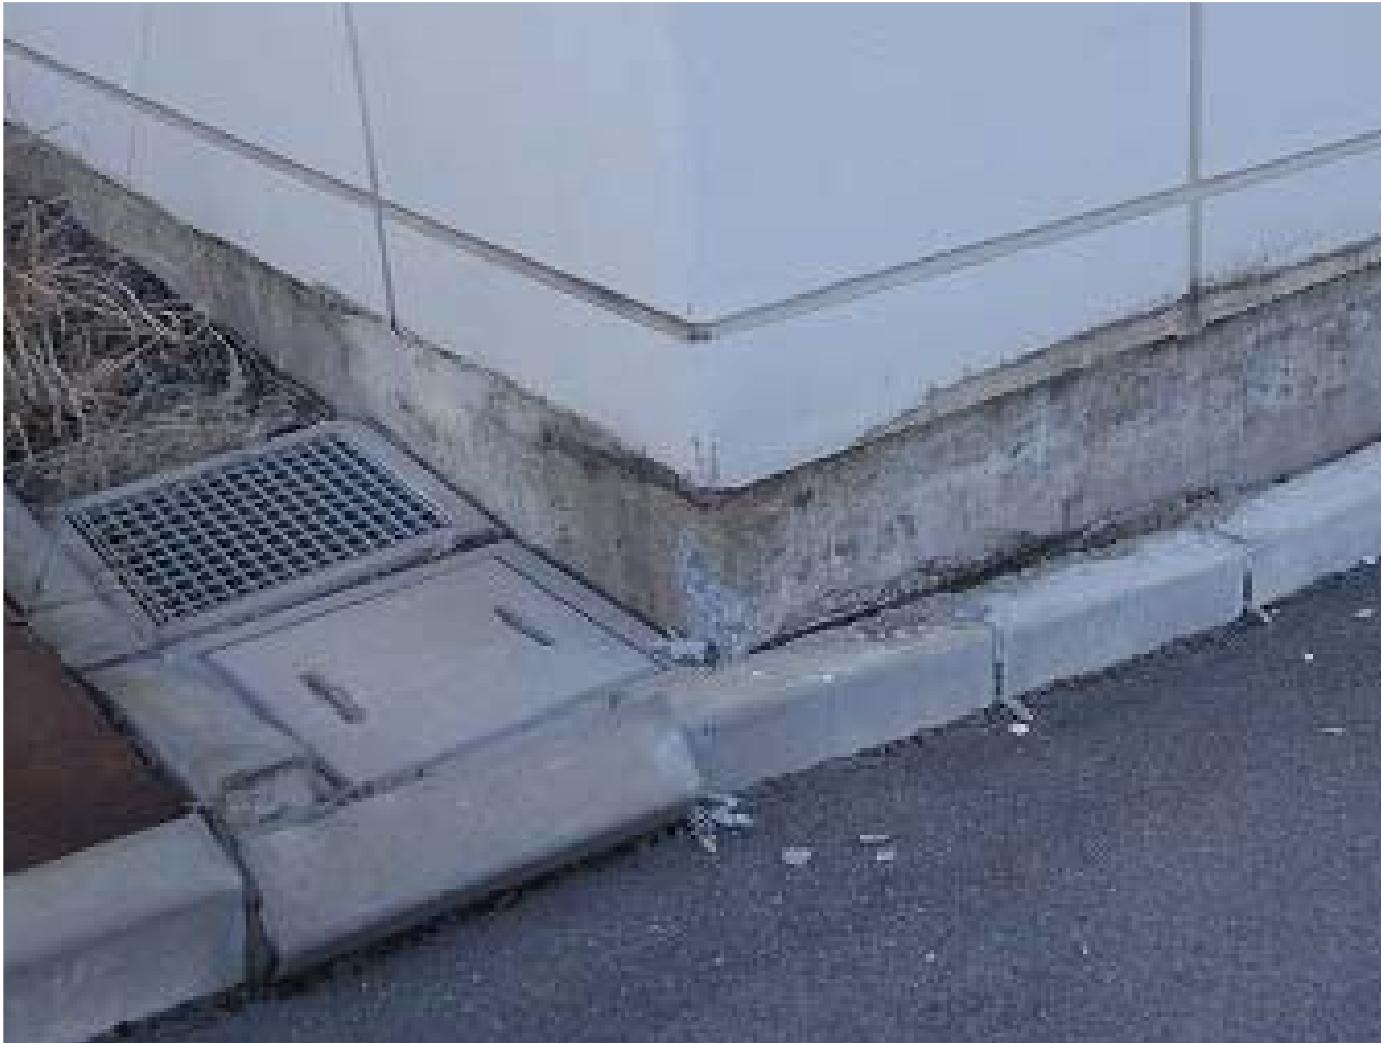
Hadron Outside Area (2)

Again about 30 cm drop.

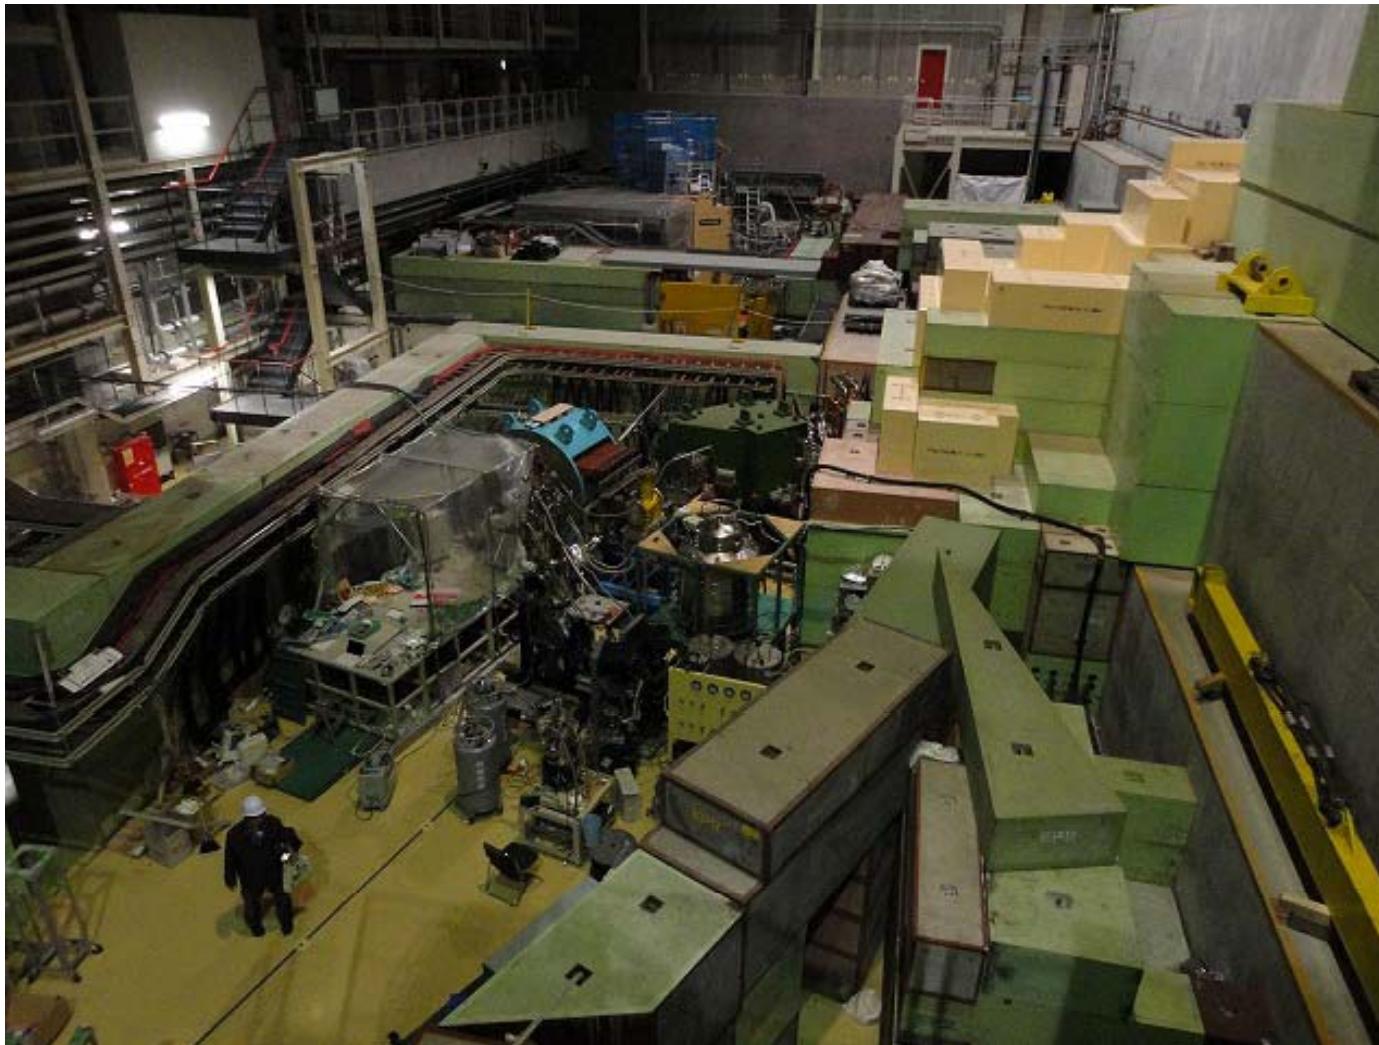
Hadron Experimental Hall

Due to many underpins, hadron hall looks OK.
No significant damages were observed.

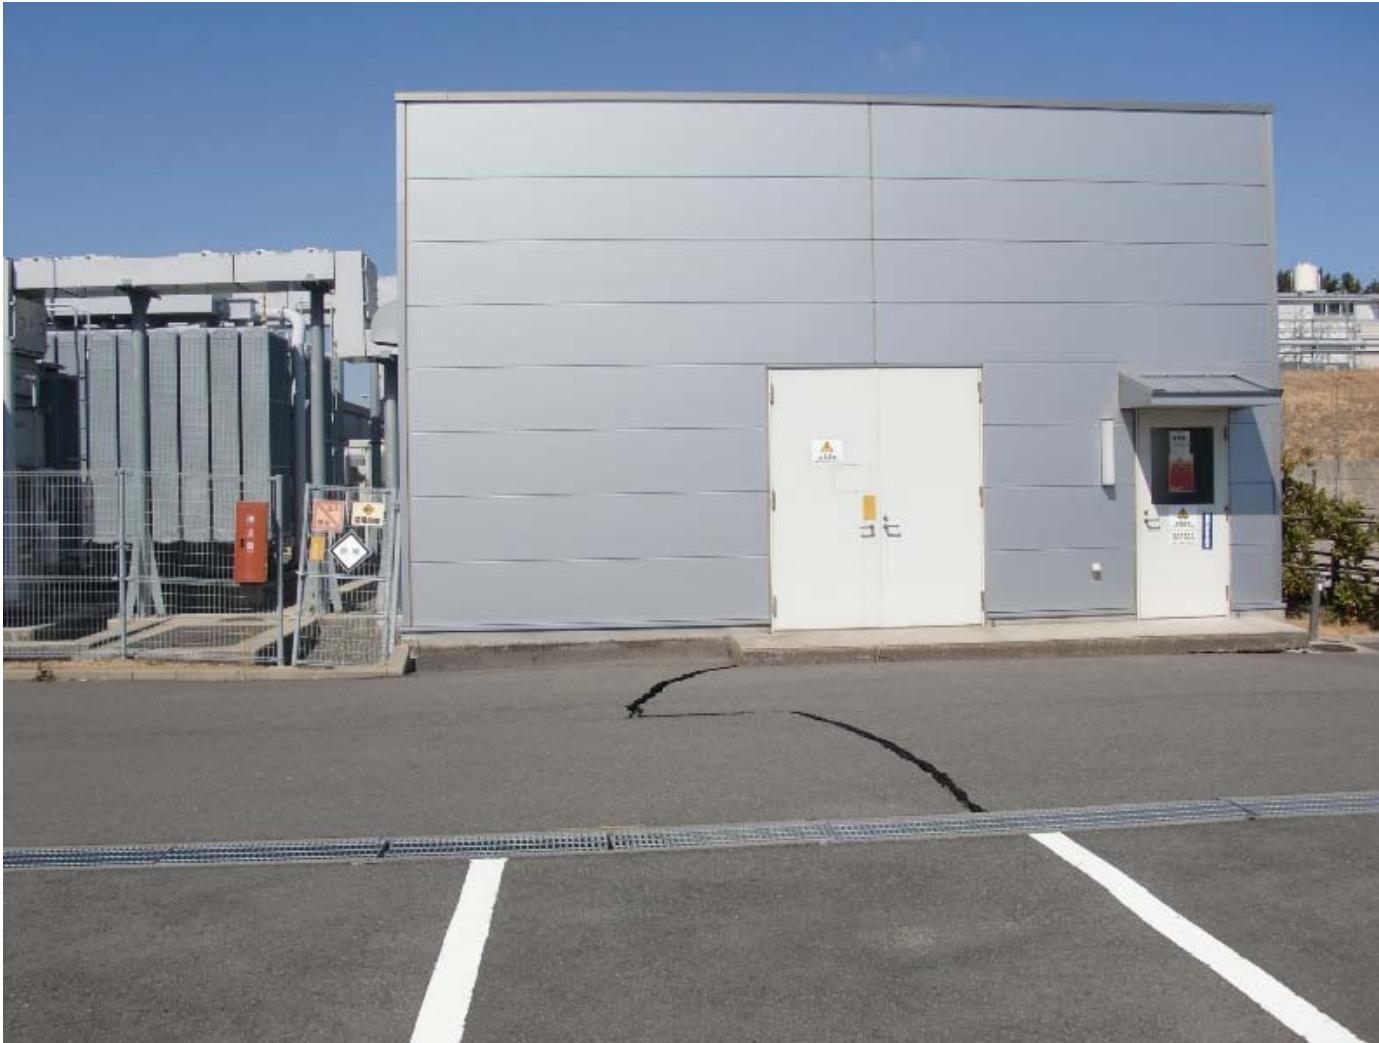
Major Power Transformer for Linac, etc.

- Out of two major transformers, one for Linac was inclined, whereas other for MR was OK. On March 23 it turned out that Linac transformer is recoverable, though.

About 10 degree leaned. At the beginning we were told that it would not work at least half a year. Later it turned out that it would work immediately.

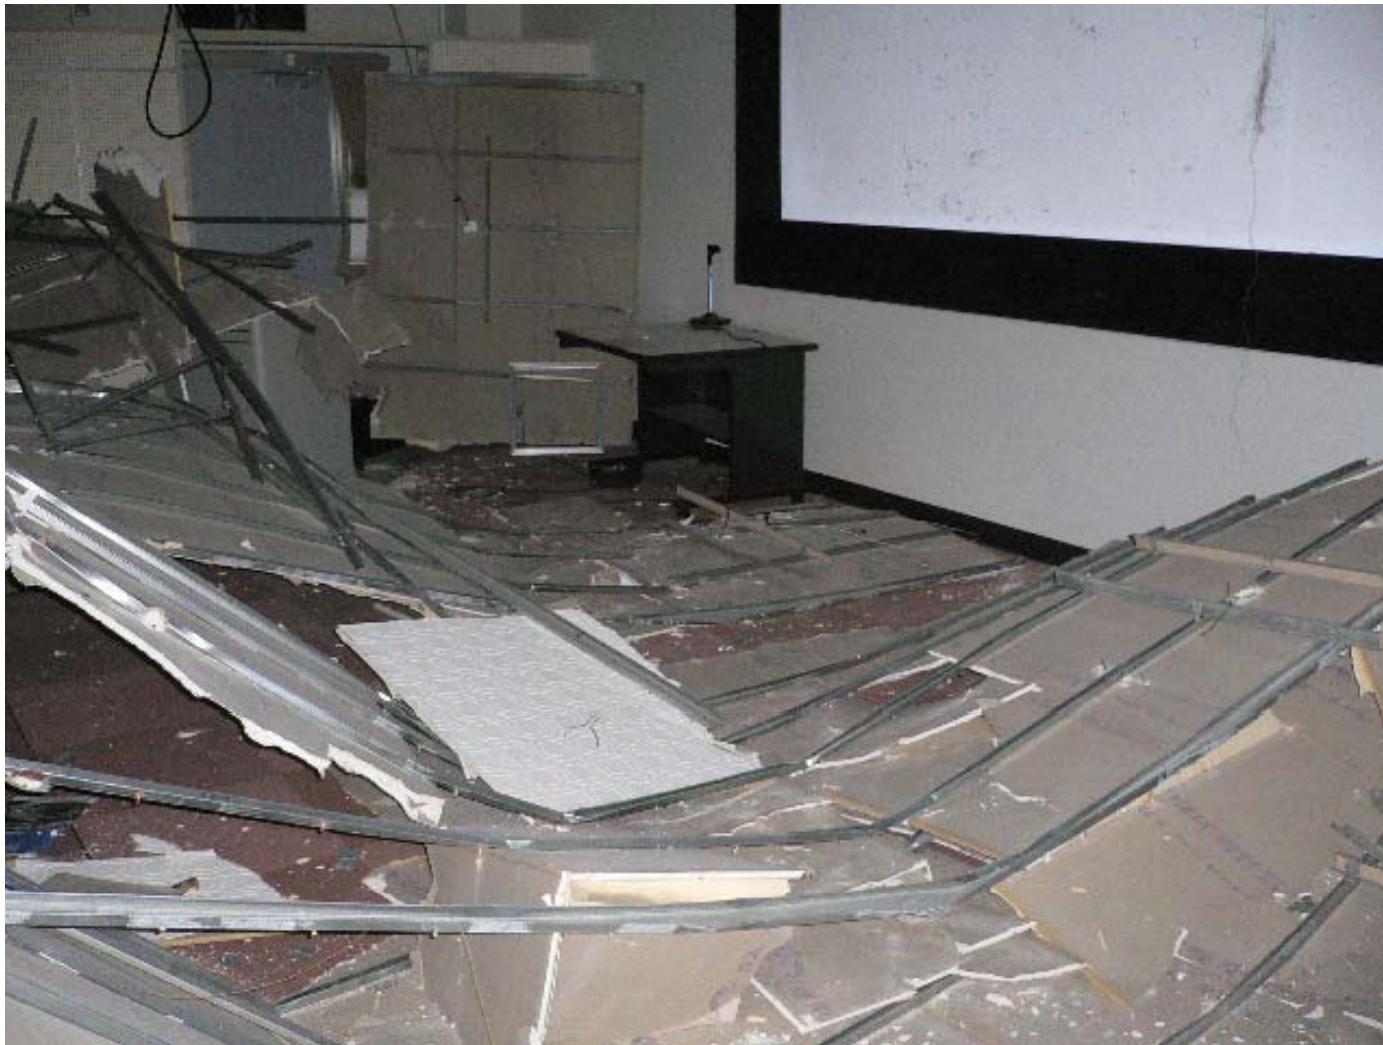
Lecture to the Visitors

The lecture was given in the front desk. Then, the entire ceiling was dropped. Immediately, instructed to hide under the desk. No injuries. Place is JRR-1.
