Status after April 4th (Linac #1)

Investigation for the interior of cavity

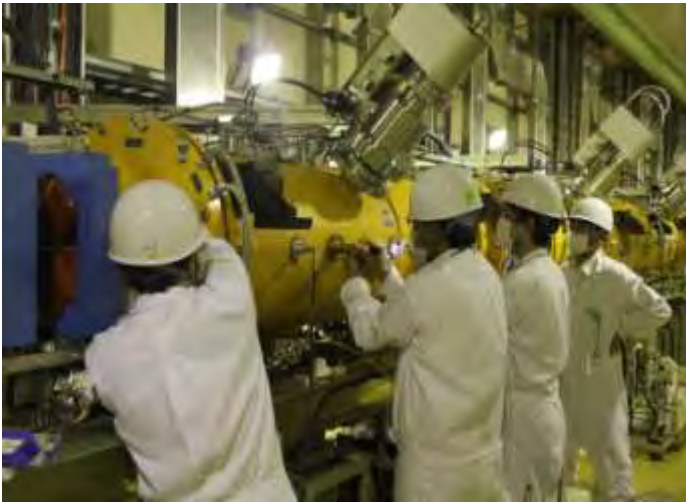
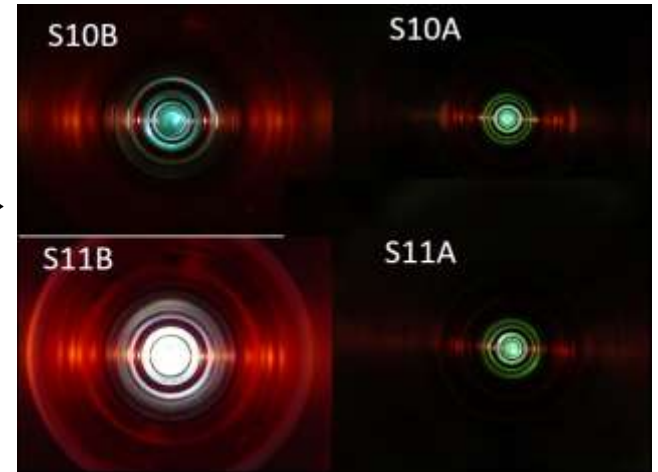
- Setting camera to measure interior
- In so far, no serious problems were found

← Measurement

Camera view →

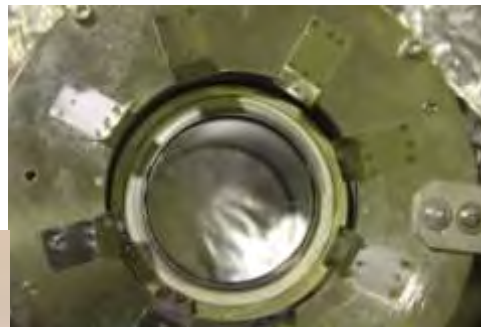
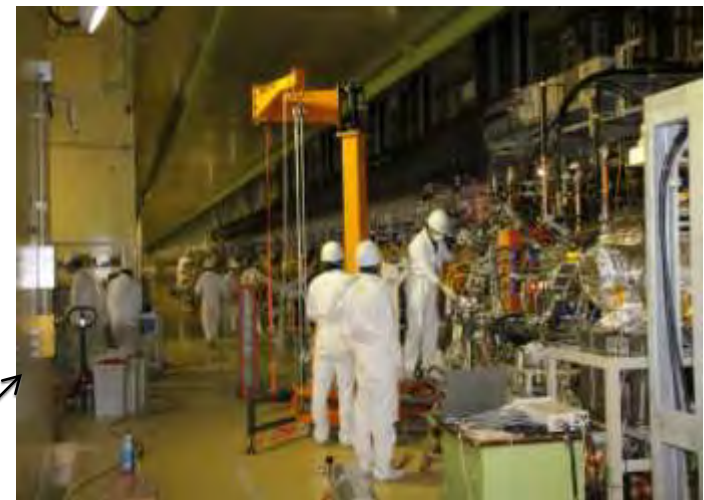
Damage for Monitors

- About 15 current monitors had problems.

Examination of all monitors is not a trivial task. Removal together with quadruple magnet.

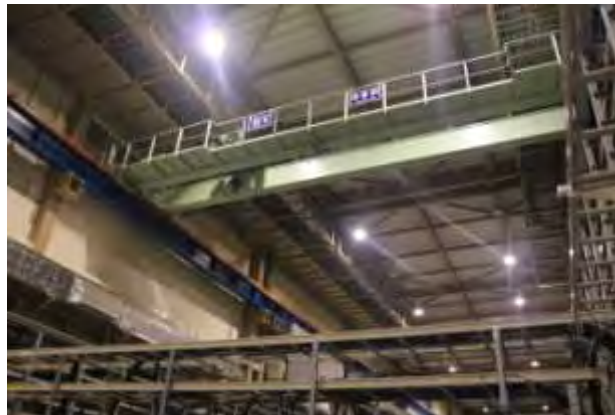
- Many bolts were dropped from the crane at the top.

- If this problem remains, the recovery work will be delayed.

Cracks seen on the neck position for the crane →

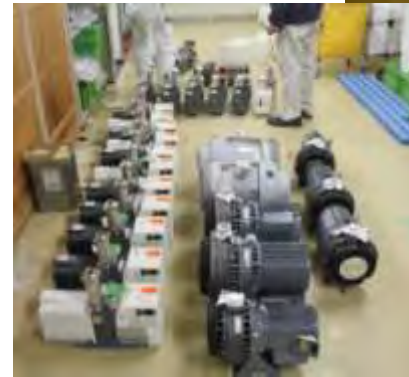
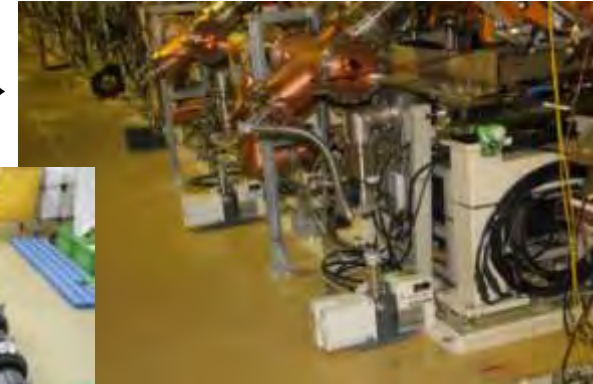
- Vacuum pumps with waters were tested and installed

Vacuum pumps after inspection →

← Pumps with waters inside bolts that were dropped.

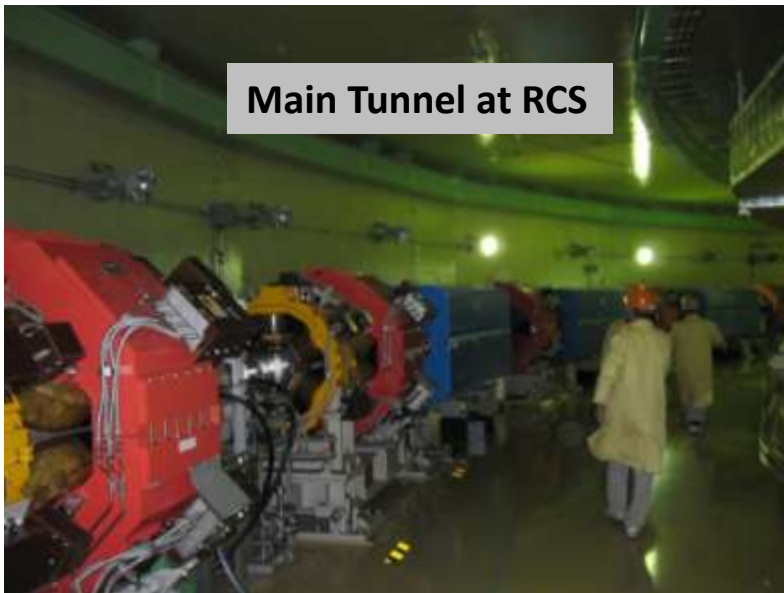
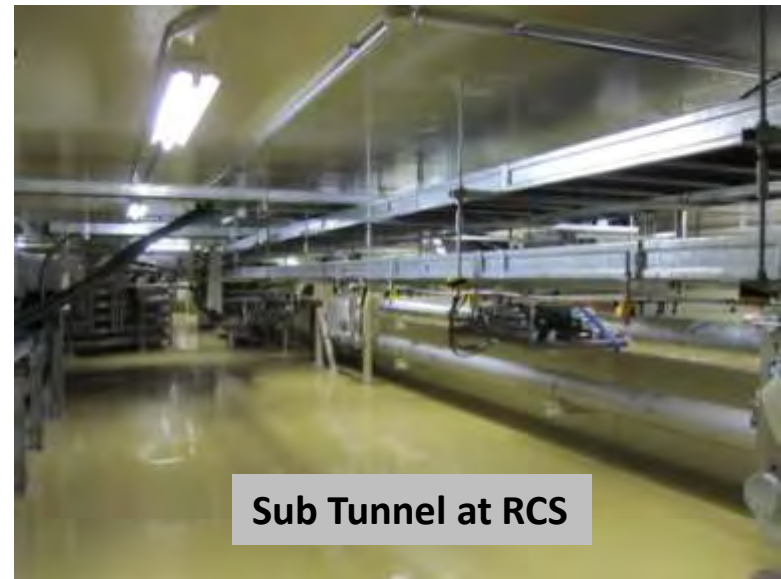
Main tunnel and sub tunnel at RCS (no serious damage).

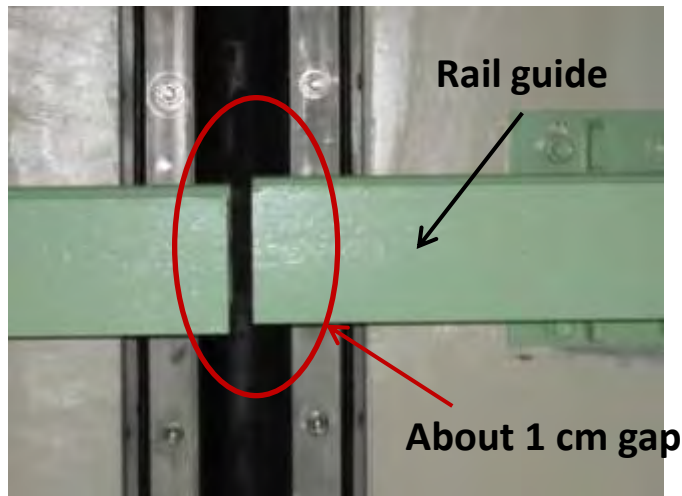
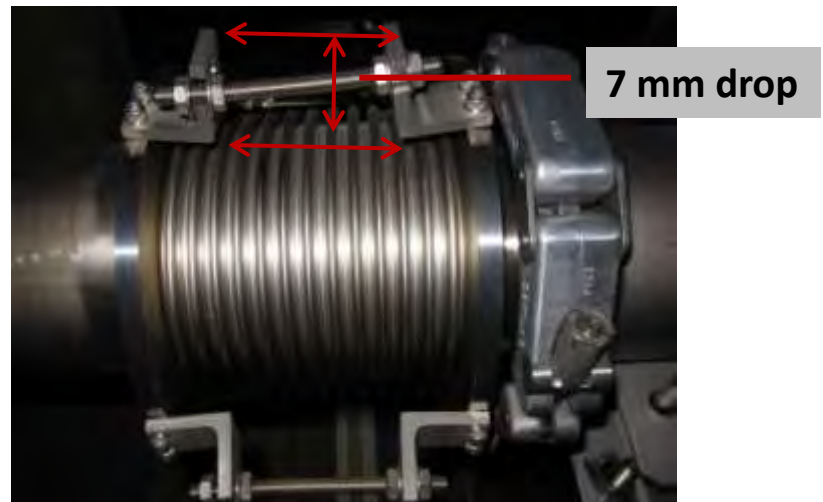
Connection point between RCS and Linac (about 1 cm gap).

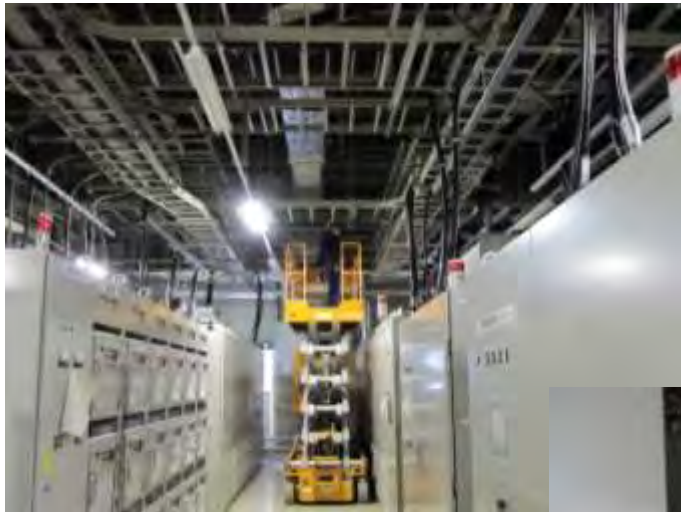
↑ Examination of Cable Racks

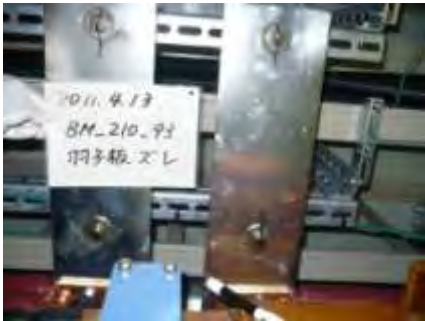
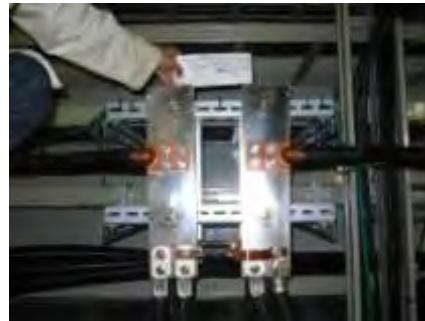
- No serious damage.
- Slight movement as seen below.

↑ supporting plate with slight movement.

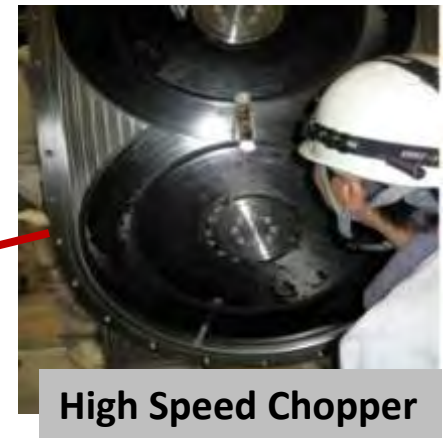
- Vacuum leakage is observed.
- Bolts were either removed or unfastened.

- This part is healthy.

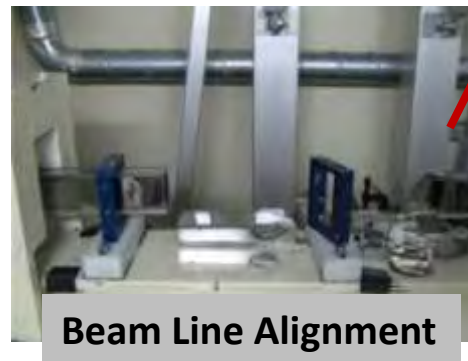
- Vacuum system is OK
- Small damage for cables.

- Partially destroyed but recoverable.

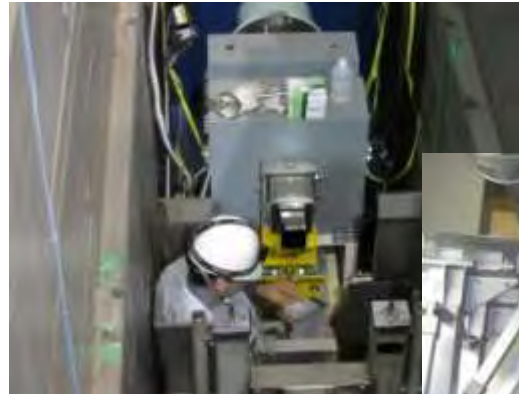
← Guide Mirrors.

BL-08: Guide Mirrors were partially damaged, in particular, near the joint region between buildings.

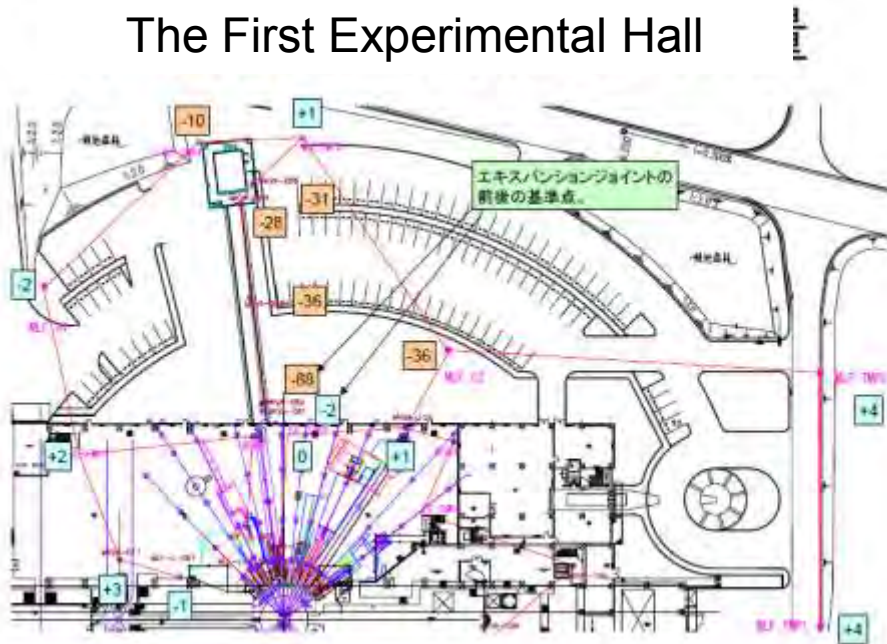
The First Experimental Hall

- For an extended part, like BL-08 a large gap is observed vertically. At this joint position about 9 cm drop is observed and the guide mirrors were damaged.

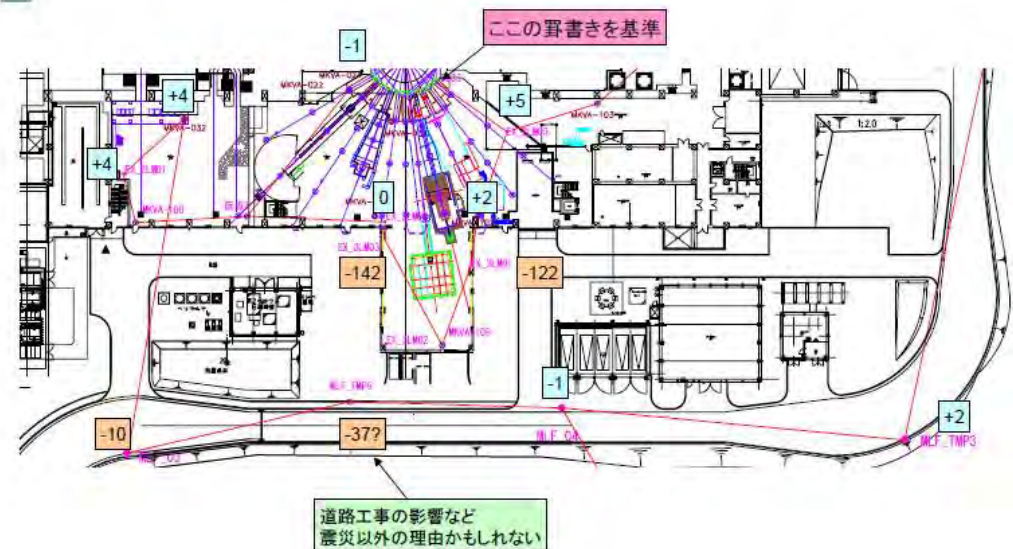
The Second Experimental Hall

- A large drop (say , BL-19) for about 14 cm for the extended part.
- Discussion on how to repair the entire extended halls.

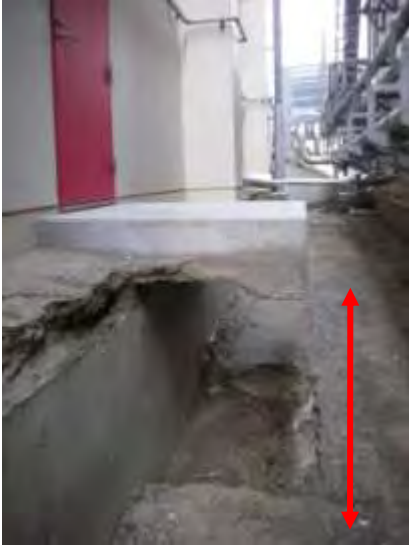
← Entrance for the Hall. About 1 m gap.

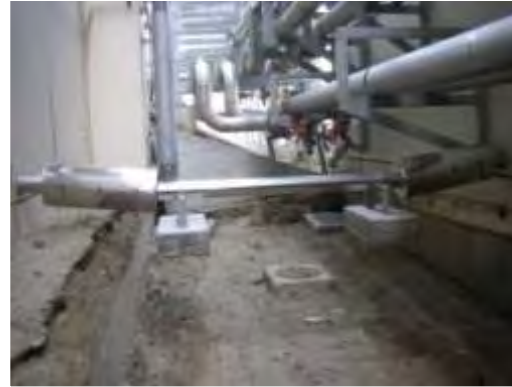
↑ Disconnected pipes
Distortion of bellows →

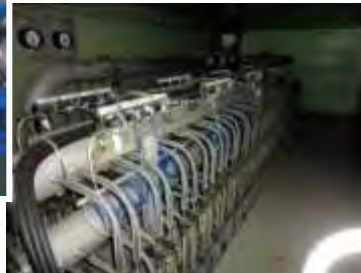
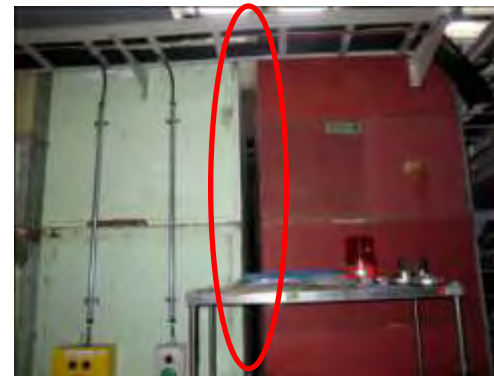
Slight displacement is observed for experimental apparatus.

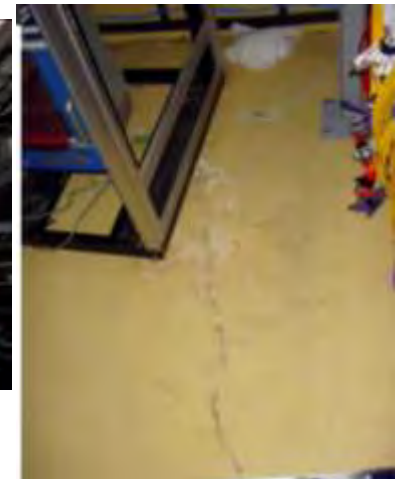
Crack observed on the floor. Water leakage is observed.
