Report from the Working Group

Working Group for the External Expert Panel
on the Radioactive Material Leak Accident
at the Hadron Experimental Facility of J-PARC

The Second External Expert Panel Meeting to
Review the Radioactive Material Leak Accident at
the Hadron Experimental Facility of the J-PARC
at KKR Hotel Tokyo on July 5, 2013

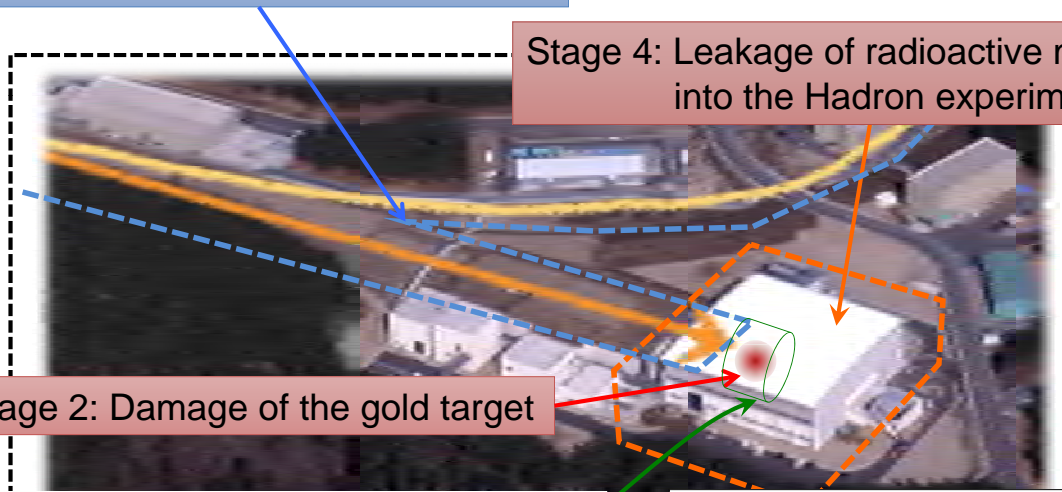
The sequence of the accident is dissected into five stages where the causes therein are analyzed

Stage 1: Delivery of abnormal beam

Stage 4: Leakage of radioactive material into the Hadron experimental hall

Stage 2: Damage of the gold target

Stage 3: Leakage of radioactive material into the primary beamline

Stage 5: Leakage of radioactive material into the environment outside the HD Facility

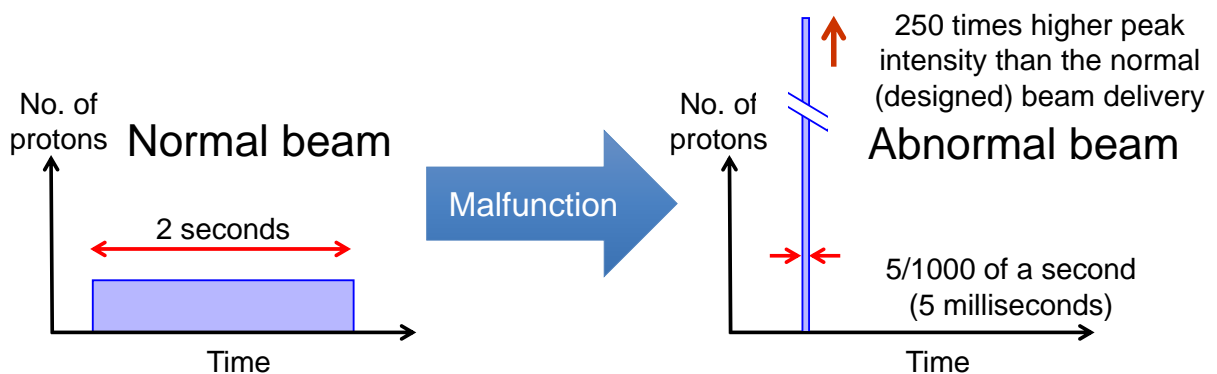
Stage 1: Delivery of abnormal beam

- At around 11:55 of May 23, 2013, due to a malfunction of the slow extraction system of the 50 GeV Synchrotron (MR), a proton beam consisting of 2×10^{13} protons was delivered to the gold target within a very short period (5/1000 of a second).
- Normally 3×10^{13} protons are slowly and evenly extracted and delivered to the gold target over a period of 2 seconds.
