Status for Linac, etc.

Status on April 1 (1)

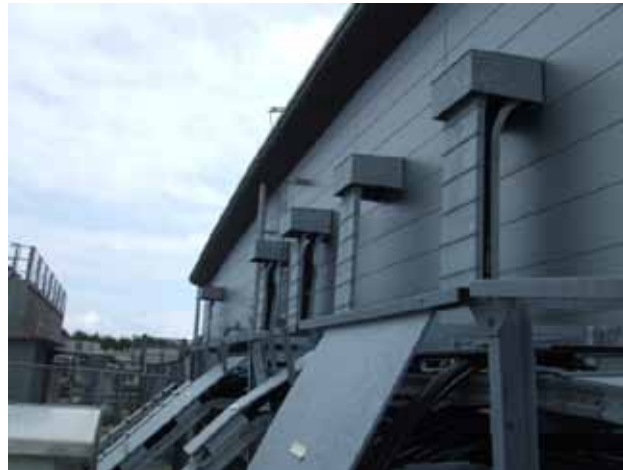
Normal wires.

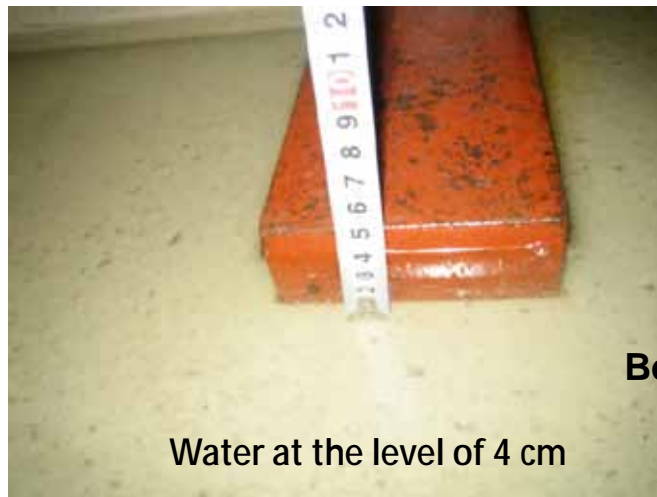
On-Site
Neutrino
Detector

- April 1 (Fri): (continued)
 - Results of pumping water for Neutrino and Hadron (below), No water for 3 GeV.
