December 17, 2013
J-PARC Center

The Observation of the Gold Target at the Hadron Experimental Facility

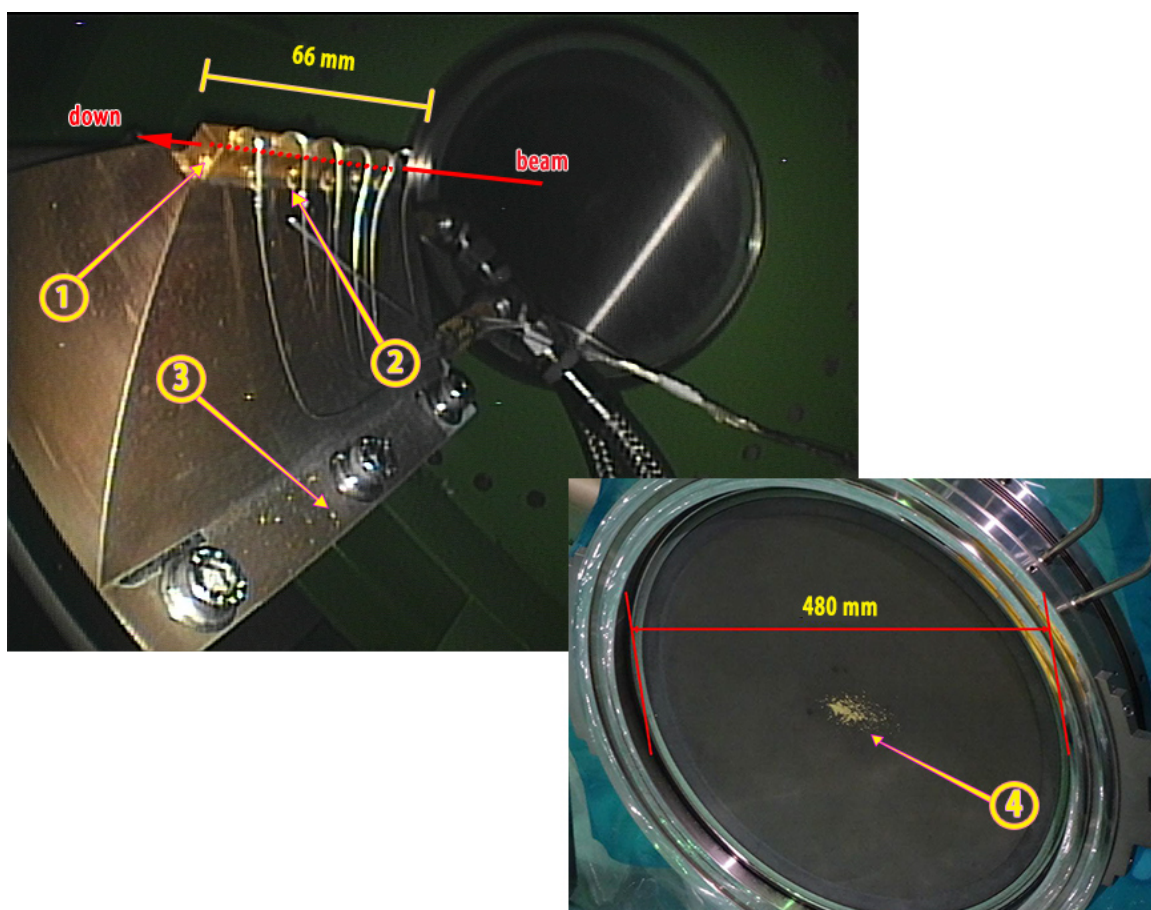
During the observation, we verified: 1) a hole 1 mm in diameter at a downstream end of the gold target, 2) gold-colored nubs, which probably are traces of dripped out melting gold from slits of a gold rod of the target, 3) probably droplets of melted gold on the copper base block and 4) traces of sprayed out melting gold on a beryllium window at the downstream of beam. Please note that these droplets marks are observed only on the right side of the target as viewed from the downstream.

These observations nicely match with our simulation results. Consequently, we consider that, at the injection, temperature of the gold target partially exceeded melting and further vaporizing points, and melted gold was pushed outward due to a rapid volume expansion resulted from vaporization of the melted gold.
